**KANDİLLİ OBSERVATORY AND EARTHQUAKE  
RESEARCH INSTITUTE**

***May 19, 2011 KUTAHYA-SIMAV  
EARTHQUAKE***

**Prepared by; Dr. Can Zülfikar  
Res. Assist. Yaver Kamer  
Res. Assist. Eren Vuran**

**June, 2011  
ISTANBUL**

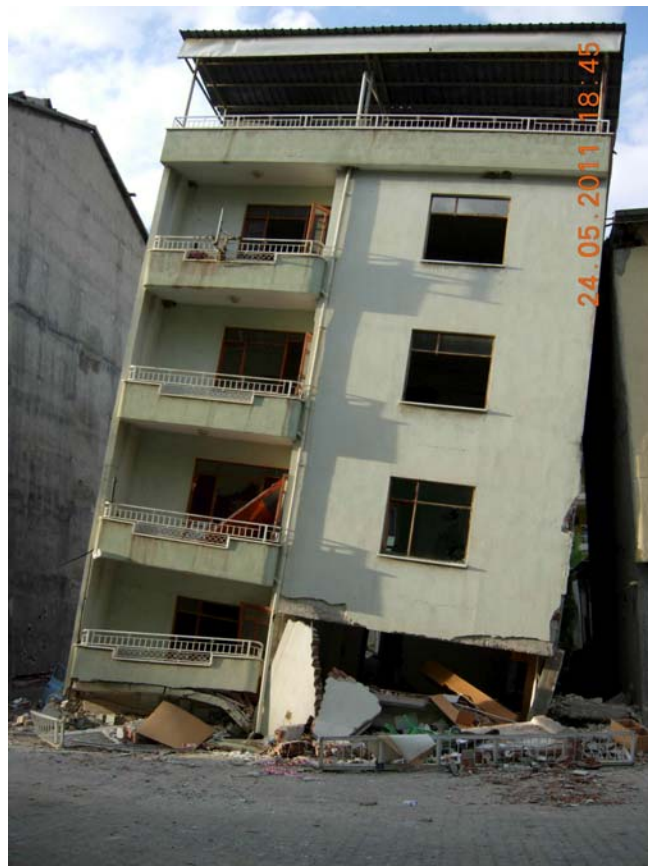
**Figure 47:** *Collapsed building at the town center*

- In the collapsed building, there were beam-column joint failures of which the column was totally splitted up from the joint.
  - Transverse reinforcements in columns and beams, which are supposed to provide confinement effect on the section, were not designed with proper intervals, bar size and 135 degrees hooks.

- Column section dimensions seem to be inadequate and longitudinal reinforcement bar sizes were usually small. Steel grade S220 was used as all reinforcement bars.

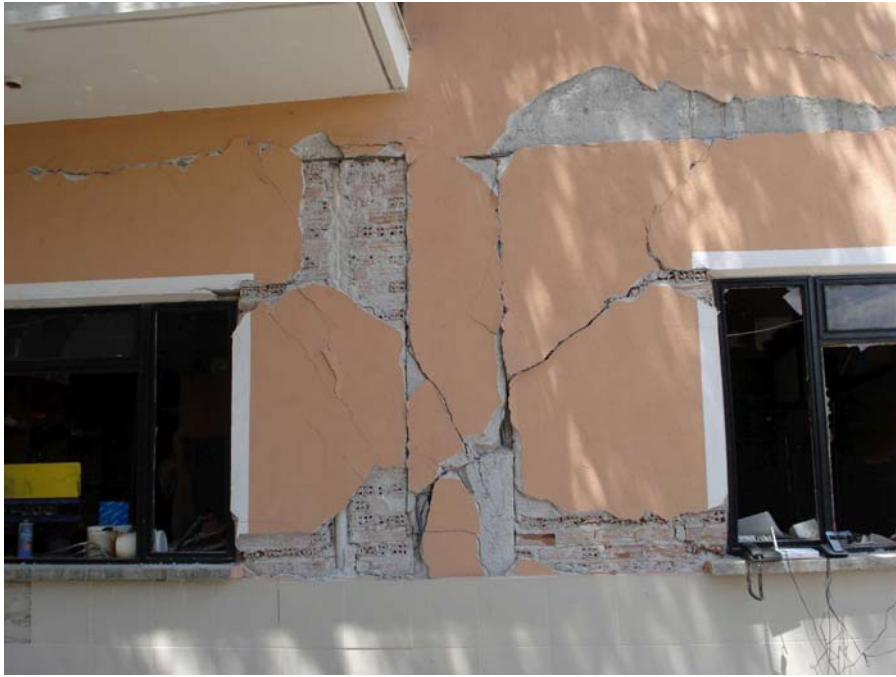
**Figure 52:** *One of few examples for heavy structural damage, column behaved as a short column ,infill walls were composed of fired structural bricks instead of standart infill wall bricks.*

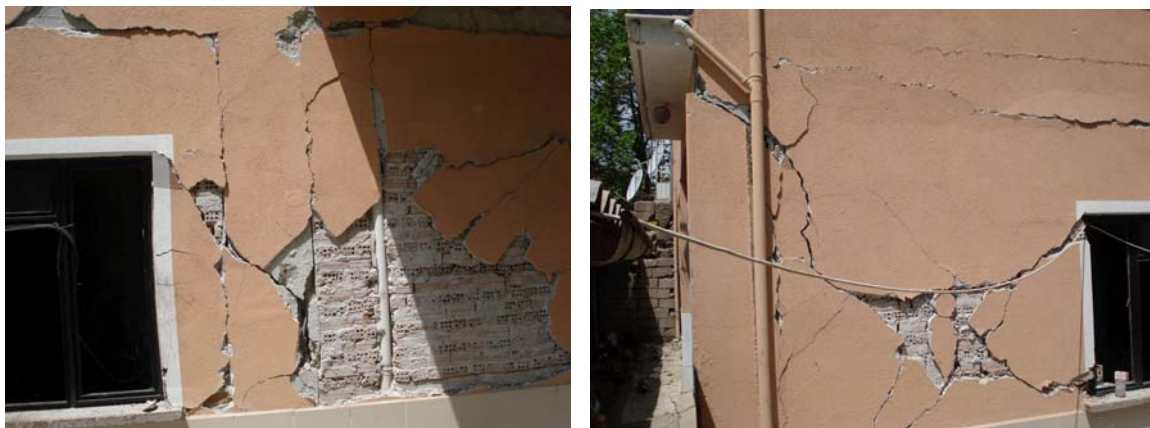
**Figure 53:** *Same building with previous picture, similar damage pattern*

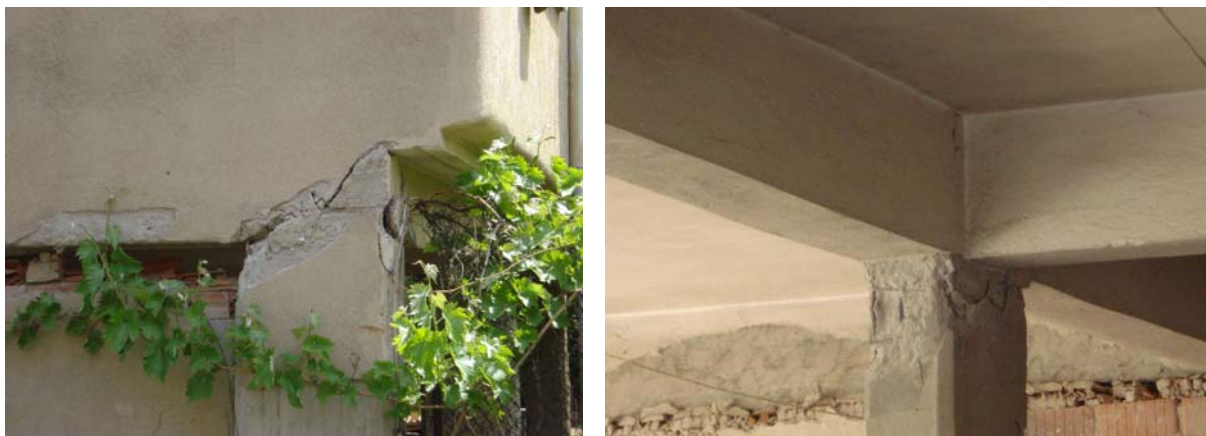
**Figure 54:** *Heavy structural damage at column ends*

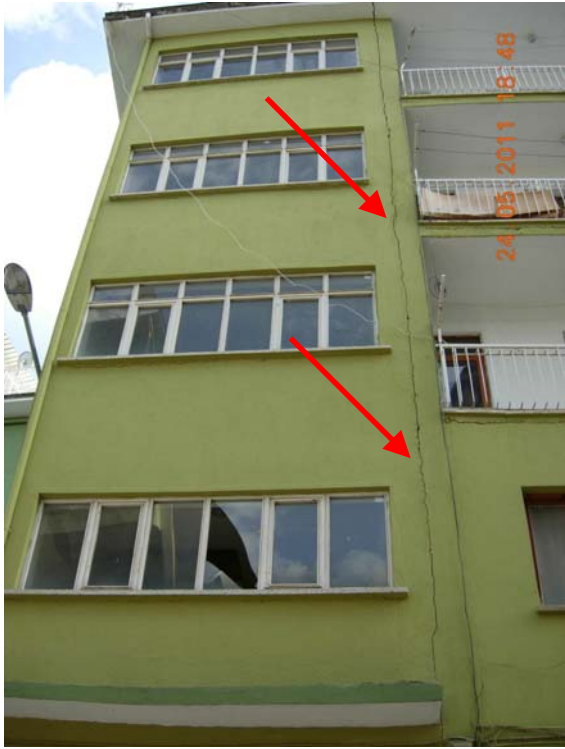
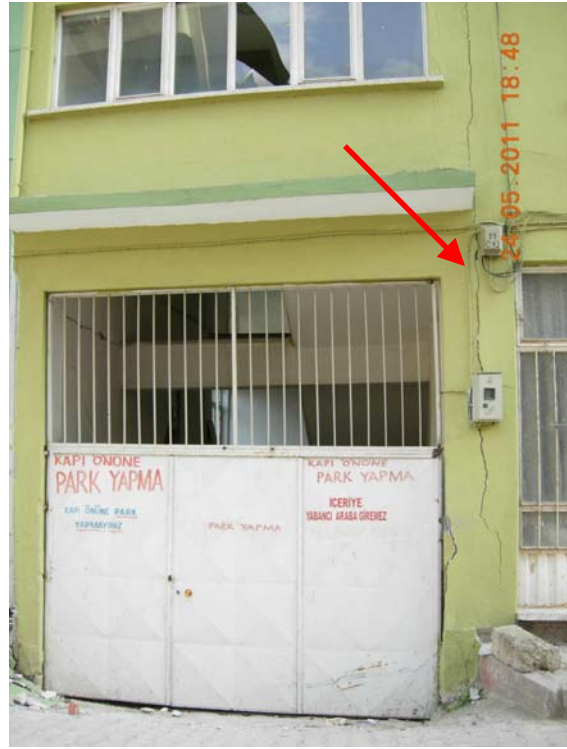
**Figure 55:** Damaged building, in front of the collapsed building, crack on the column extends from ground floor to roof.

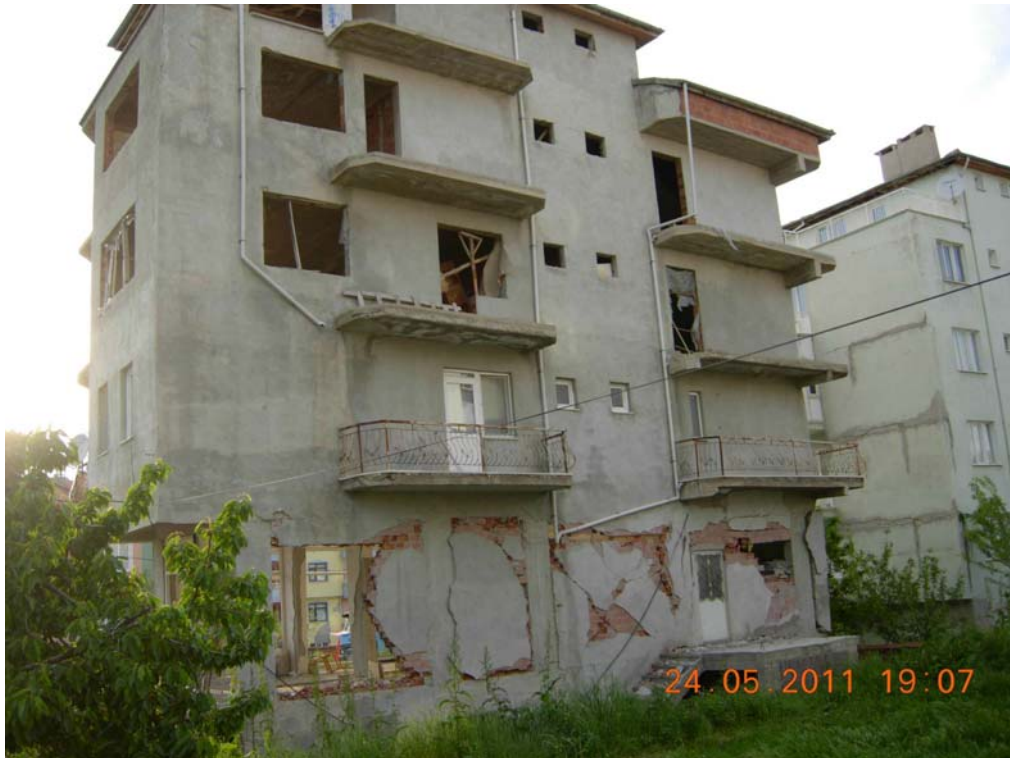
**Figure 58:** *Non-structural infill wall damage on a new building which is still under construction*

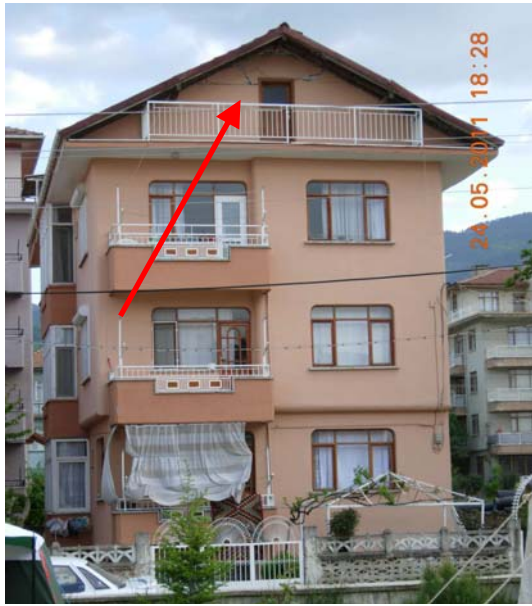
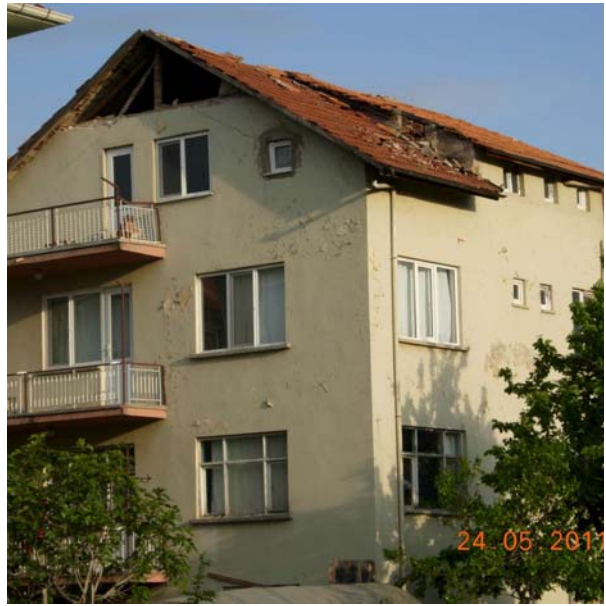
**Figure 59:** *Roof damage*

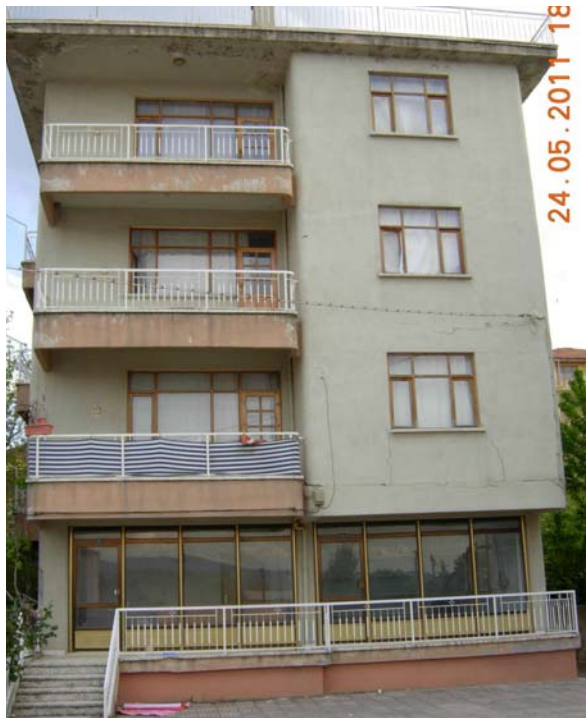
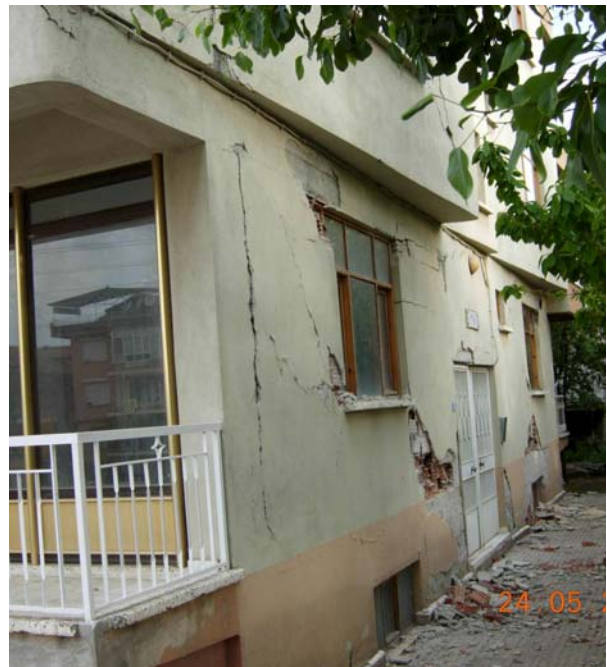
**Figure 60:** *Infill wall damage, front and side view*

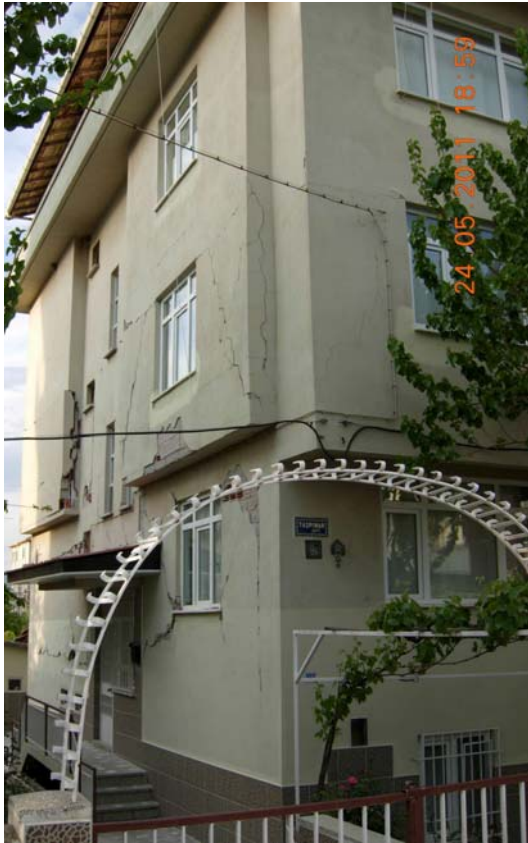
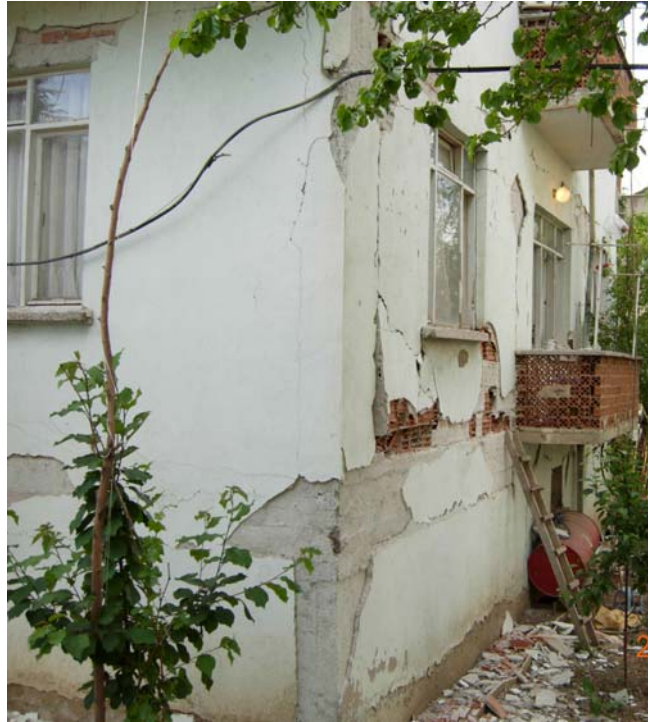
**Figure 61:** *Infill wall damage and spalling of the plaster of structural members, front and side view*

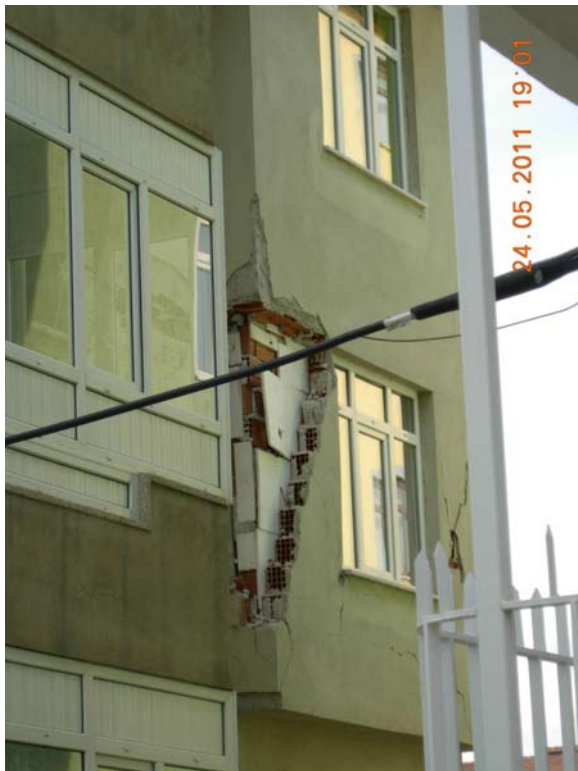
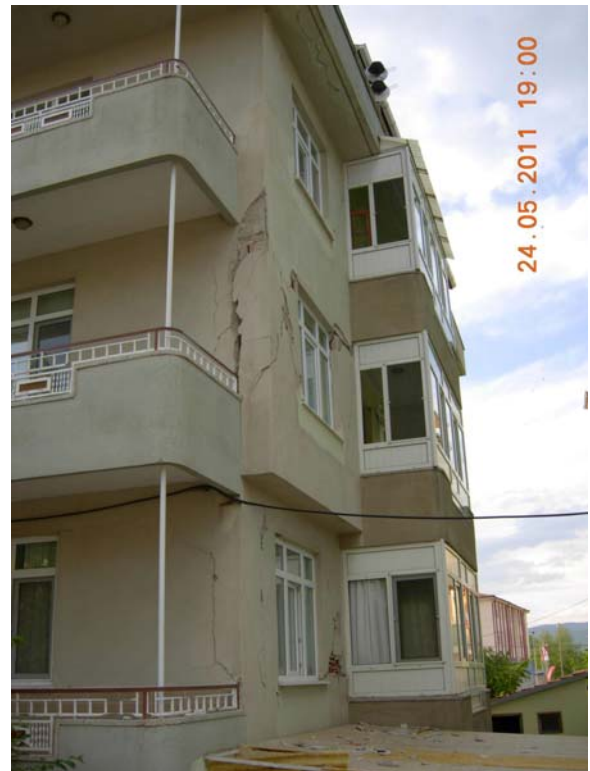
- Generally, outer infill walls are composed of two layers of thin infill wall bricks, consisting one layer of styrofoam which has 1.5 cm thickness. Because of low labor quality and absence of connection or binding within two brick layers, high level of damage at outer infill walls became inevitable. Although, infill wall damage patterns are considered as non-structural damage and will not affect load carrying capacity of the structure, it constitutes risk, causing injuries and casualties via partial failure or out of plane turnover.

**Figure 62:** *Damage at outer infill walls*

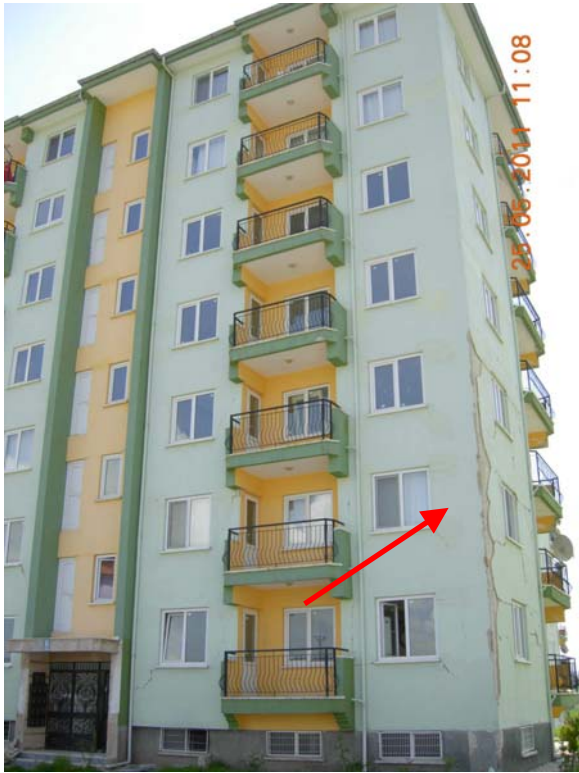
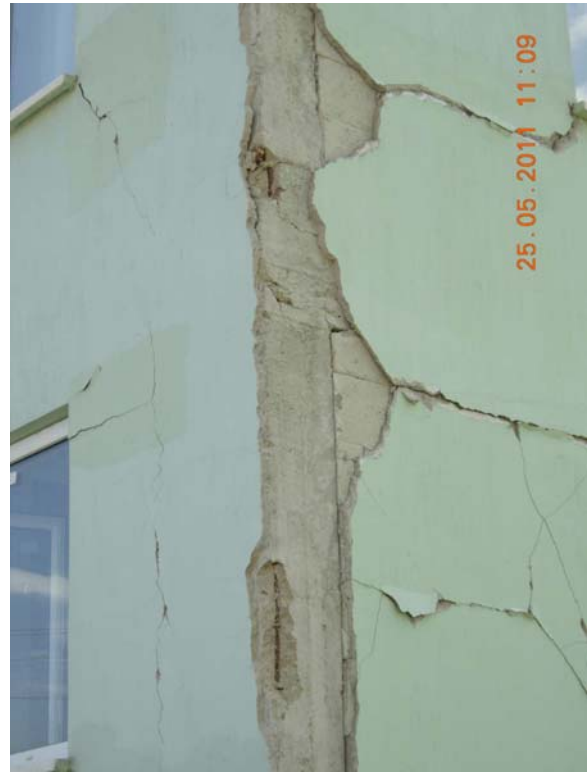
**Figure 63:** Damage at 7 storey rectangular building, spalling of concrete cover, widespread infill wall cracks

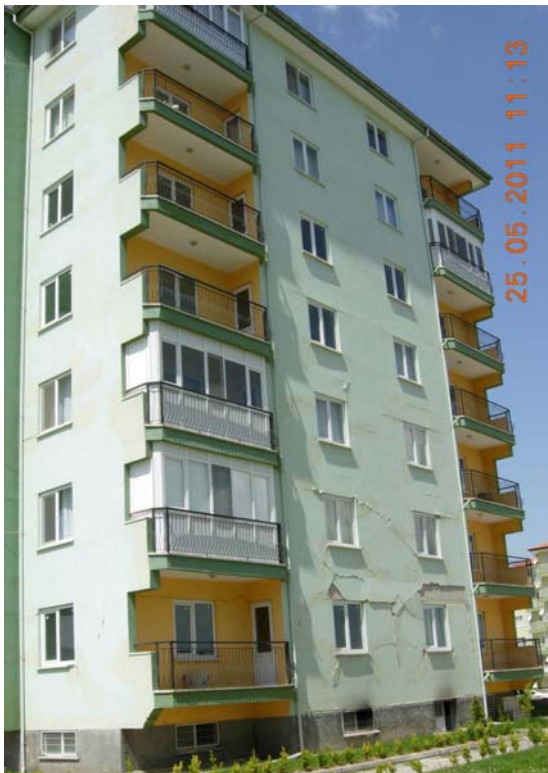
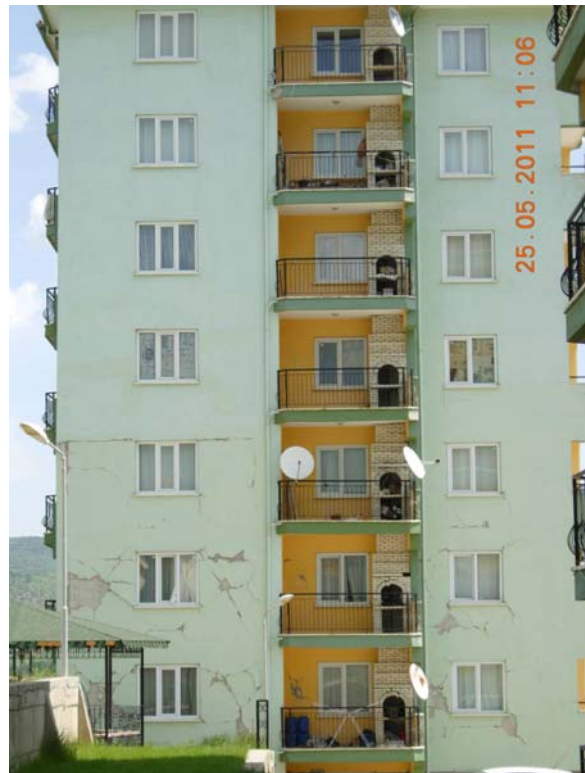
**Figure 64:** Damage at 7 storey rectangular building, moderate non-structural damage

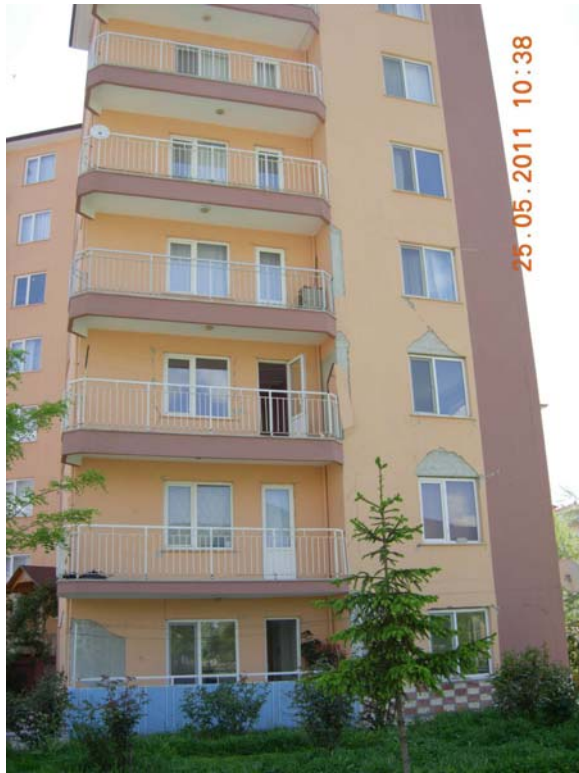
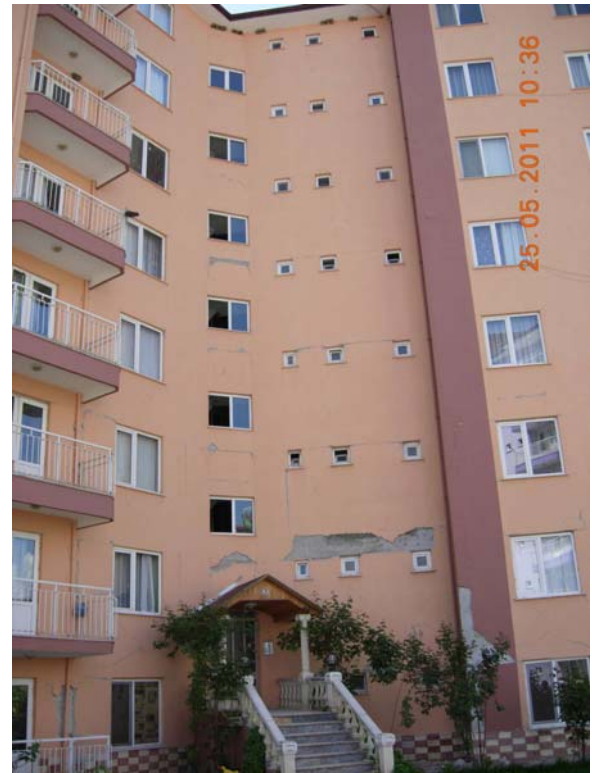
**Figure 65:** *Damage at 8 storey star buildings, moderate non-structural damage*

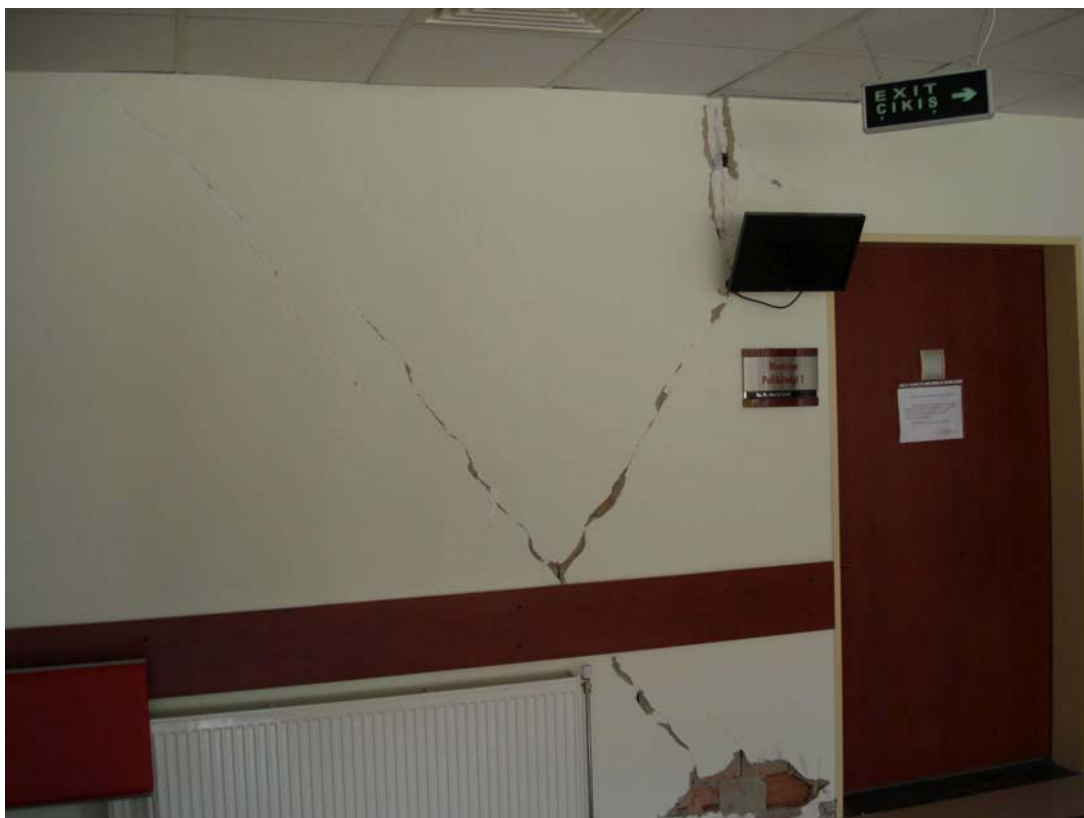
**Figure 66:** *Recently completed building of hospital complex, cracks at infill walls, but building is still at operational level*

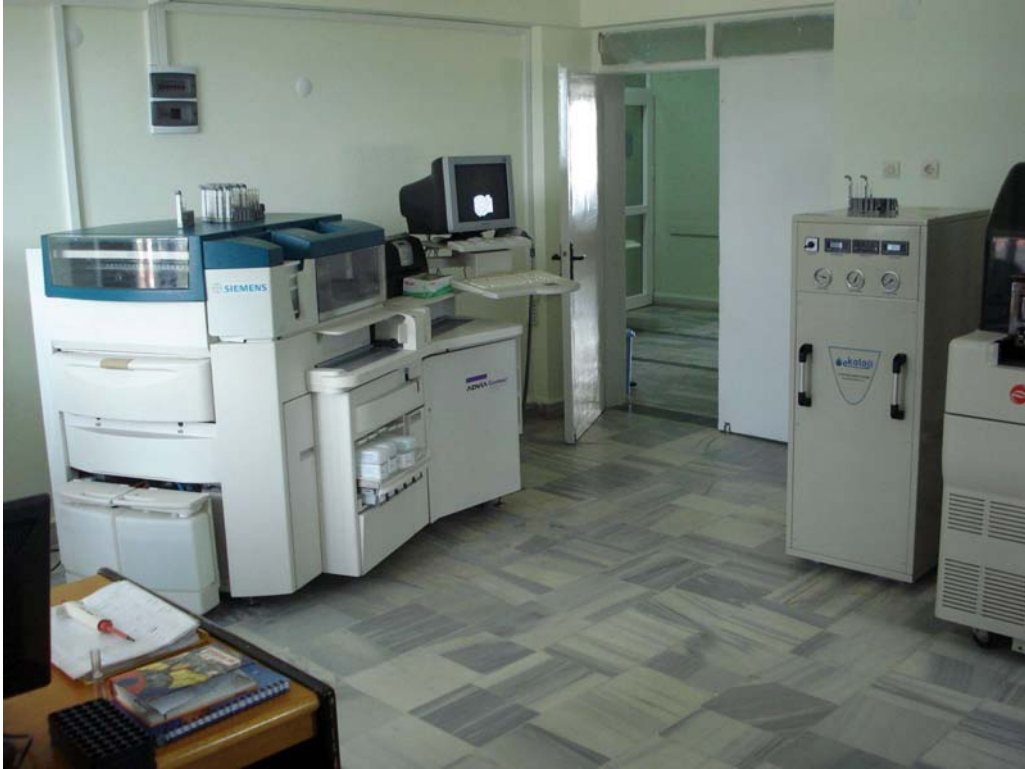
**Figure 67:** Another building of the hospital complex, which is completed in the beginning of 2000's, biochemistry lab. , all machines have displaced and smaller ones (like monitor) turned over during earthquake

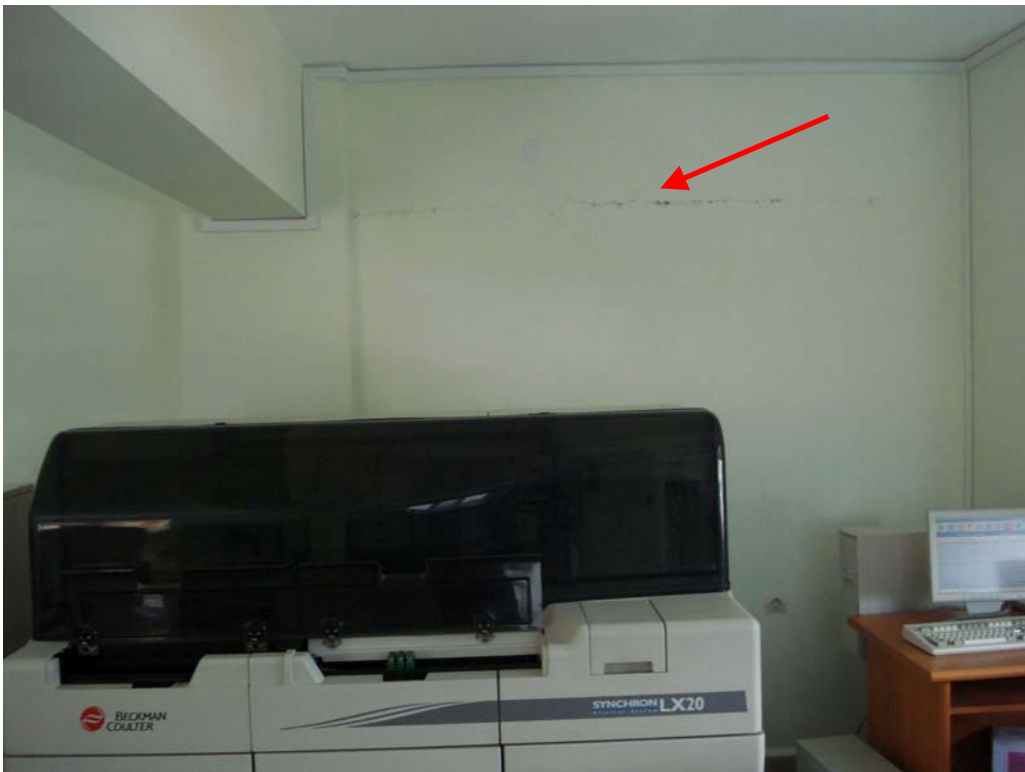
**Figure 68:** Hospital building, completed in the beginning of 2000's, biochemistry lab. (same room) , machine has displaced, and infill wall cracked during earthquake

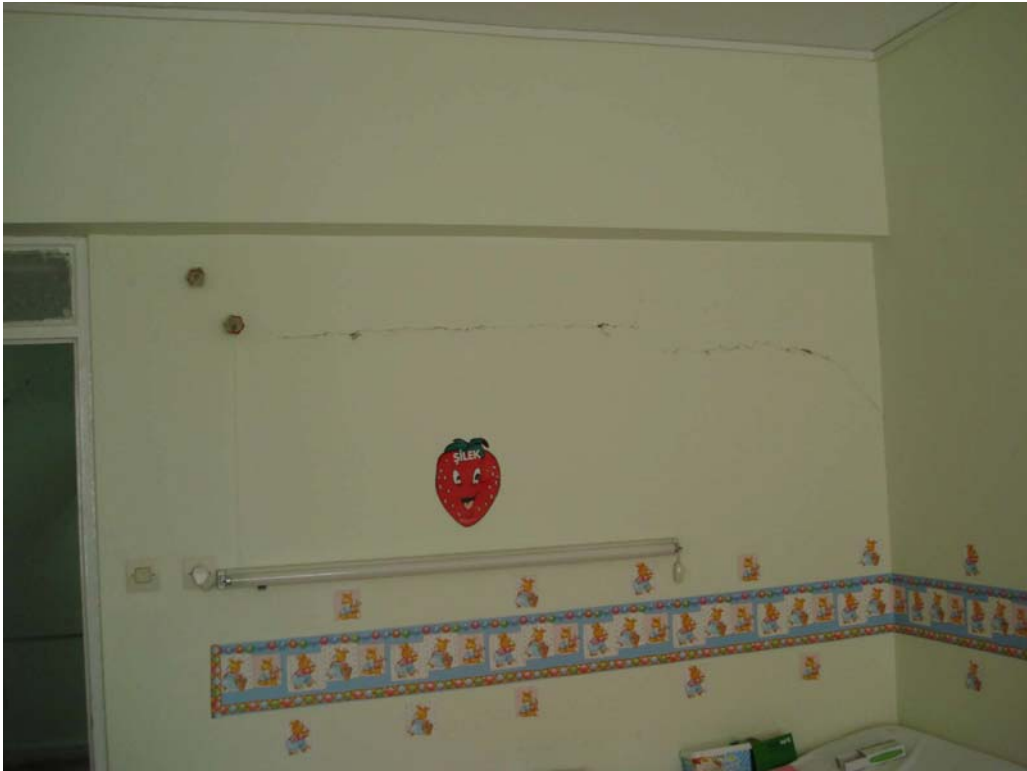
**Figure 69:** Hospital building, completed in the beginning of 2000's, infill wall crack

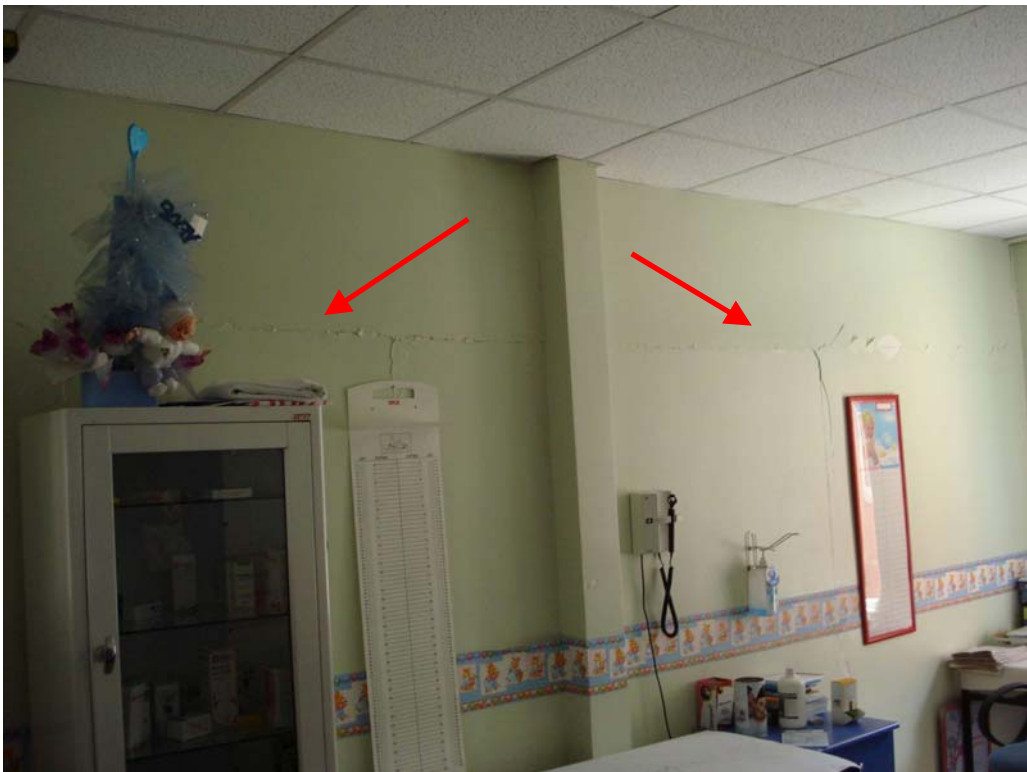
**Figure 70:** Hospital building, completed in the beginning of 2000's, infill wall crack

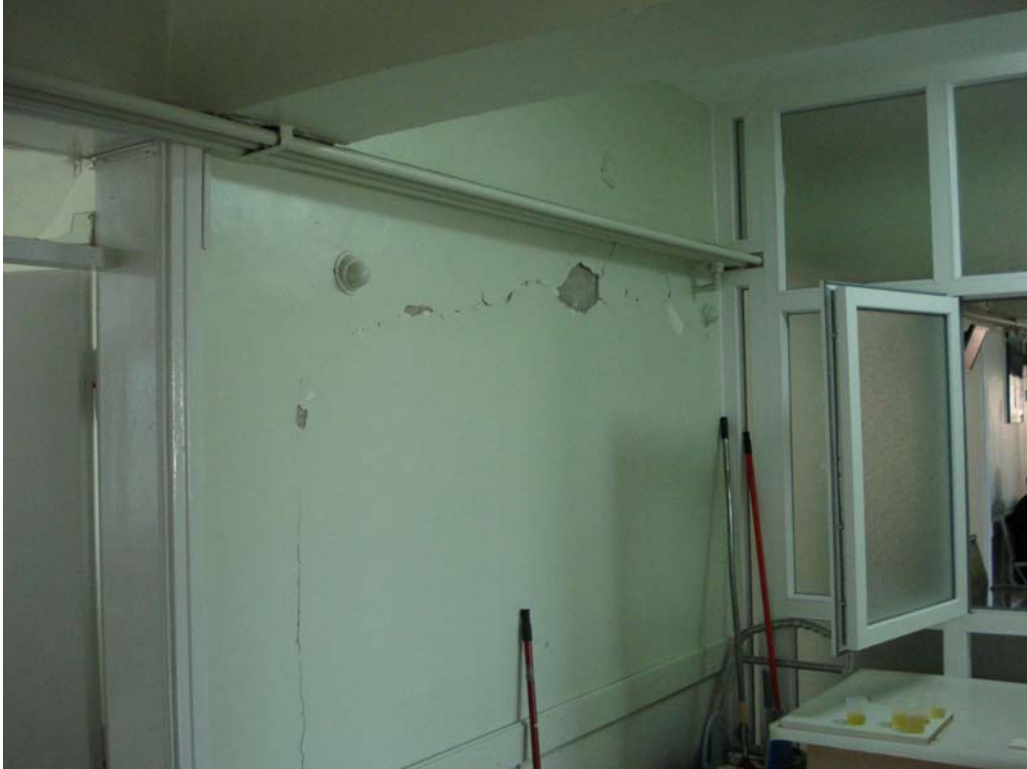
**Figure 71:** *Hospital building, completed in the beginning of 2000's, infill wall crack*

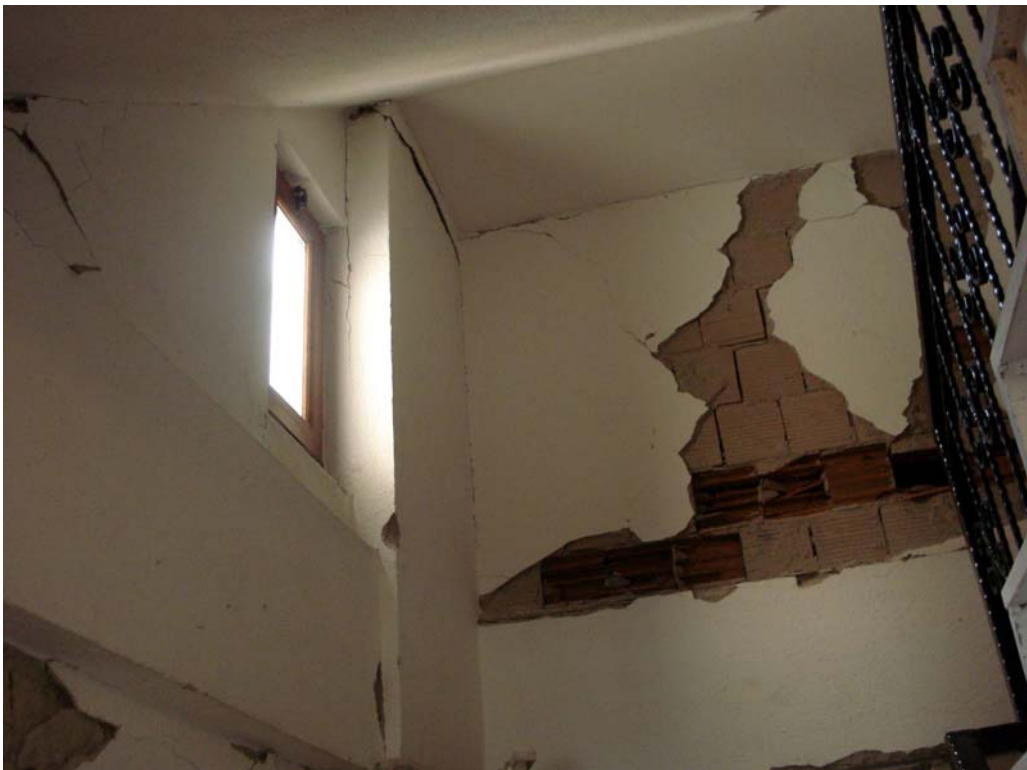
**Figure 72:** *Building next to hospital complex – staircase infill wall cracks, spalling of plaster*

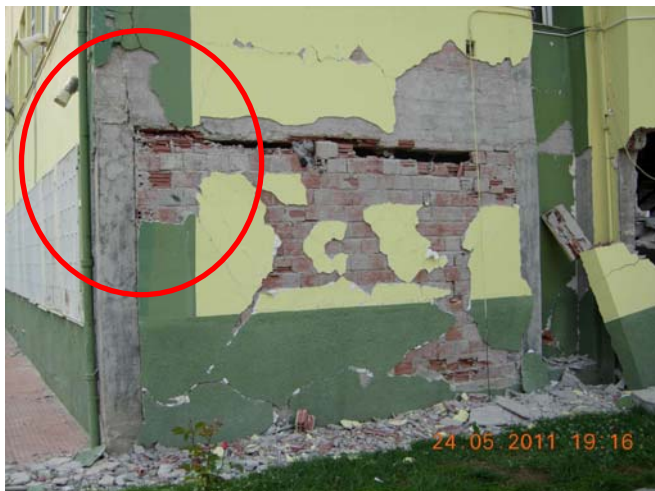
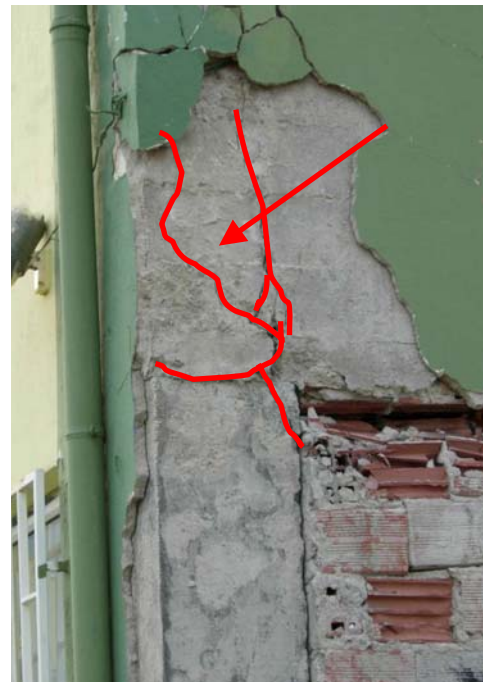
**Figure 74:** Cracks on beam-column joint of the RC part of school building

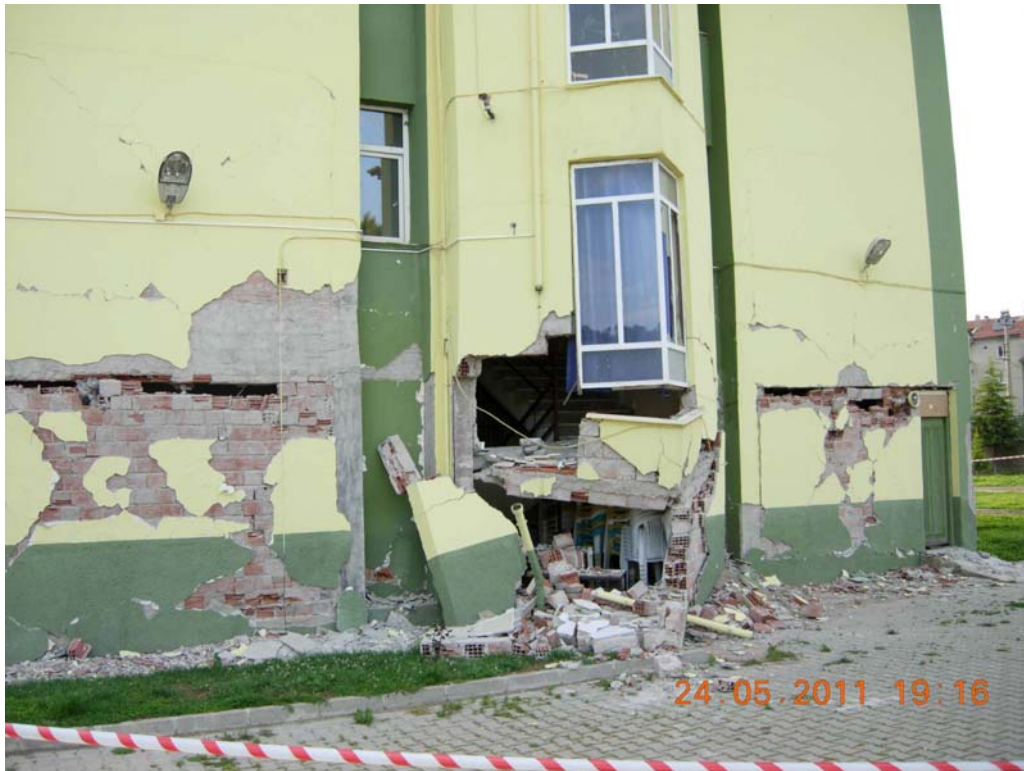
**Figure 75:** Staircase damage of the RC part of school building, general practice of the territory is to build staircase slabs so thin and without any beam to support the slab

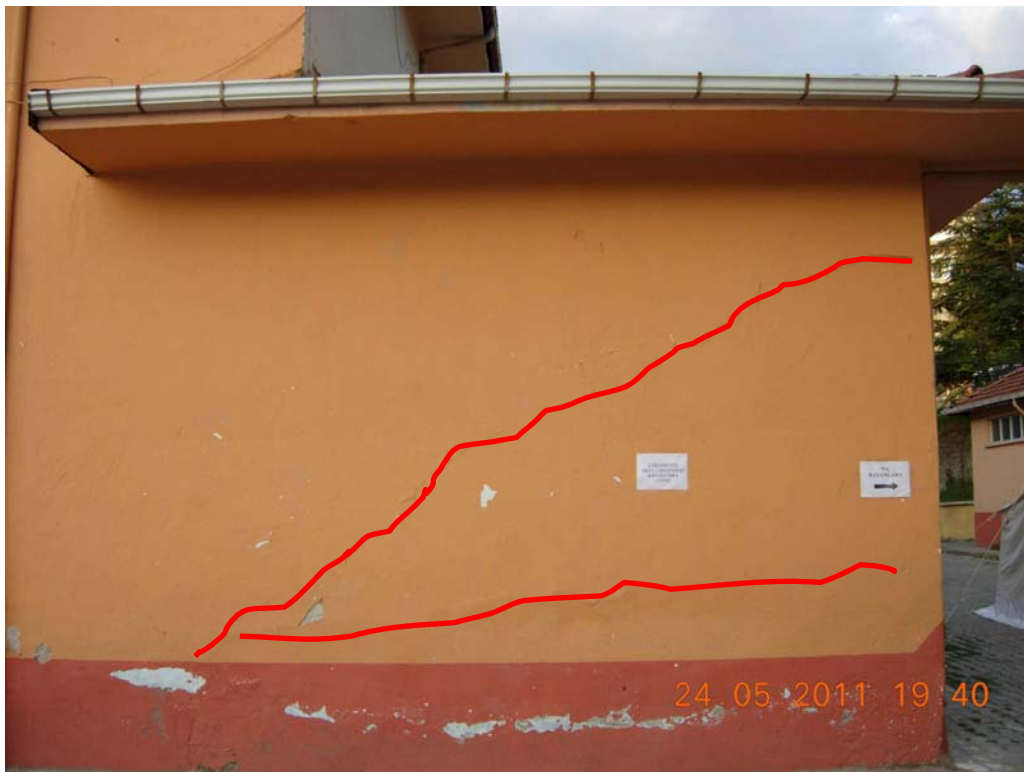
**Figure 76:** Cracks on outer walls of masonry part of the school building

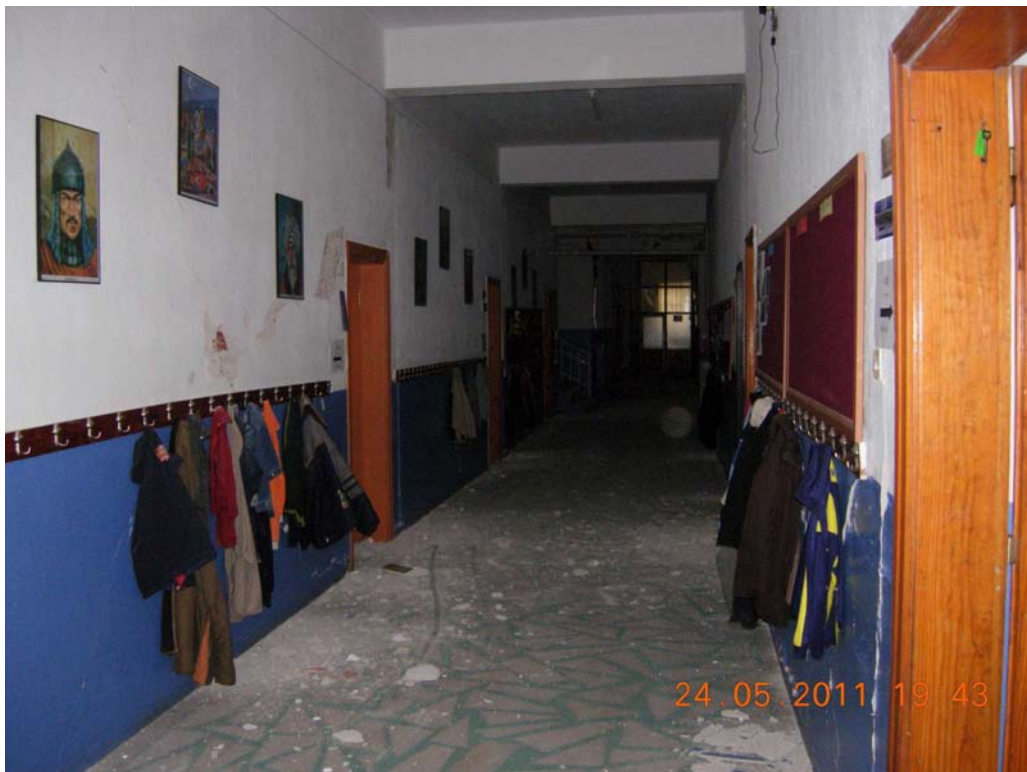
**Figure 78:** Inside of masonry part of the school building- spalling of plaster

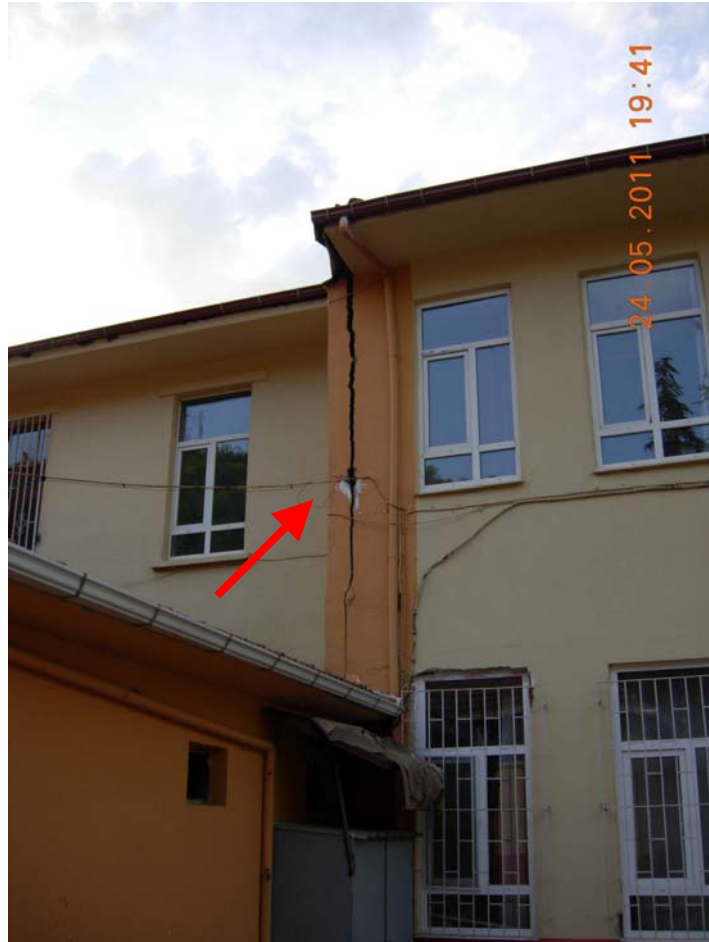
**Figure 79:** Large crack between masonry and RC parts of the school building

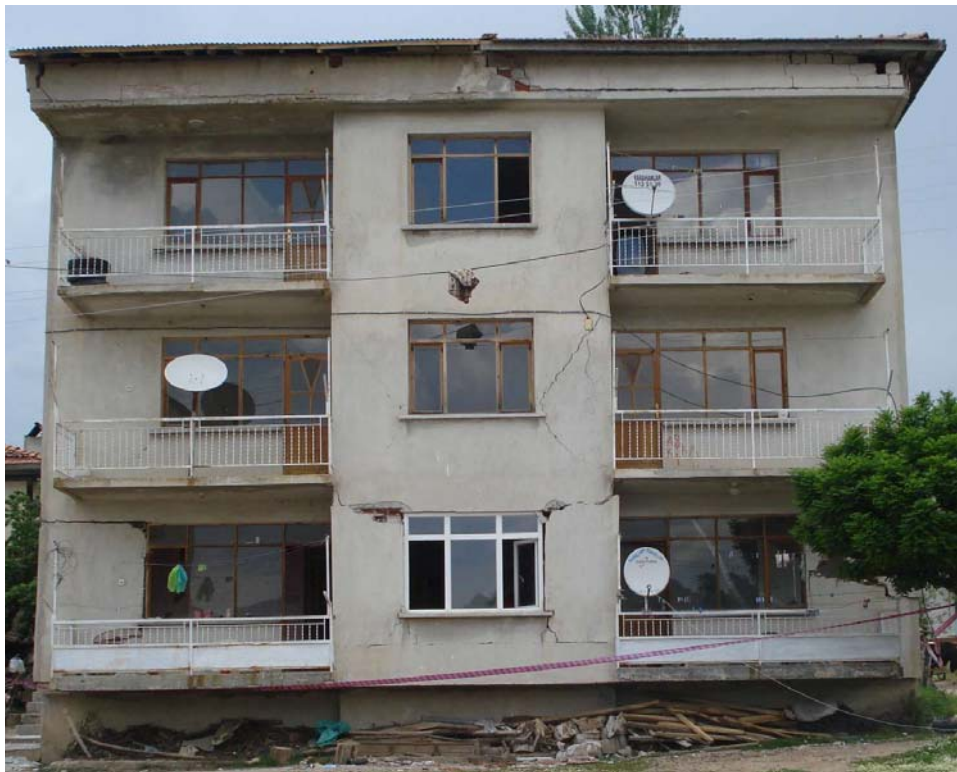
**Figure 80:** Gökçeler village, grade 3 damaged building, front view

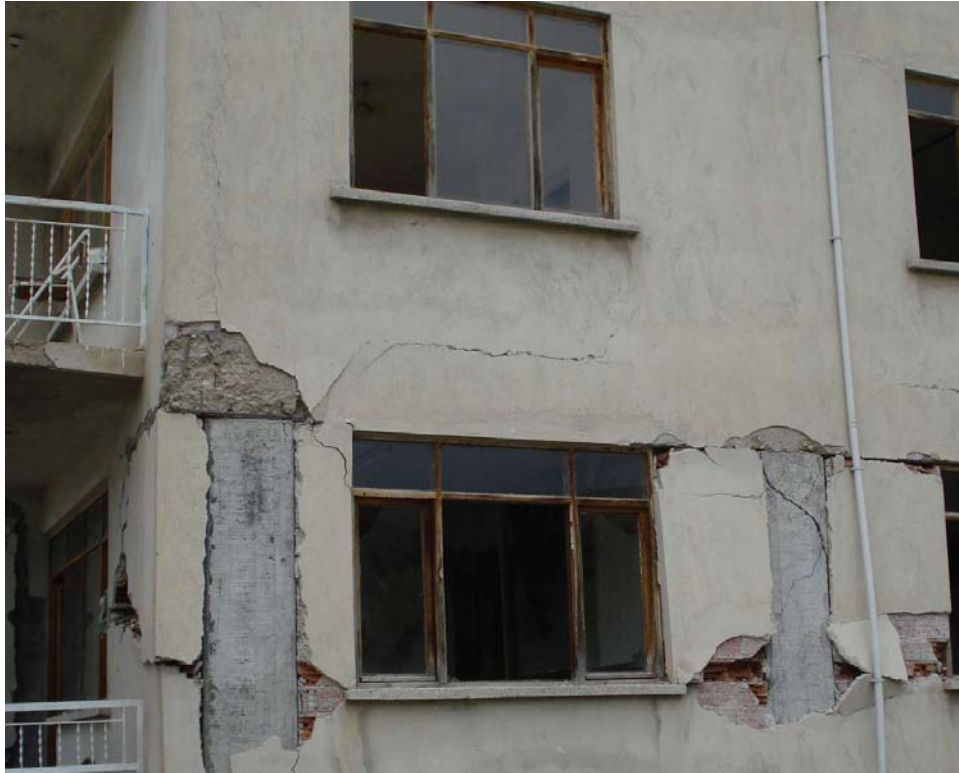
**Figure 81:** *Gökçeler village, grade 3 damaged building, side view*

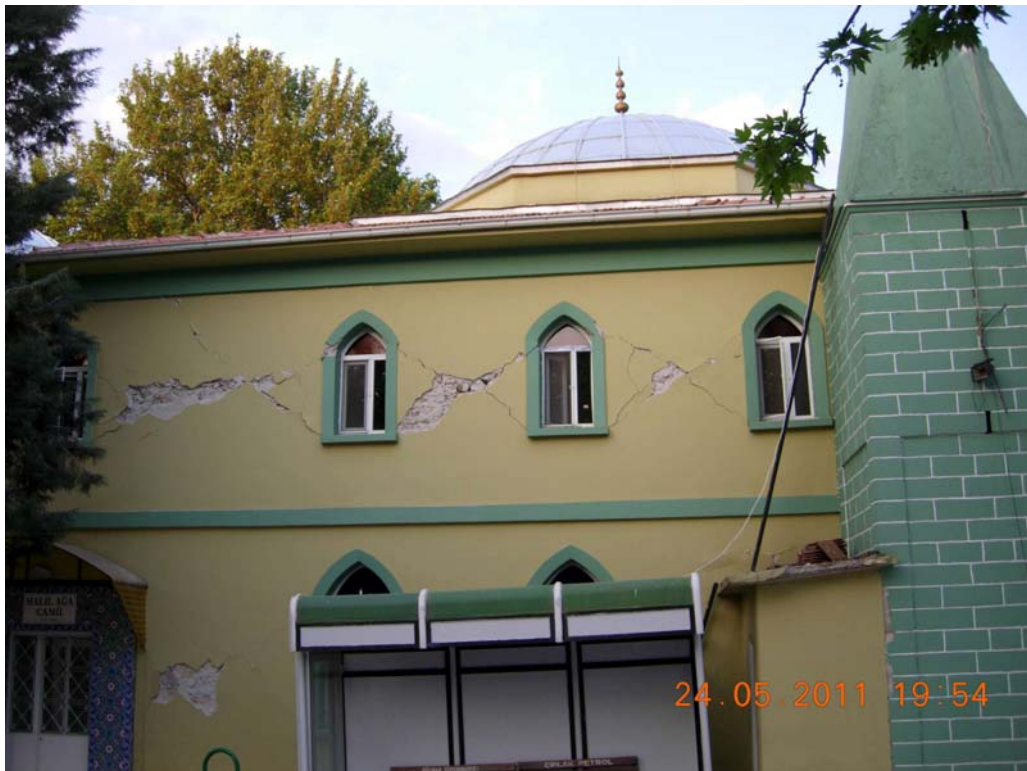
**Figure 82:** *Cracks on brick masonry mosque*

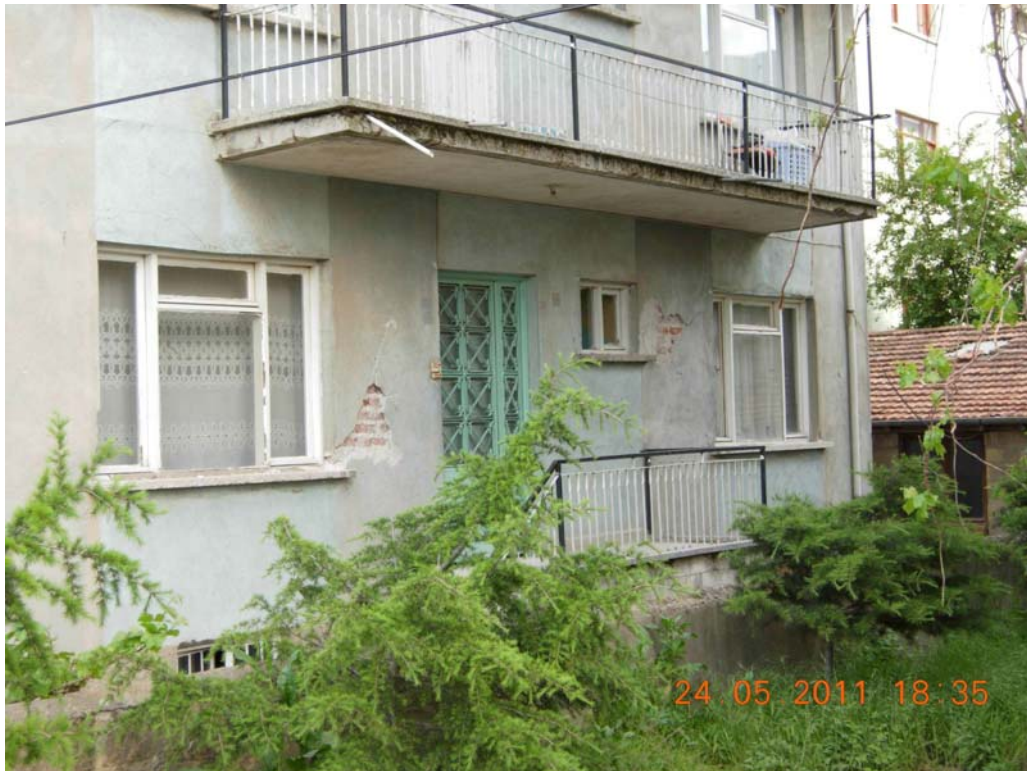
**Figure 83:** *Spalling of plaster on ground floor of 3 storey brick masonry building*
