**KANDİLLİ OBSERVATORY AND EARTHQUAKE  
RESEARCH INSTITUTE**

***May 19, 2011 KUTAHYA-SIMAV  
EARTHQUAKE***

**Prepared by; Dr. Can Zülfikar  
Res. Assist. Yaver Kamer  
Res. Assist. Eren Vuran**

**June, 2011  
ISTANBUL**

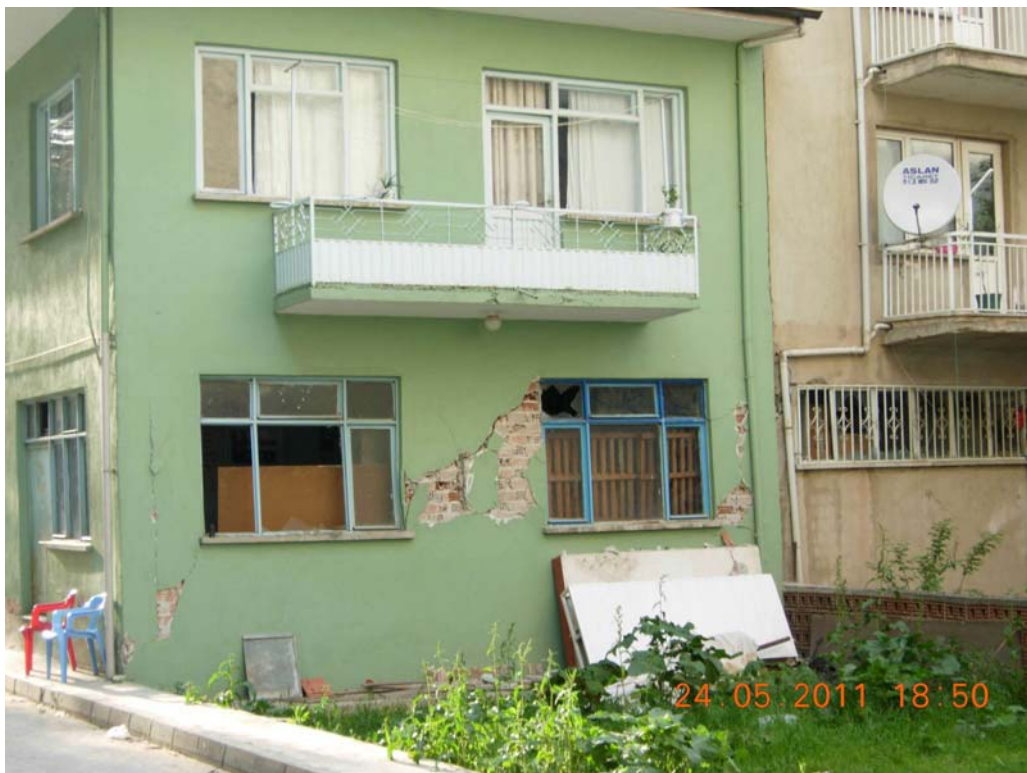
**Figure 84:** *Spalling of plaster on ground floor of 2 storey brick masonry building*
