Rapid preliminary field report for the 29th January 2005 Lorca earthquake in Spain

Patrick Murphy Corella Architect, Calle Piamonte 18, 28004 Madrid, Spain +34 696 22 69 73
alhaquen@tiscali.es

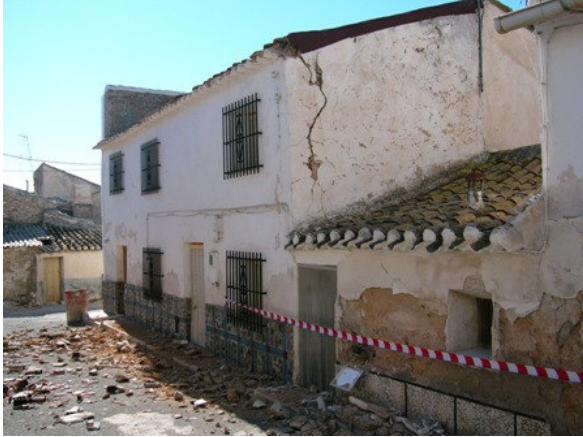
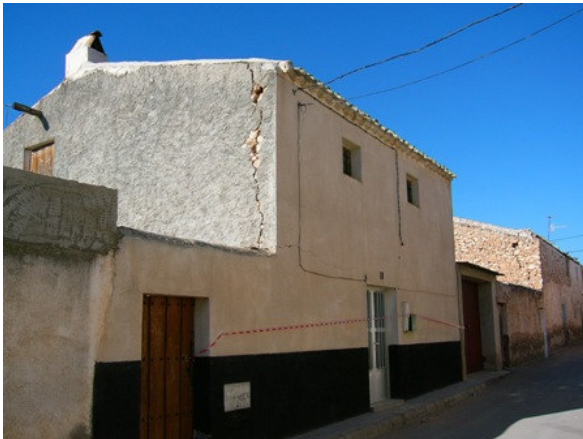
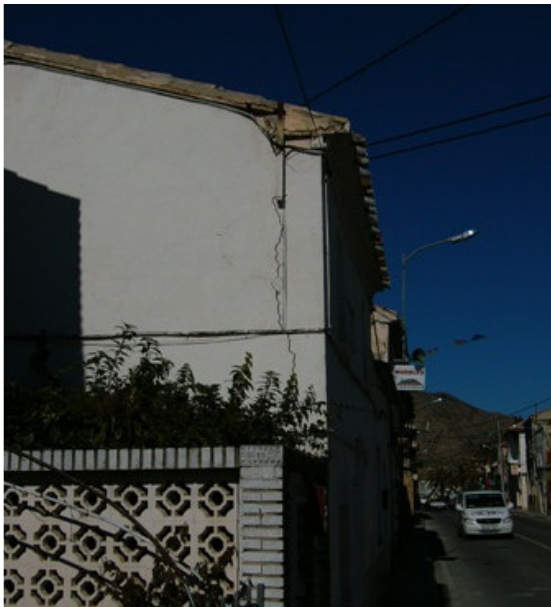
1.1 Drift of loadbearing masonry walls.

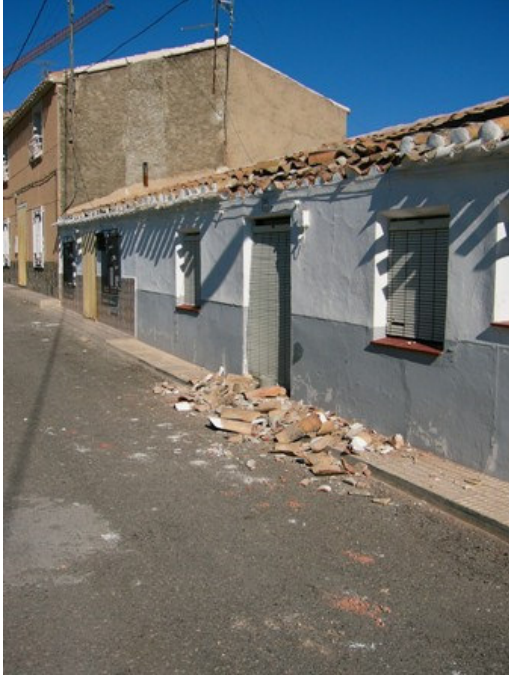
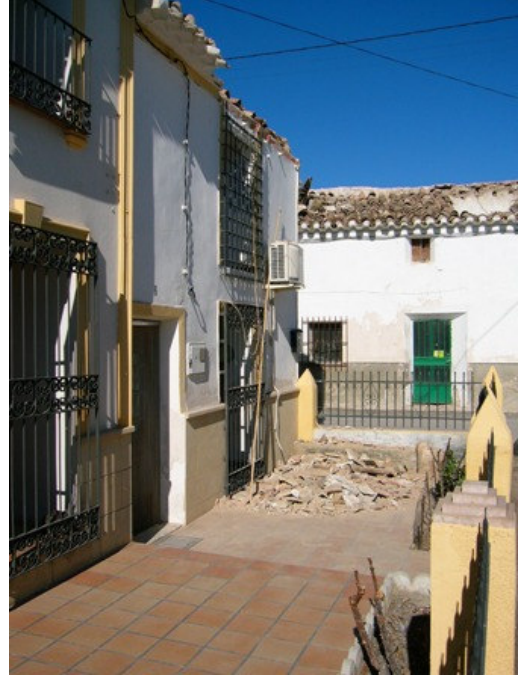
1.2 Fall of roof eaves.

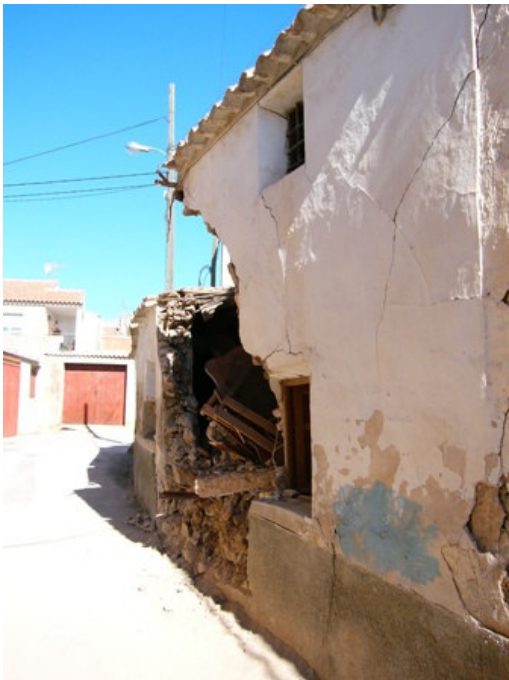
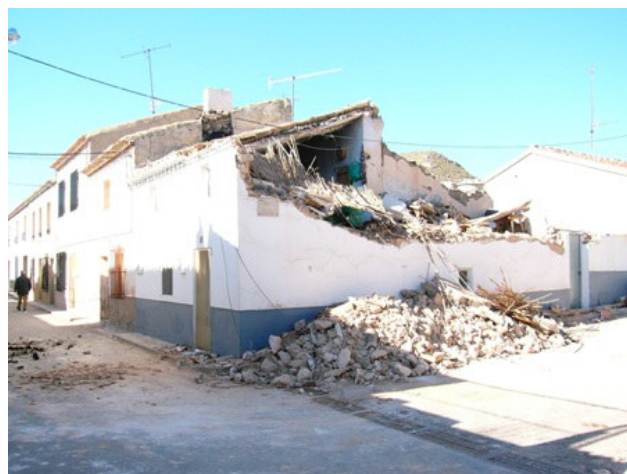
1.3 Wall failure

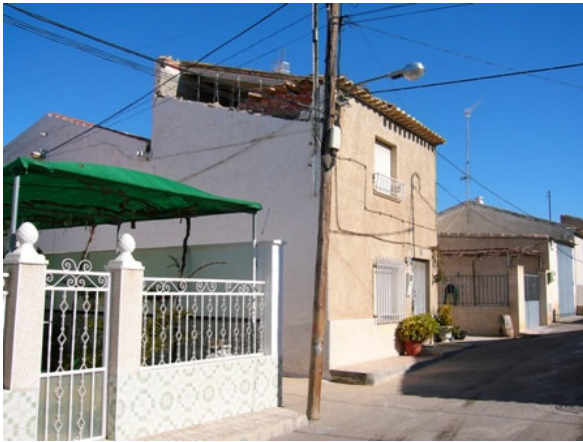
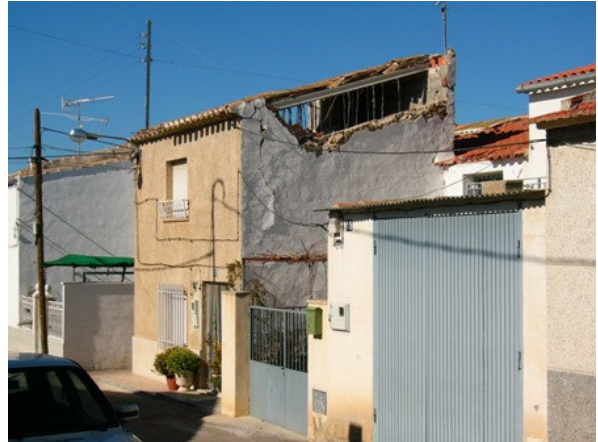
1.4 Gable wall failure

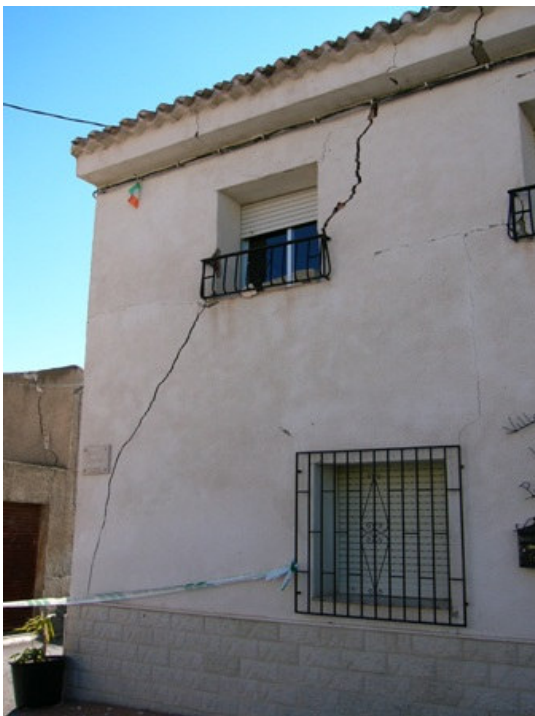
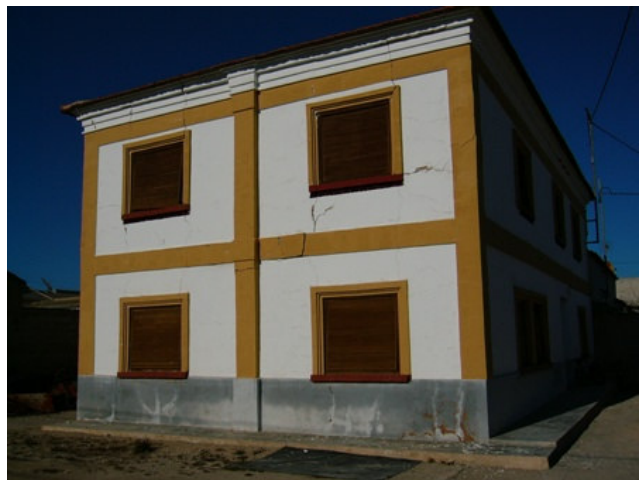
1.5 Shear Damage

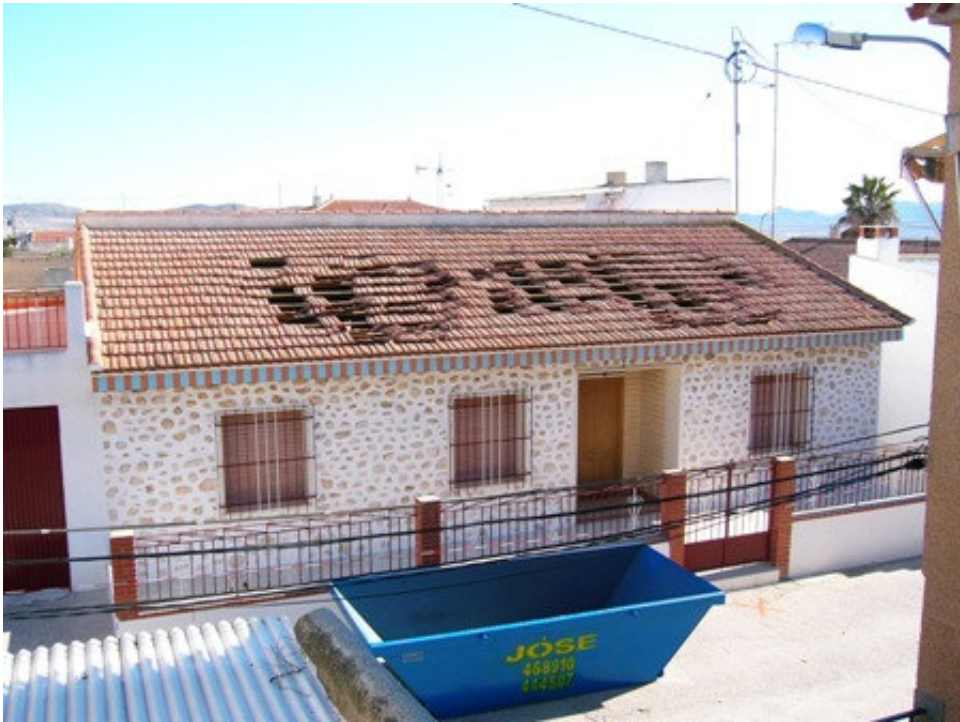
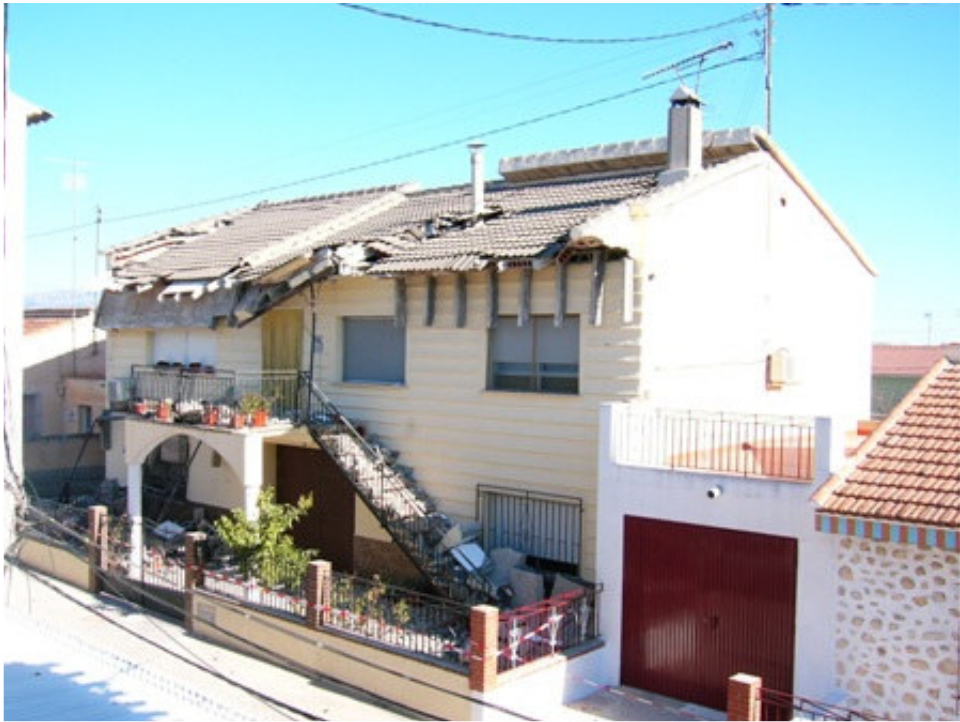
1.6 Roof Damage

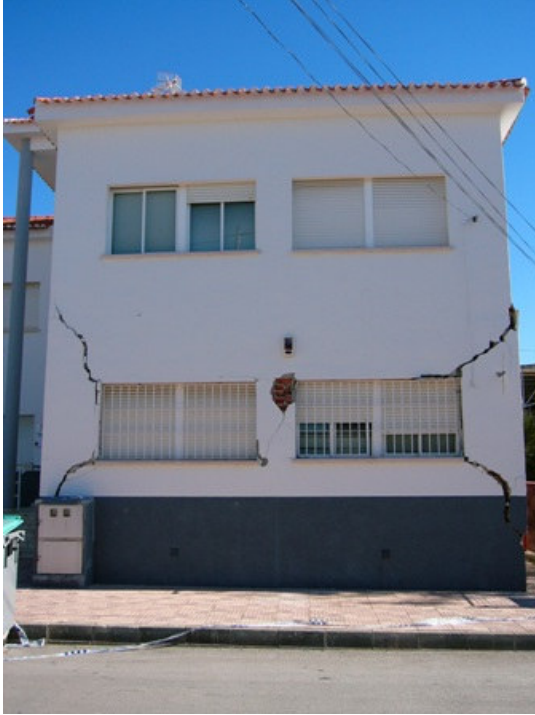
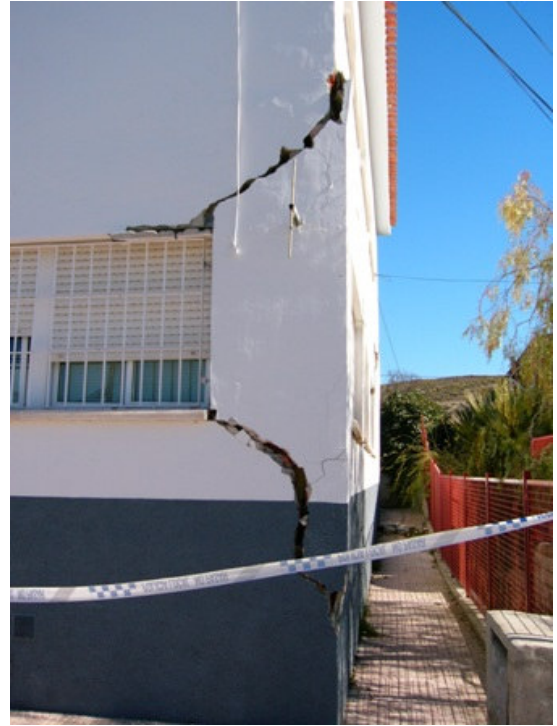
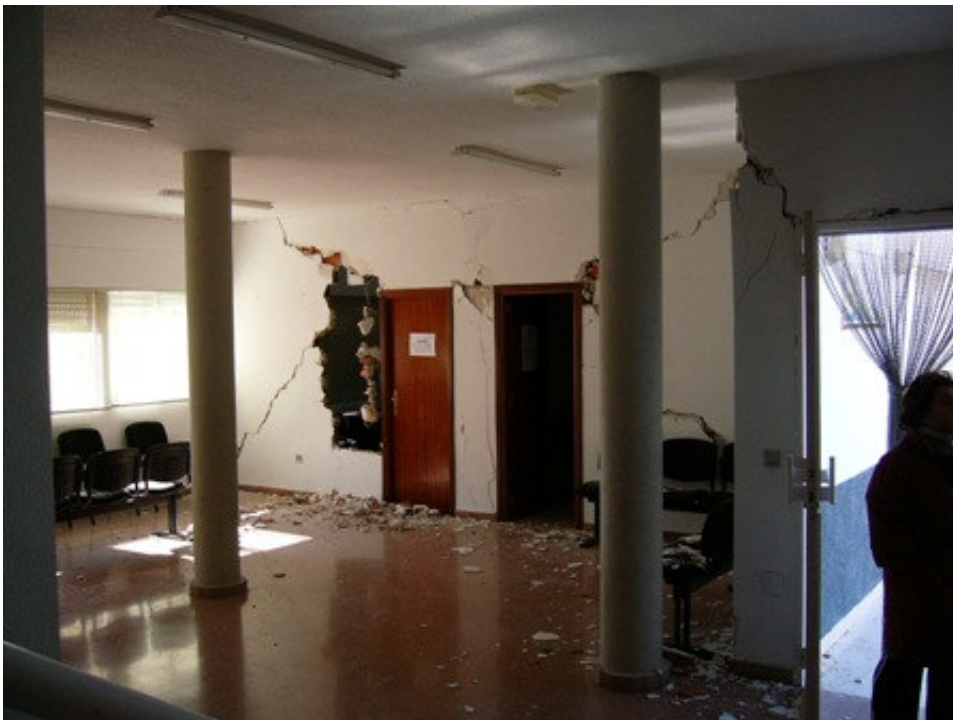
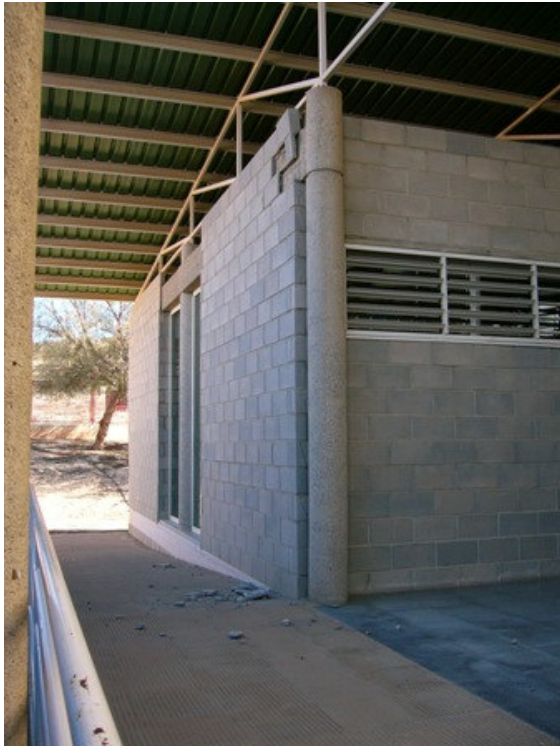
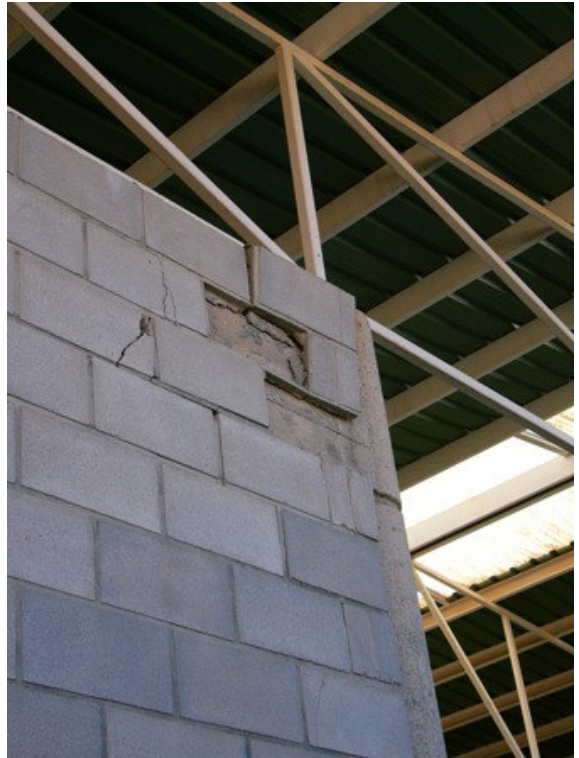
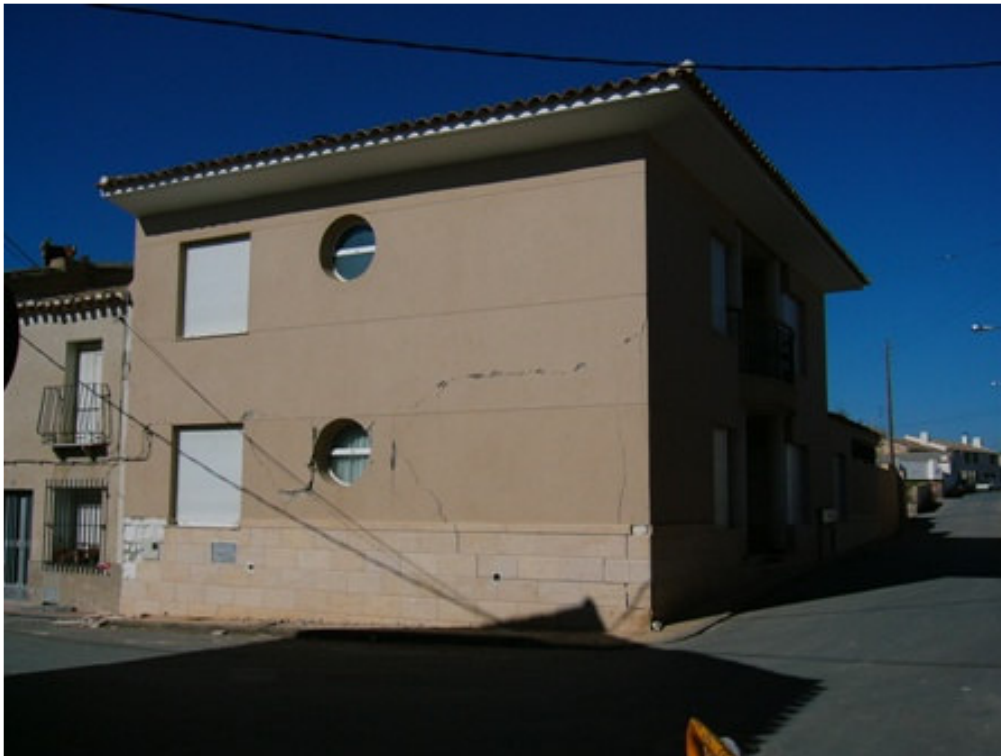
2.1 Shear damage to masonry infill panels

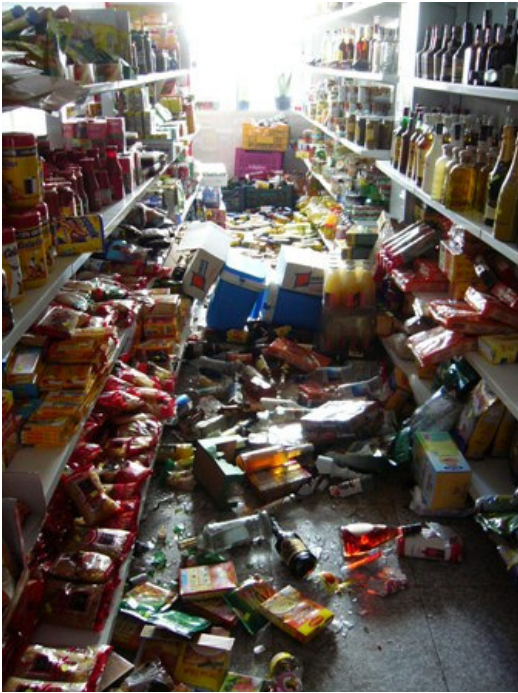
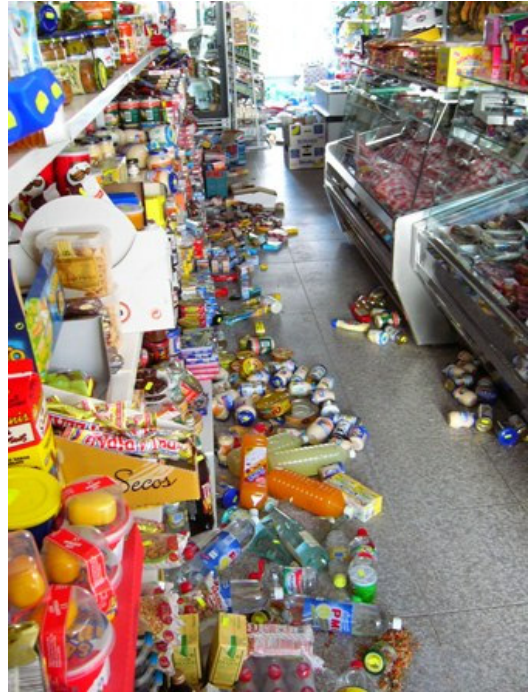
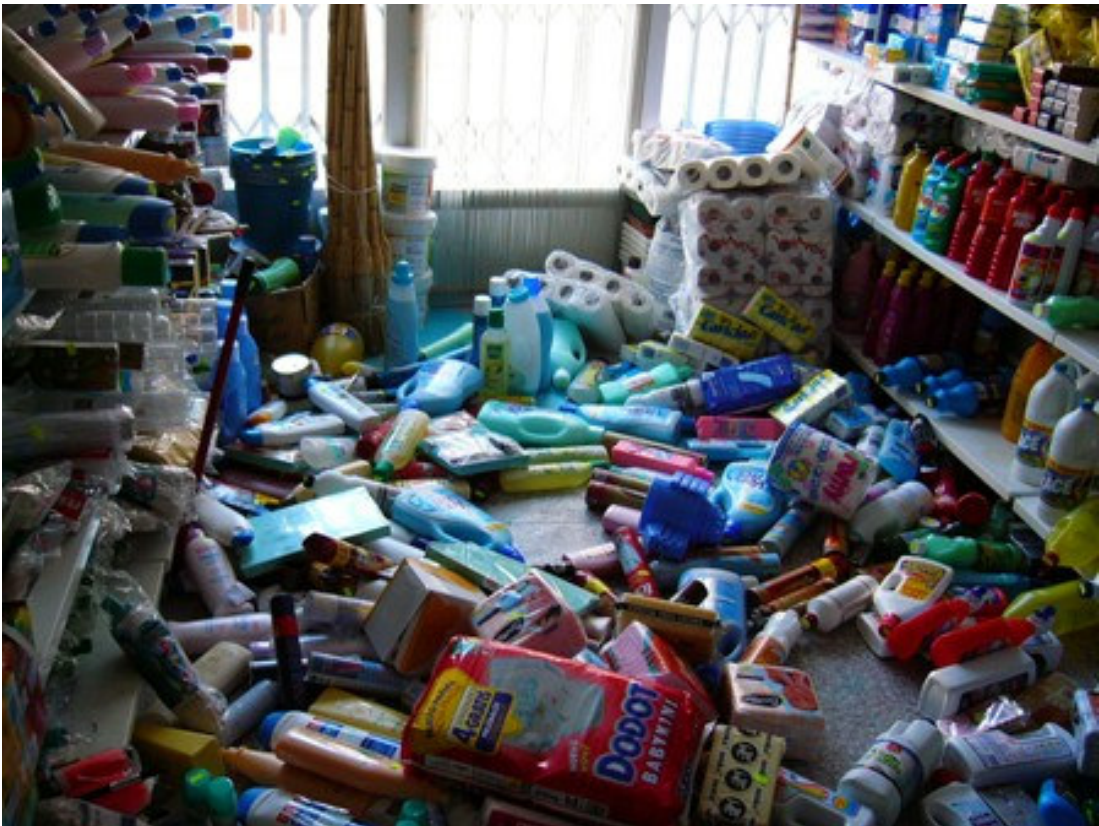
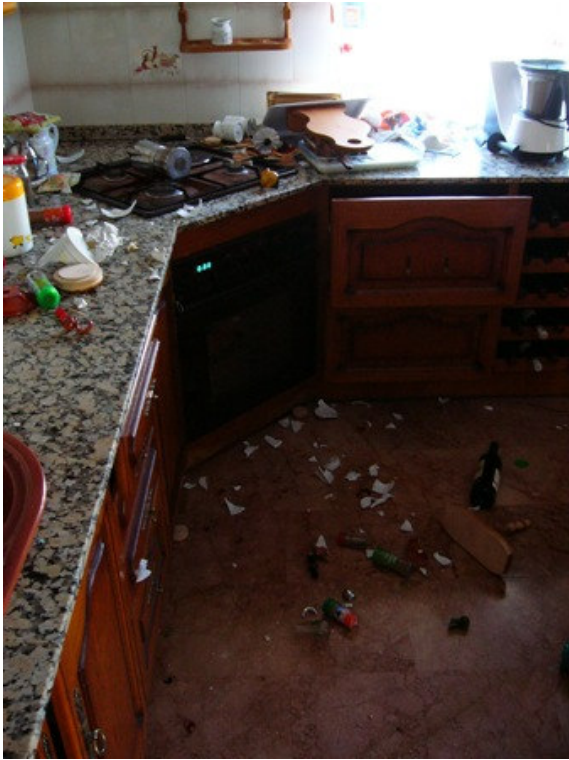
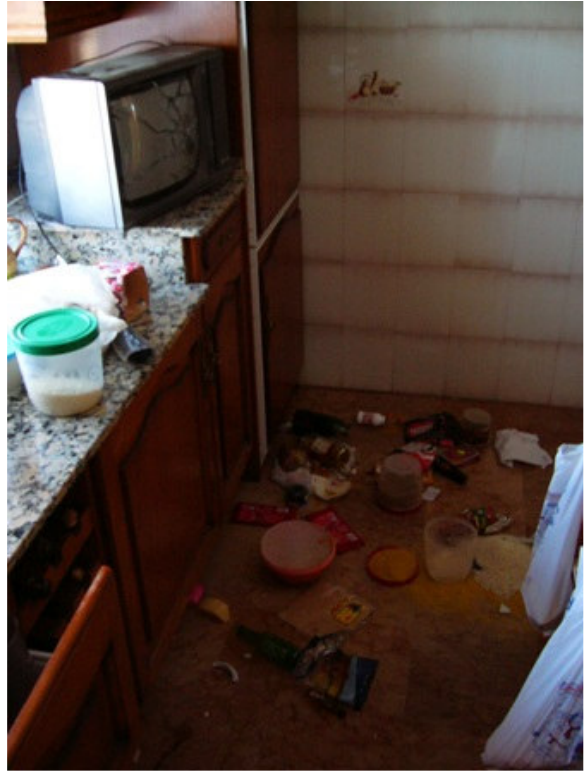
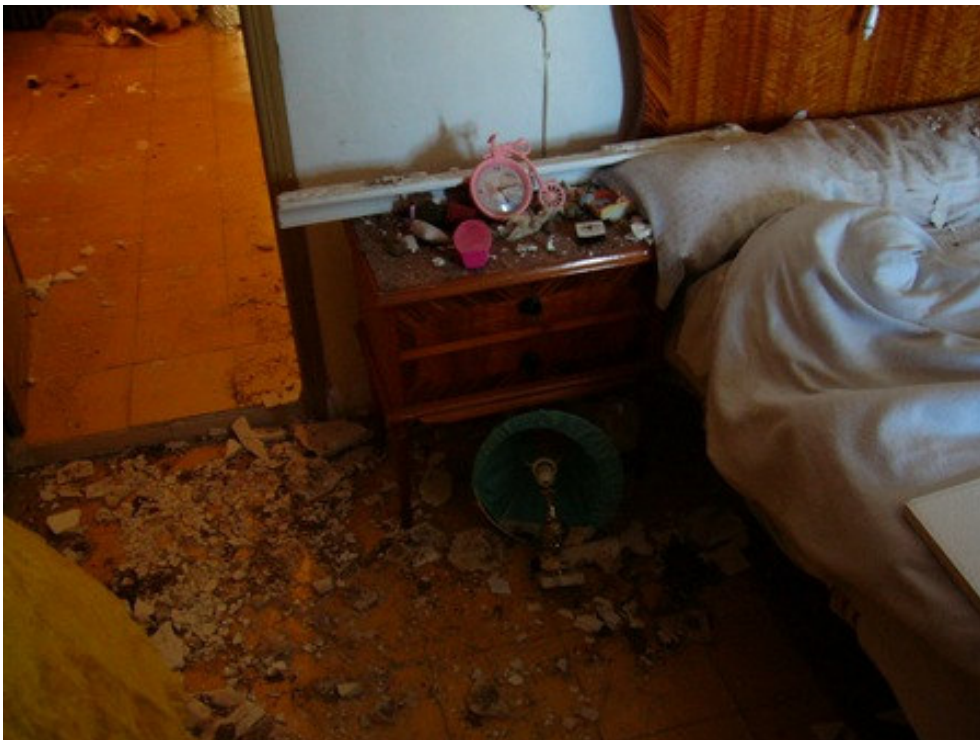
Damage to objects and furniture
