FIELD REPORT FOR THE JANUARY 29TH 2005 EARTHQUAKES IN LORCA, SPAIN

1 Executive summary

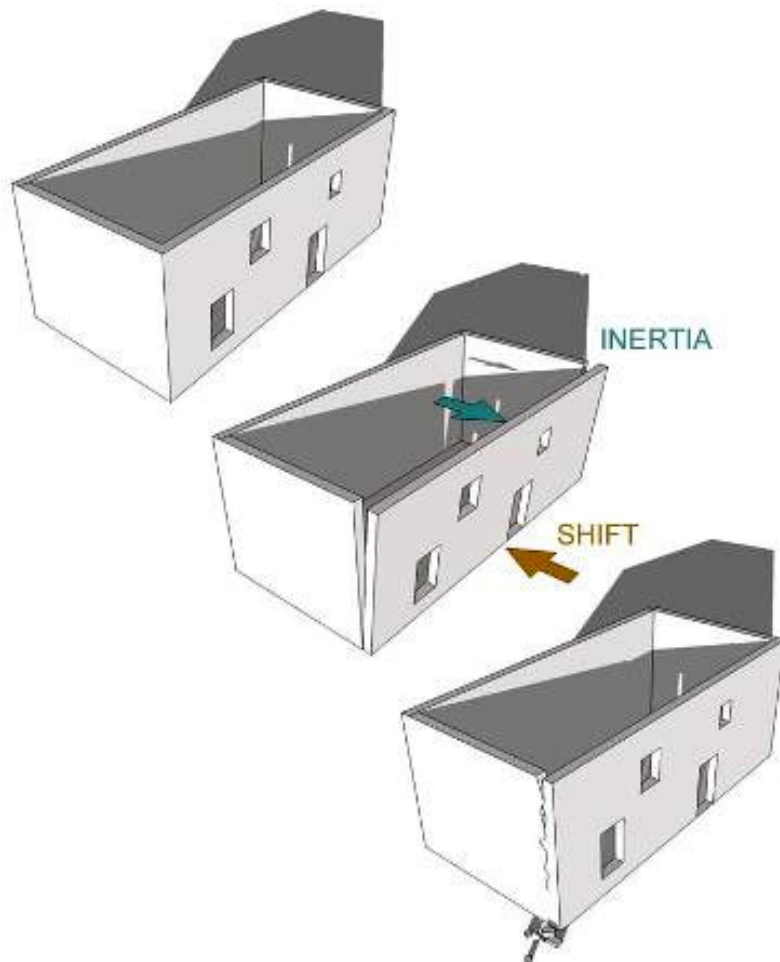
Drift of load bearing masonry façade. Zarcilla (Grade 2 vulnerability A)

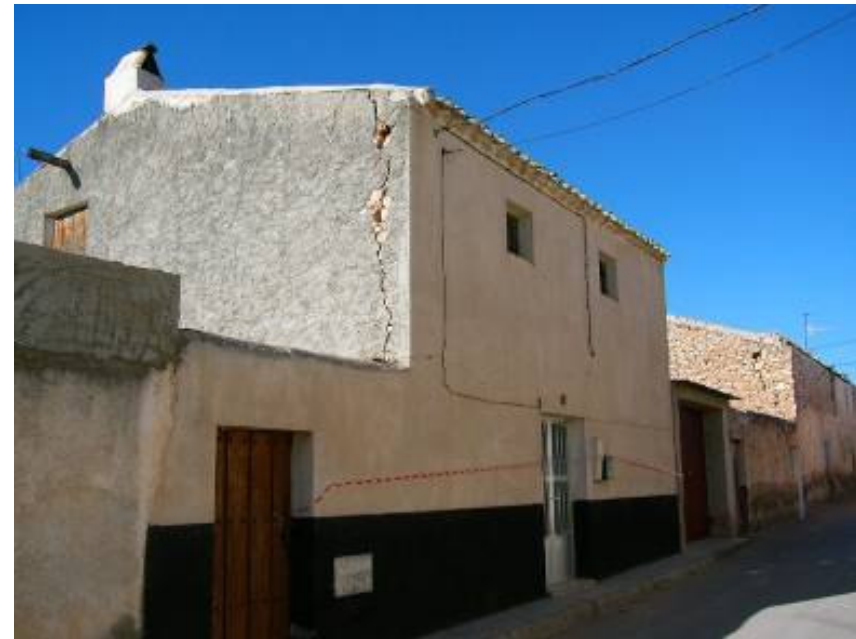
Drift of load bearing masonry façade. Zarcilla (Grade 2 vulnerability A)

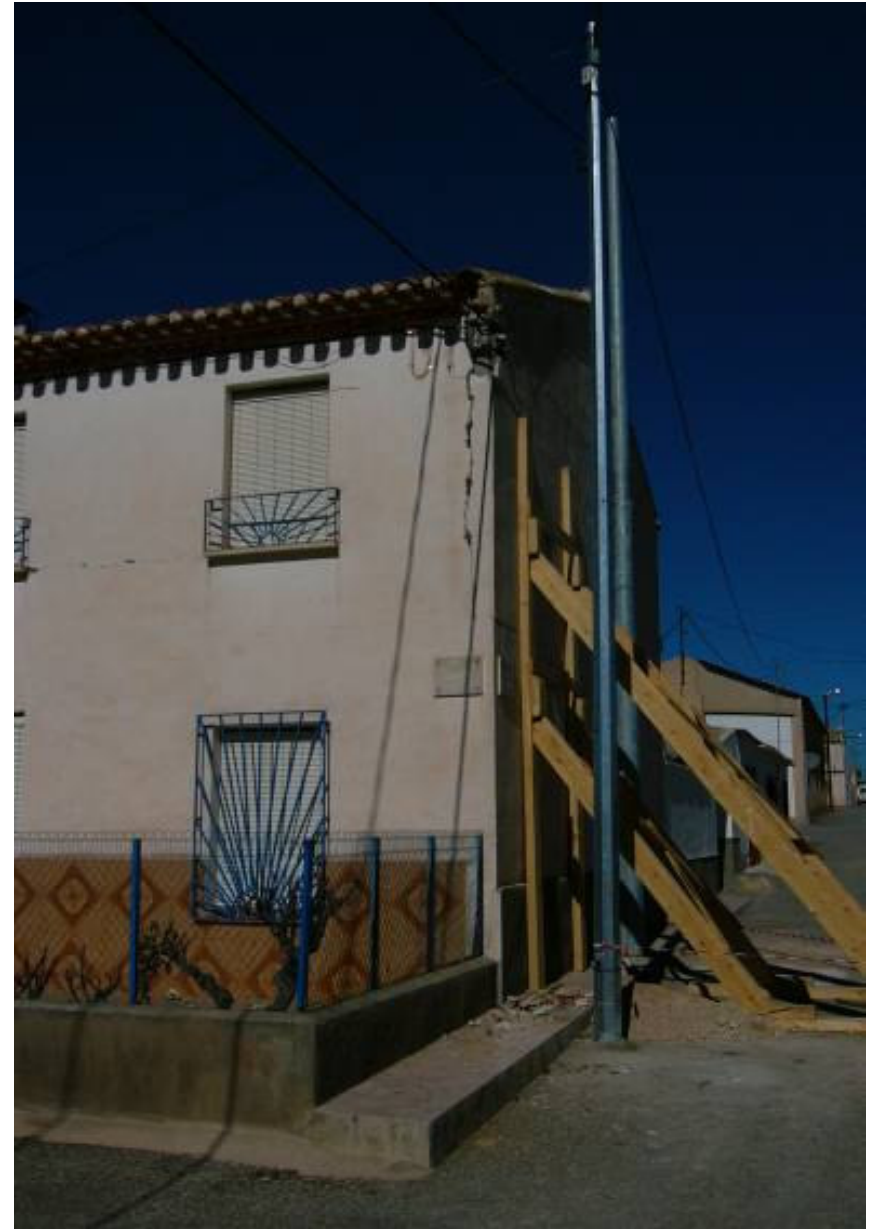
Drift of walls in blockwork construction. Zarcilla (Grade 2vulnerability B)

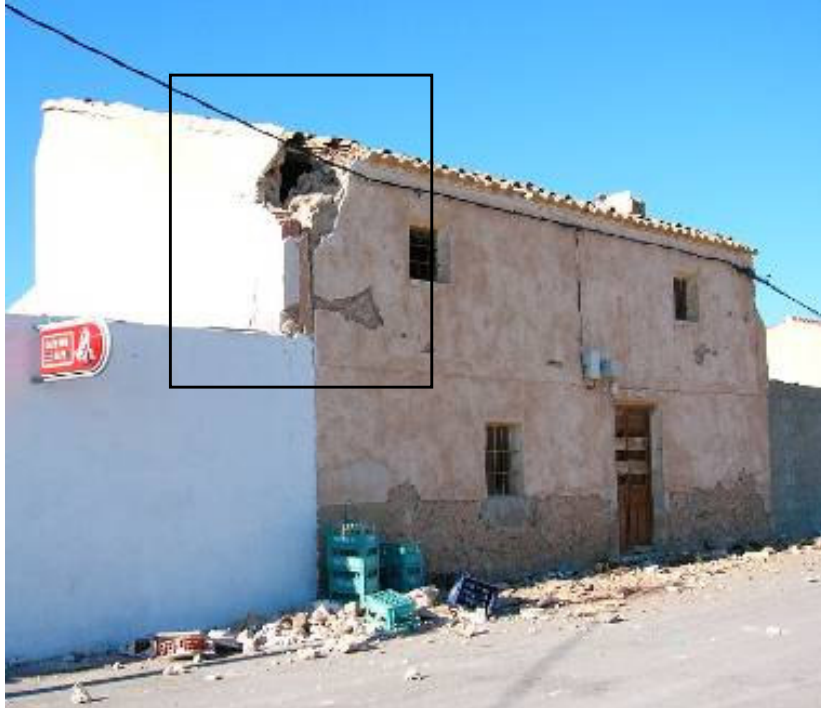
Corner failure in masonry construction in Zarçilla. (Grade 3 vulnerability B)

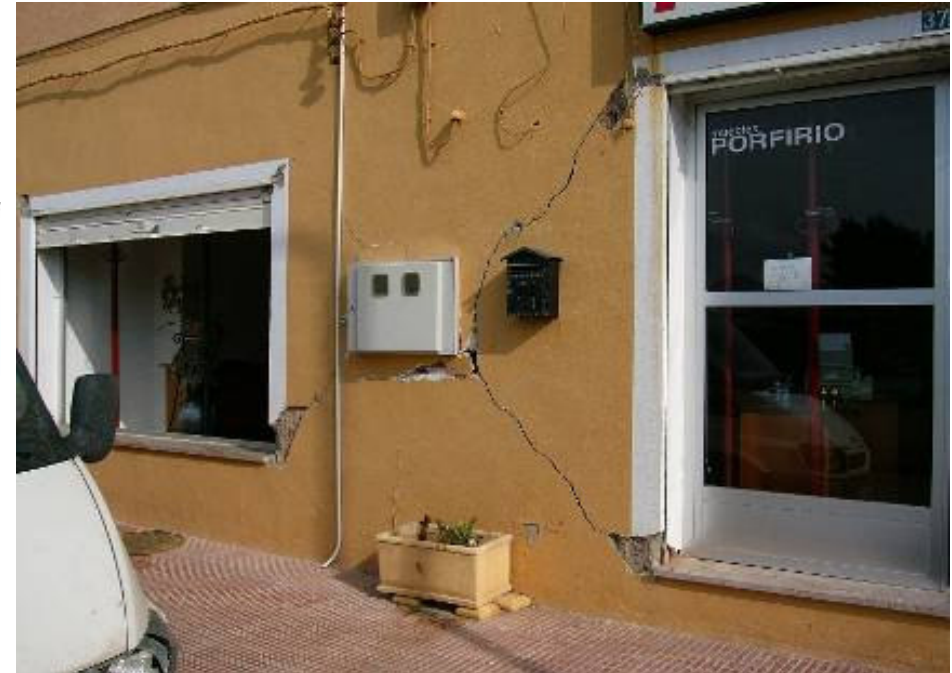
(left) shear damage in a building in Zarilla (Grade 2 vulnerability B)

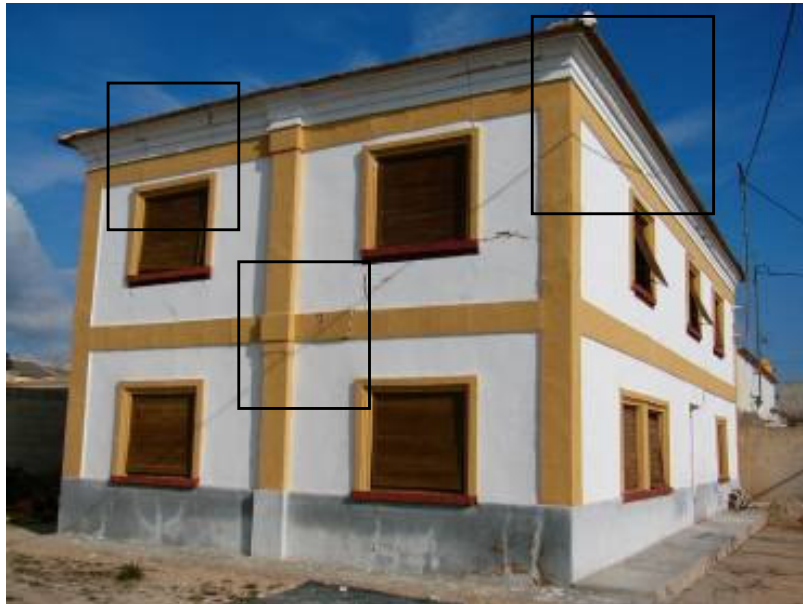
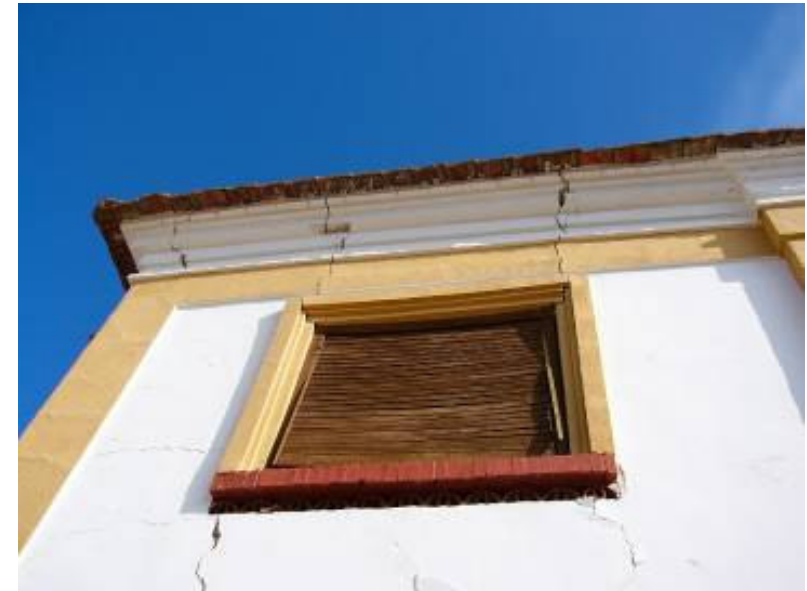
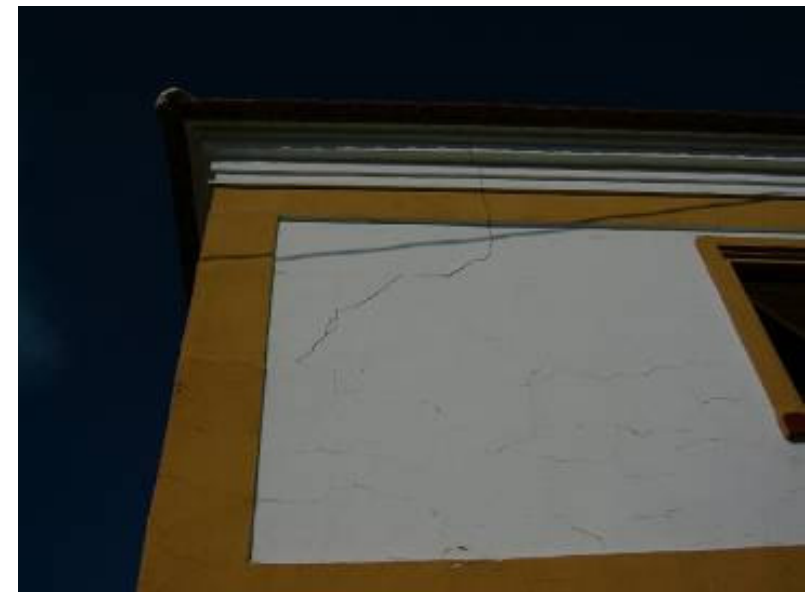
This house in Zarcilla suffered extensive shear damage in all walls and especially in vulnerable places like window lintels and corners. There is pounding damage to the column connection at the first floor level and heavy damage to internal partitions. (Grade 3 vulnerability B)

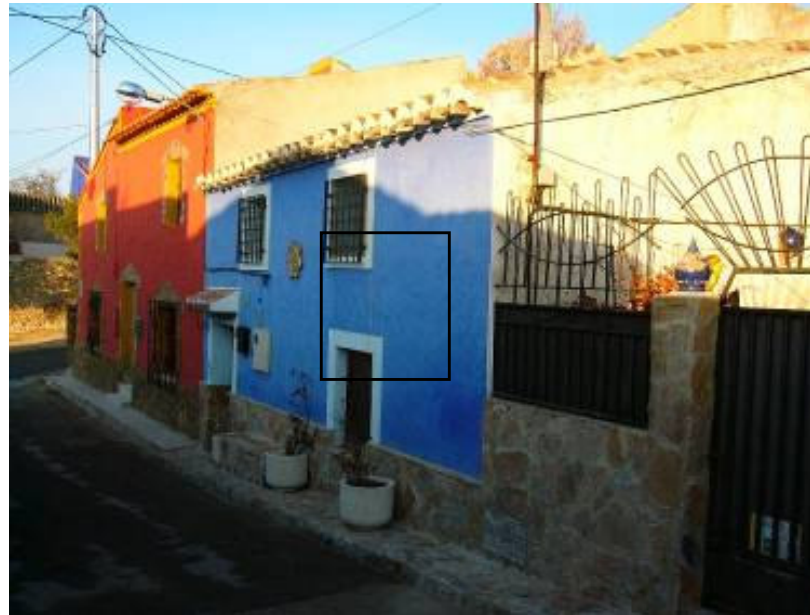
The town of Doña Inés, located over a limestone outcrop was only slightly damaged as compared with Zarcilla and La Paca located over quaternary fill, despite a smaller epicentral distance. This type of slight shear damage to walls was typical of damage in this location and assigned an intensity of 5 (Grade 1 vulnerability A)

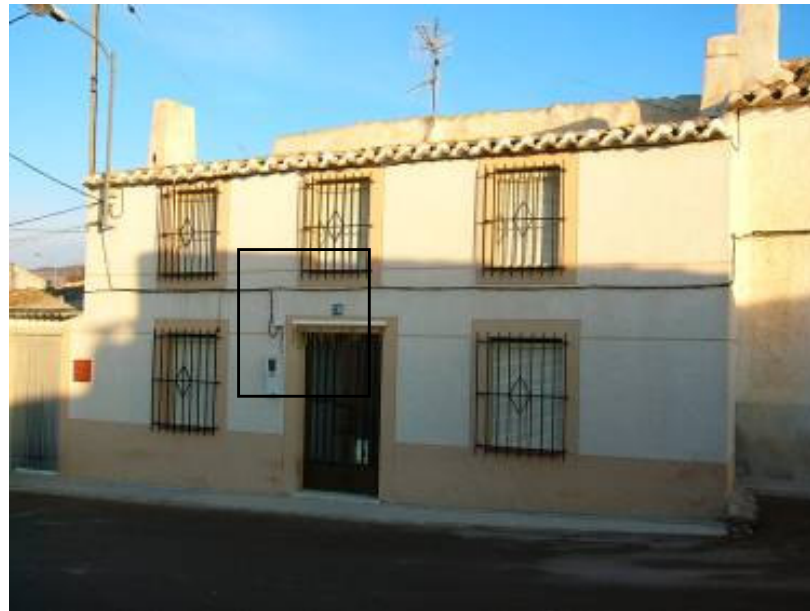
Another slightly damaged home in Doña Inés (Grade 1 vulnerability B)

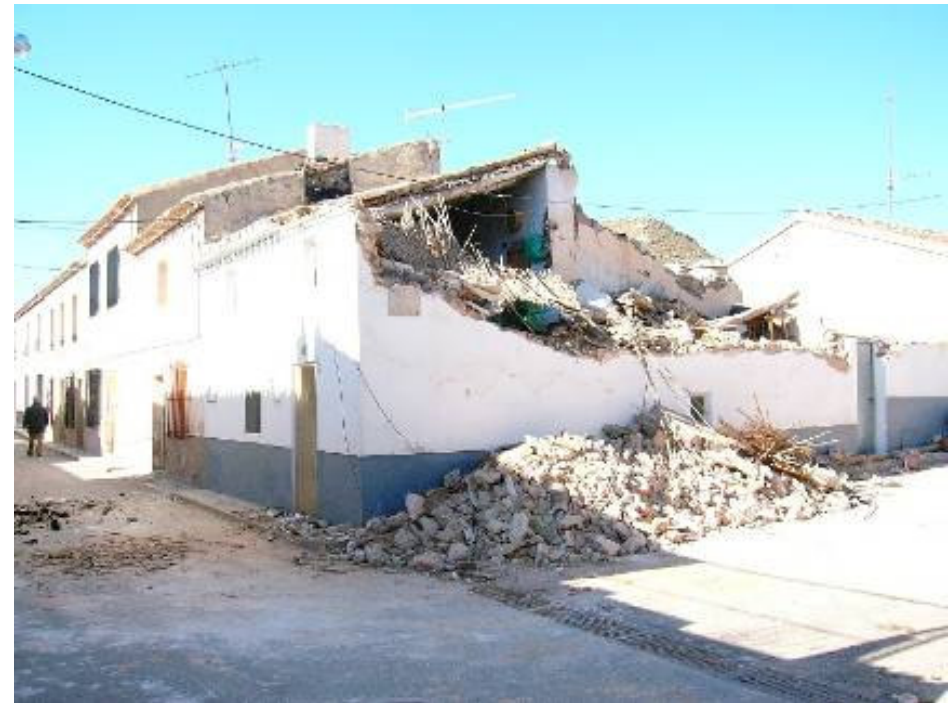
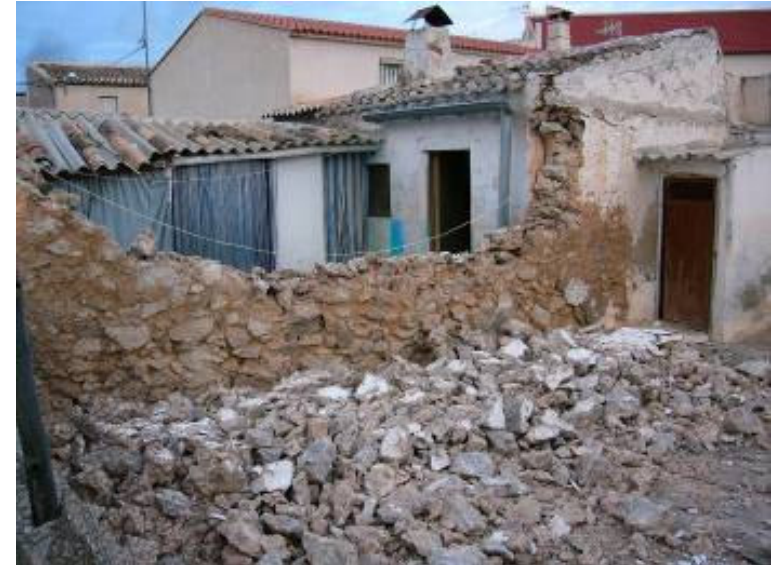
The direction of the roof joists in this house in Zarcilla to the right indicate the failed wall was an unsupported gable wall. Heavy damage has resulted to the roof and other walls from this failure. (Grade 4 vulnerability A)

(Below right) toppling failure in a simple unbraced stone wall.

This heavily damaged wall in a vulnerable home in La Paca fell out after losing connection with an internal perpendicular wall that has also been damaged. (Grade 4 vulnerability A)

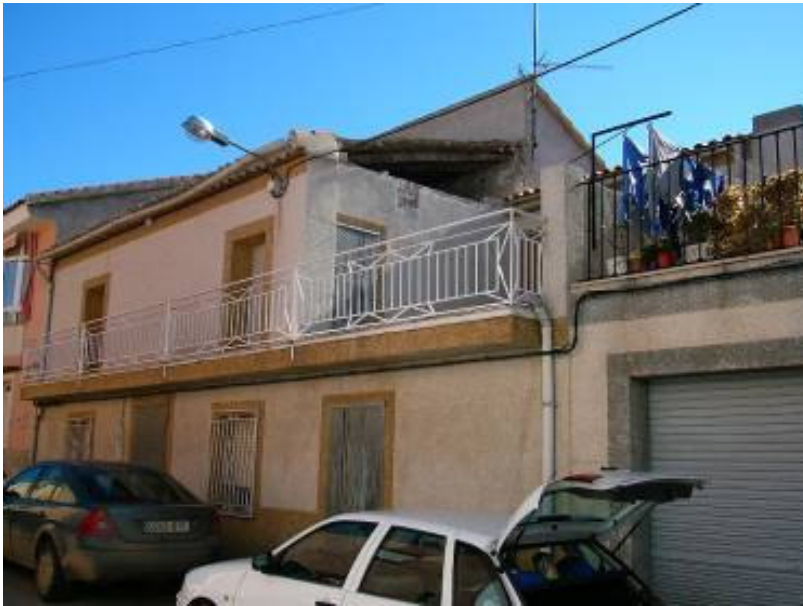
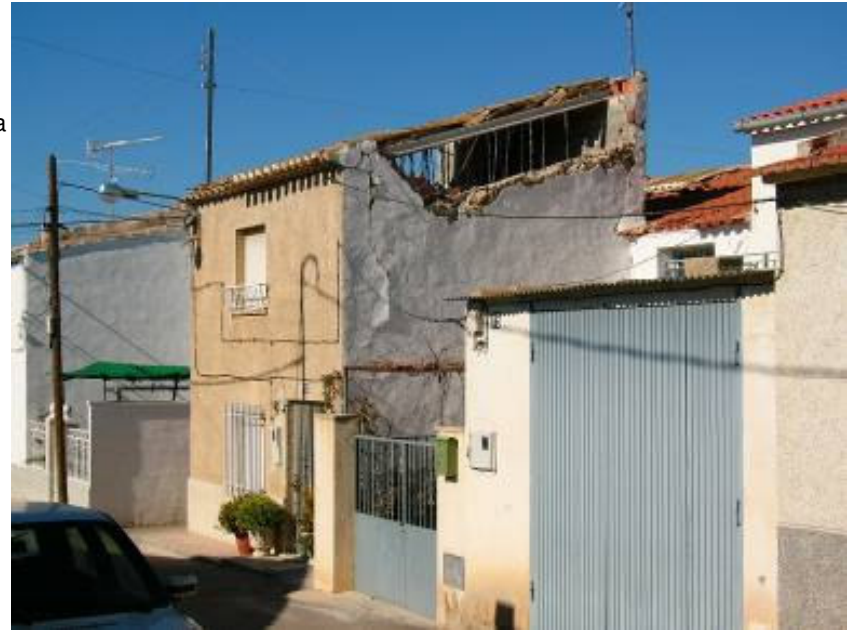
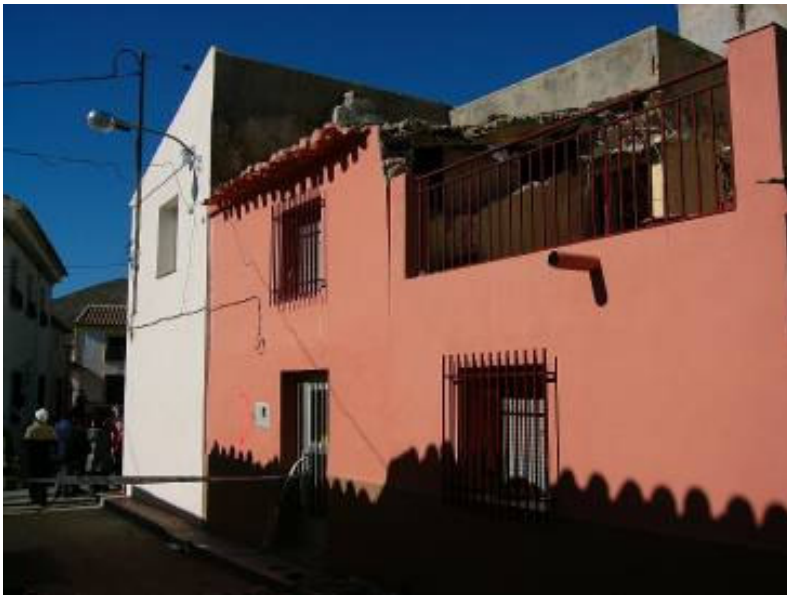
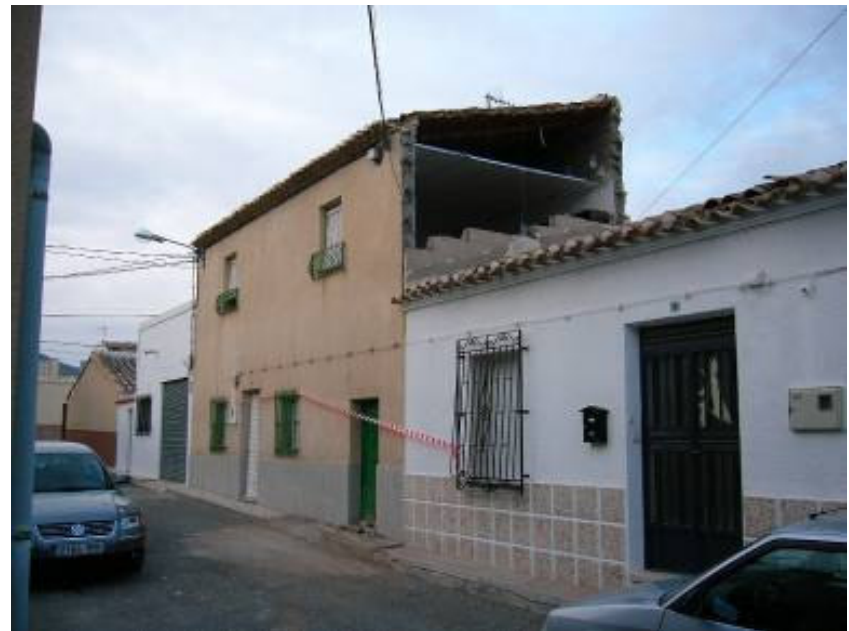
Gable wall failures from various homes in La Paca and Zarcilla (Grade 3 vulnerability As and Bs)

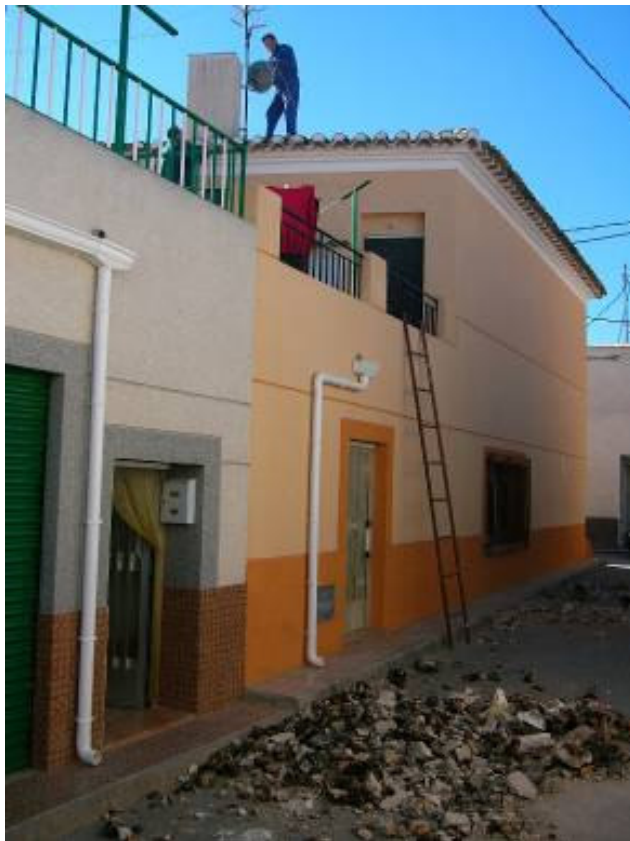
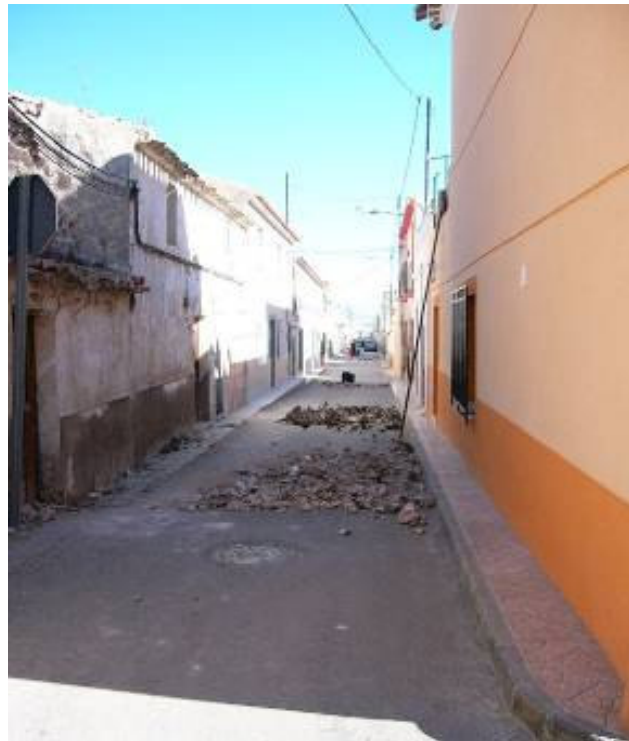
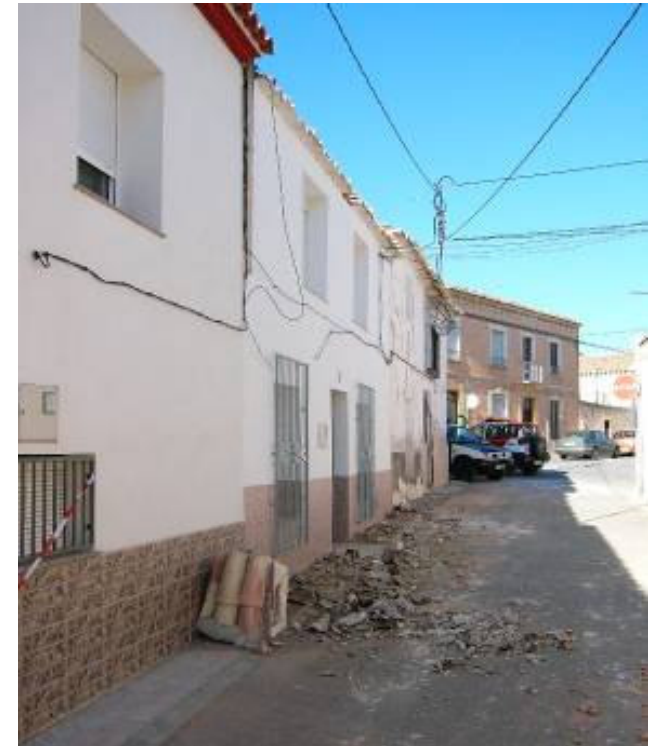
Damaged chimneys; old and new

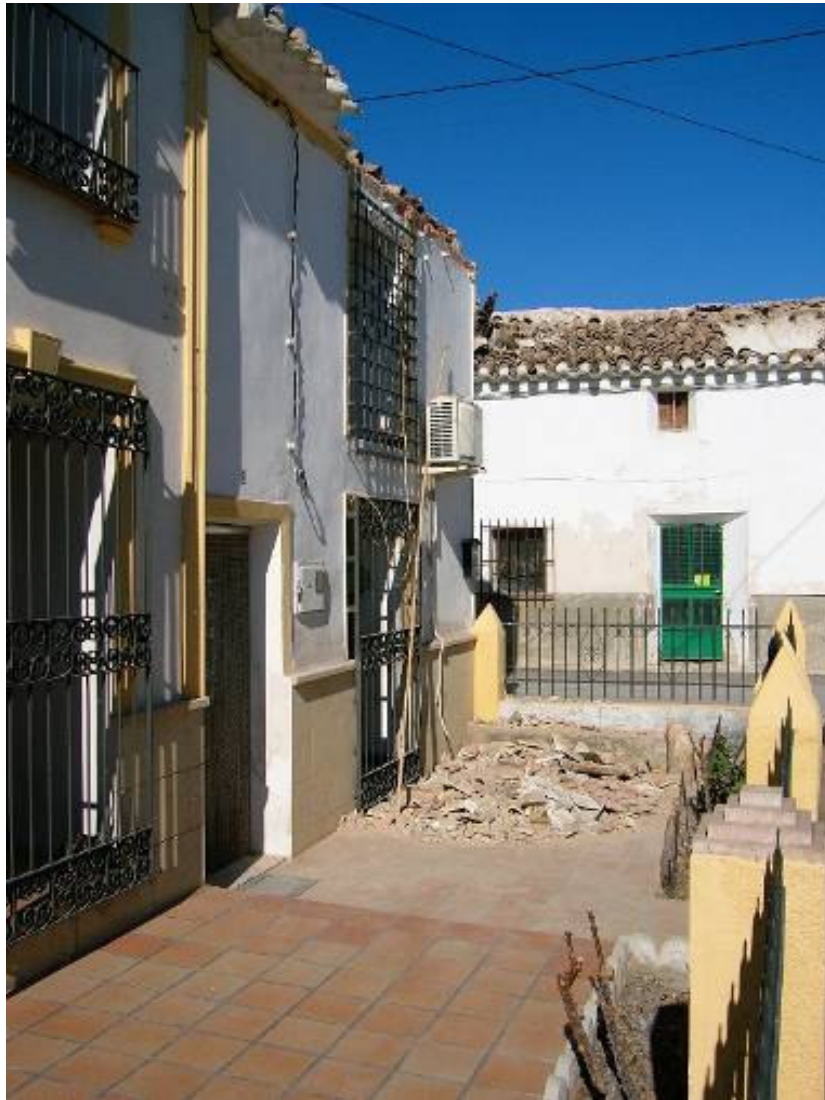
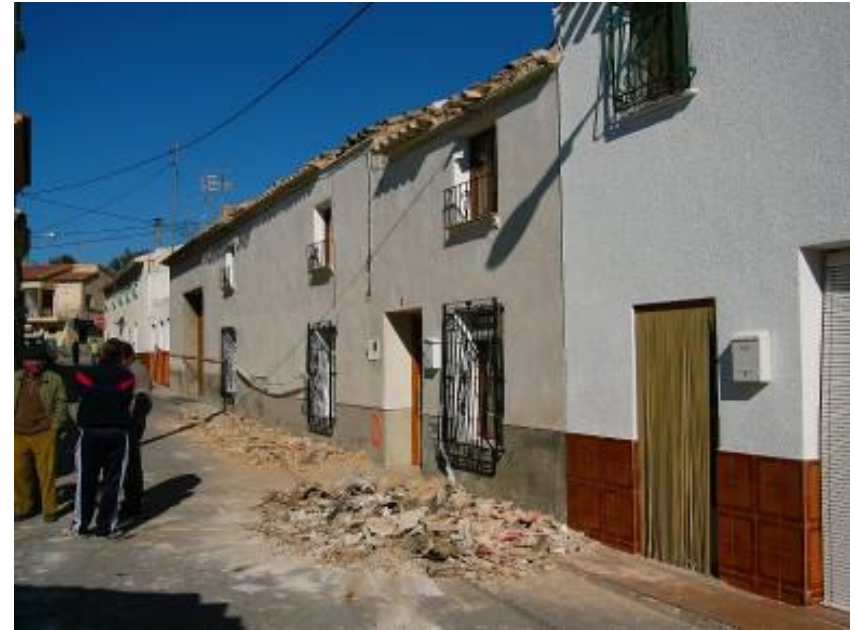
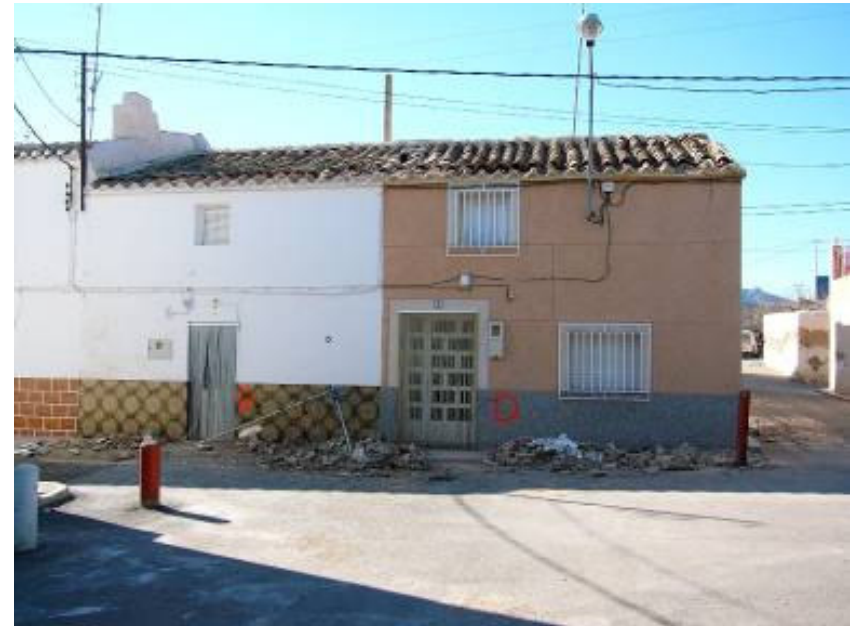
Fallen eaves in homes in La Paca and Zarcilla (grade 2 vulnerability A in all cases)

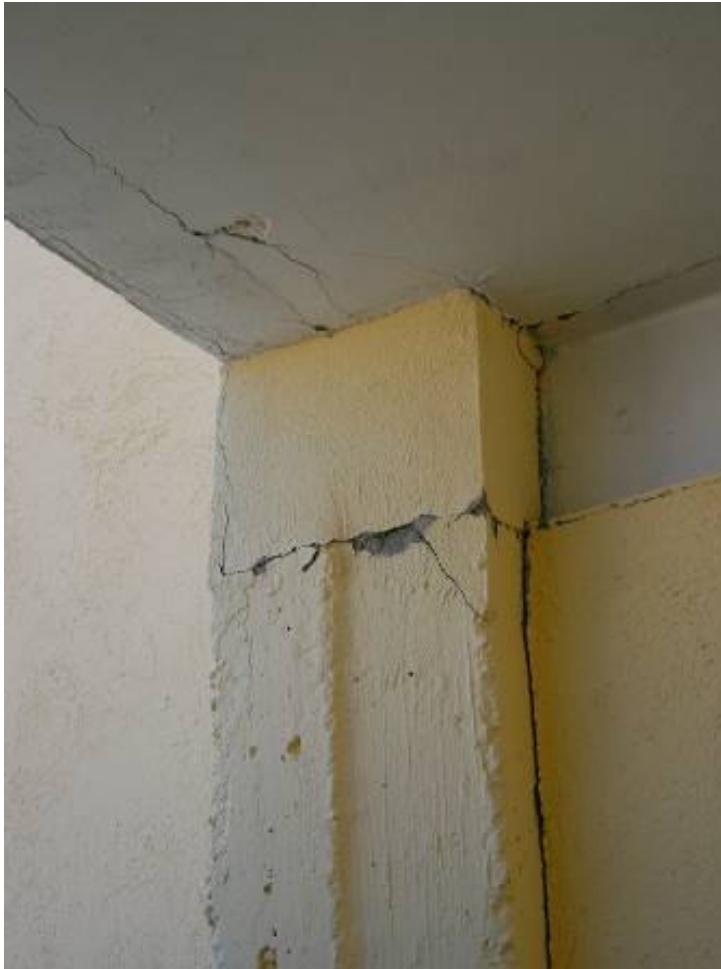
A plastic hinge developing in a column head supporting an off-centre steel joist. (Grade 3 vulnerability C)

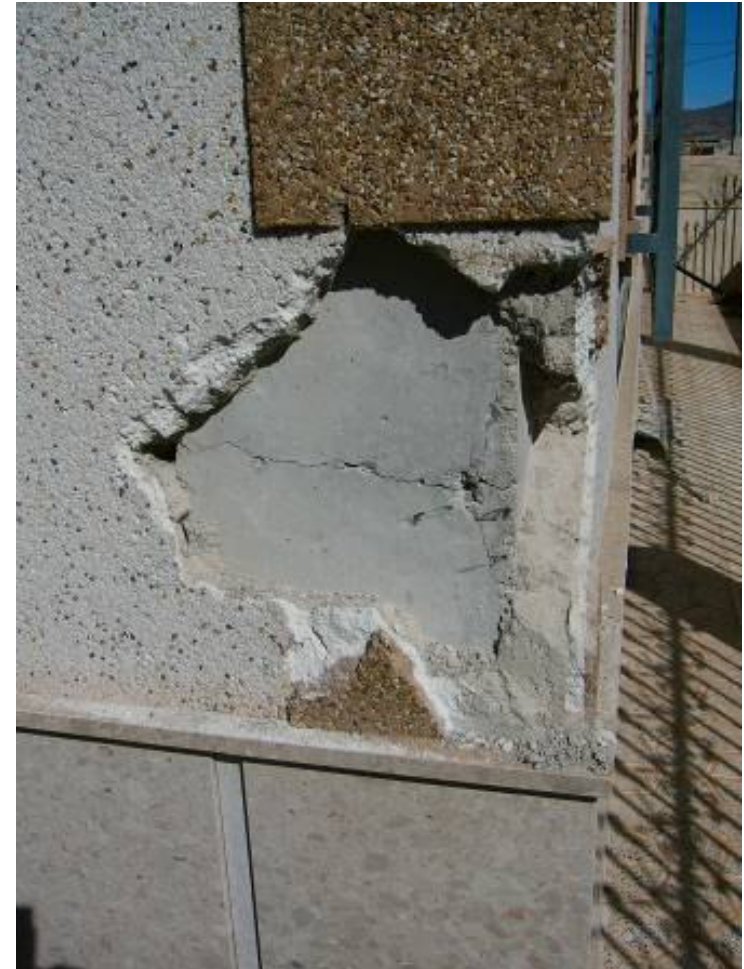
Small cracks in a RC column in a home in Zarcilla revealed in an inspection. (Grade 2 vulnerability C)

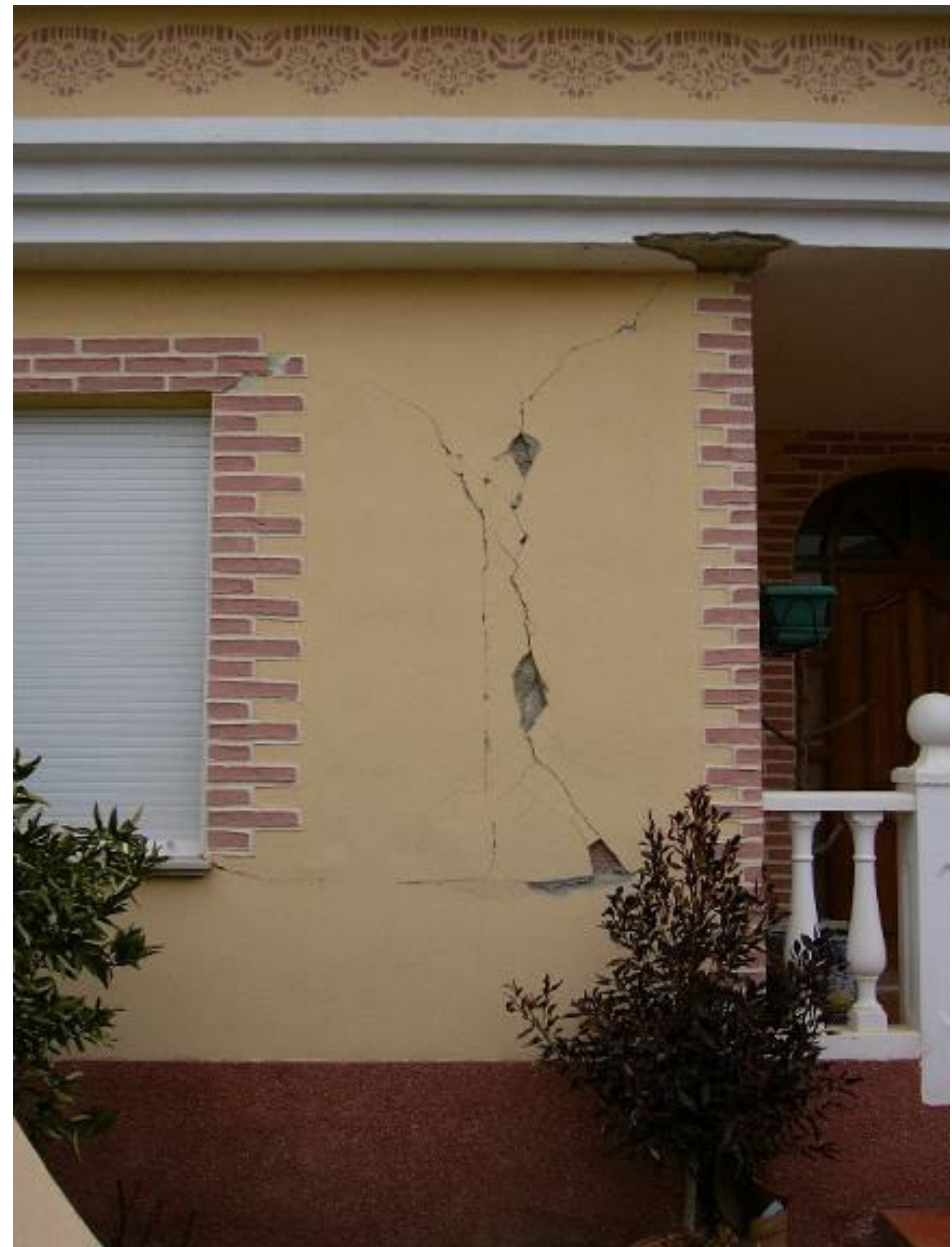
Moderate damage to infill walls in this recently completed home in La Paca (grade 2 vulnerability C)

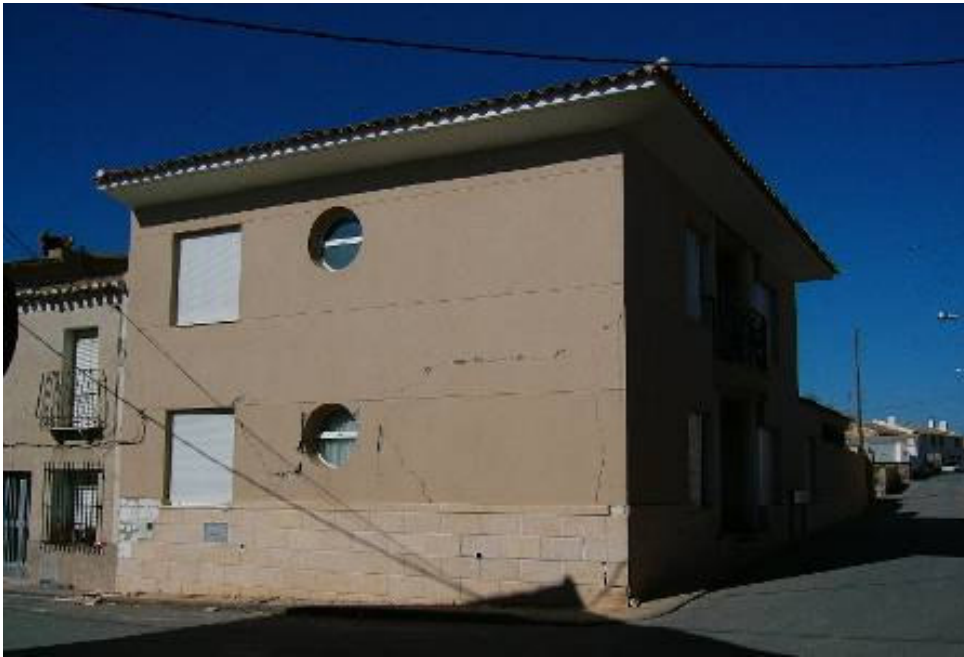
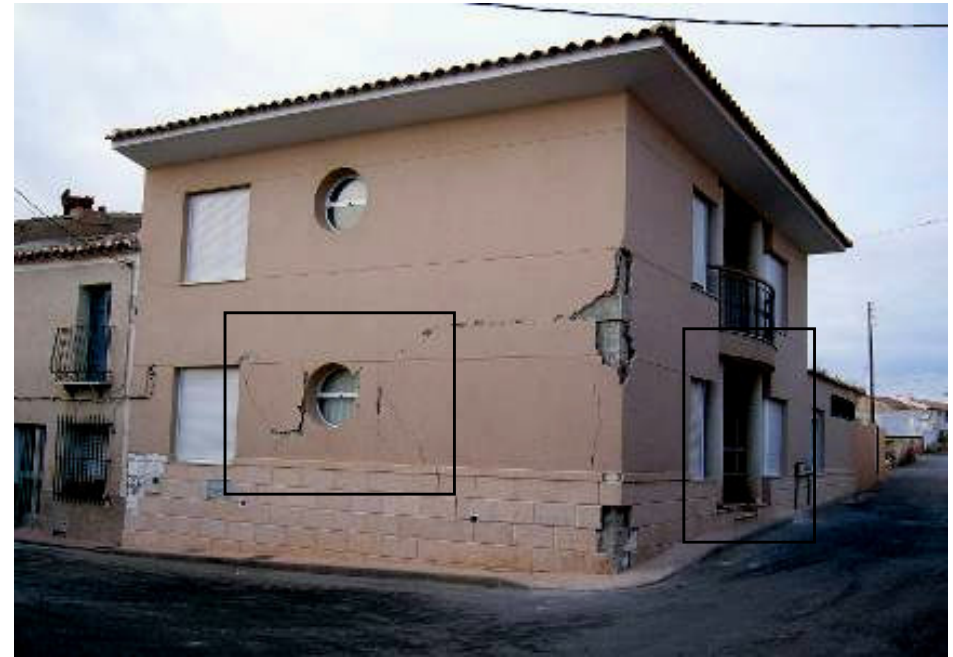
Moderate damage to infill walls in this recently completed home in Zarcilla. Note the continued damage done by aftershocks and inspection in the photograph on the right taken a few days later. (grade 3 vulnerability C)

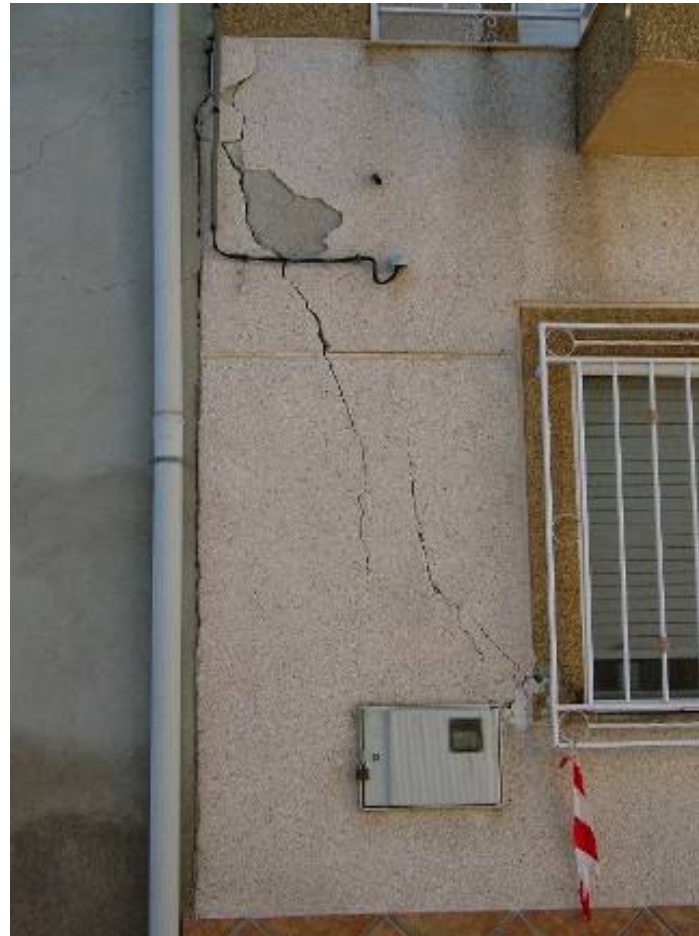
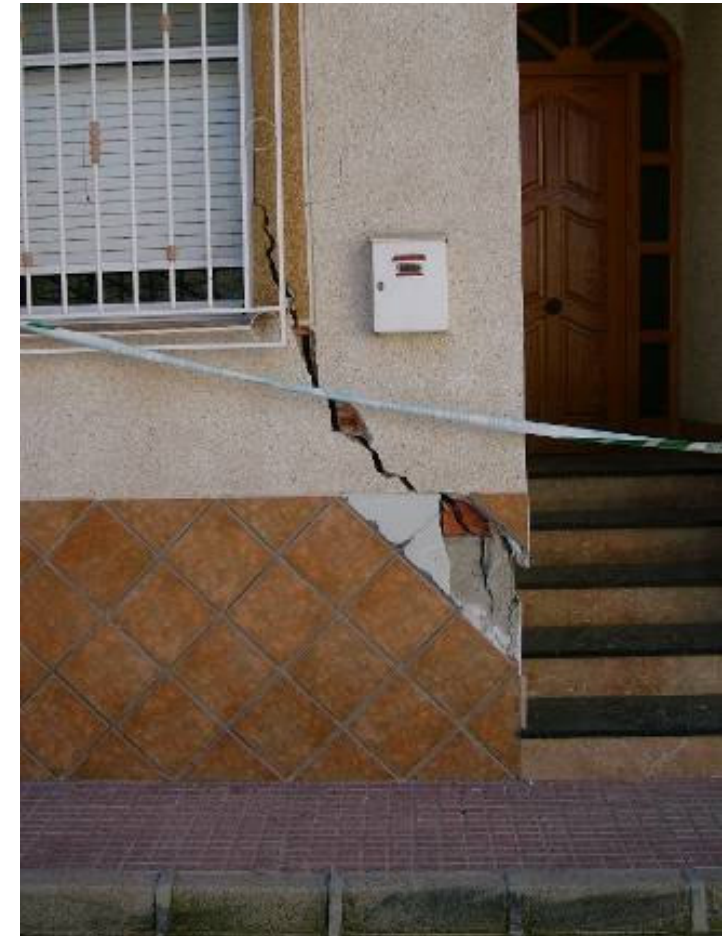
Moderate damage to infill walls in this home in Zarçilla. There appears to be slight damage to the column slab connection in the left hand photograph. (grade 3 vulnerability C)

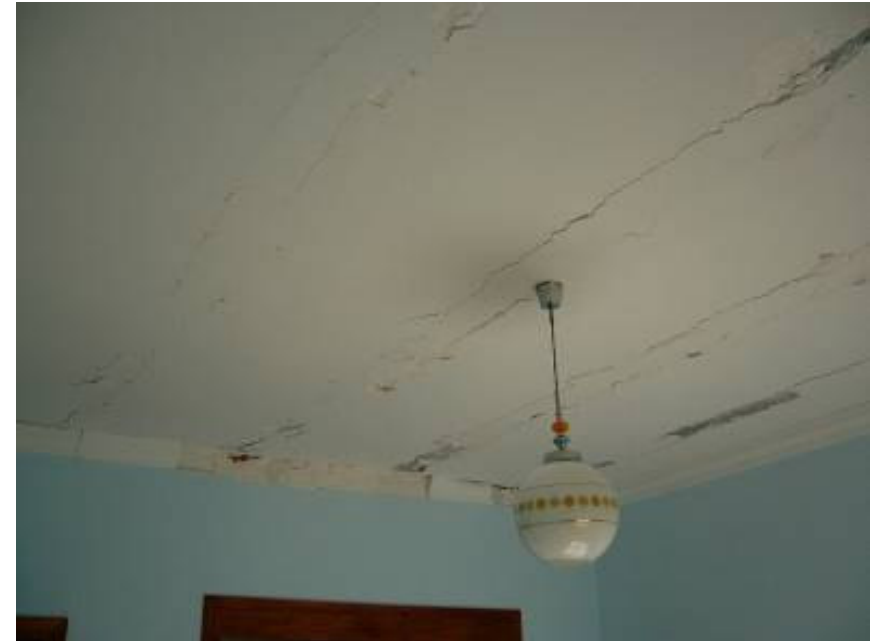
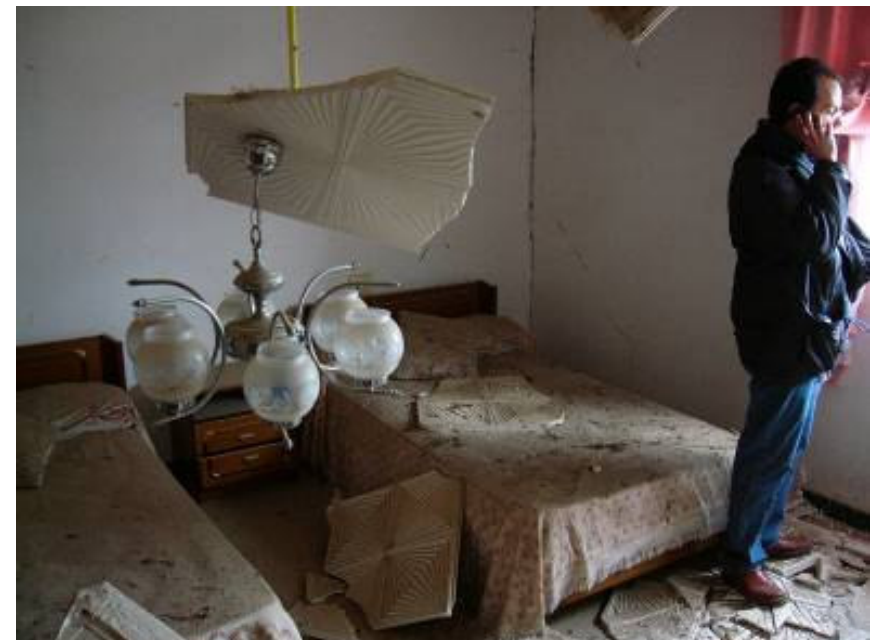
Damaged ceilings of different types in various buildings in La Paca and Zarcilla

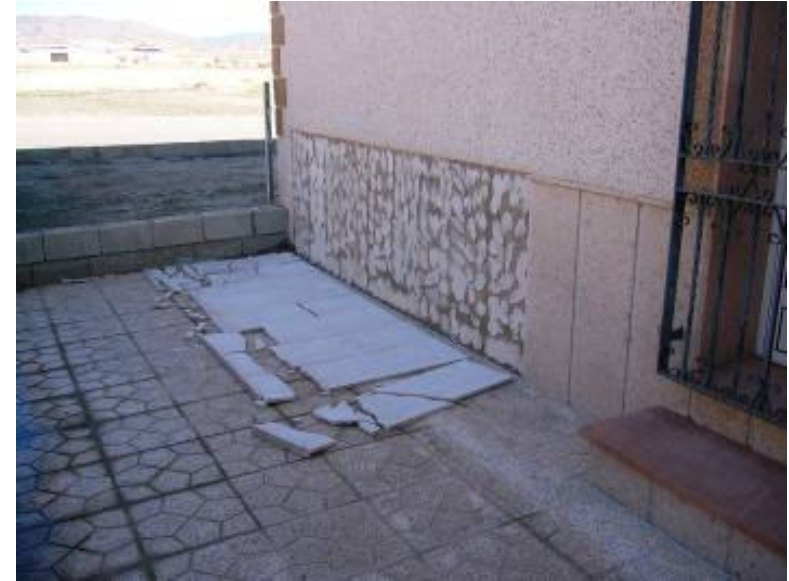
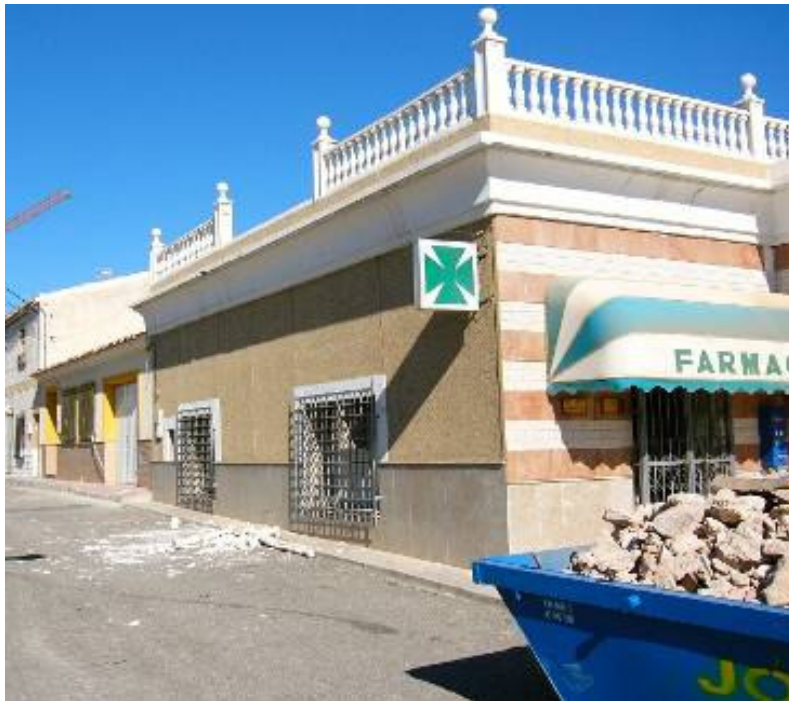
Different types of damage to decorative elements, balustrades and facing material in Zarcilla corresponding to damage of grade 2 across different vulnerability types.

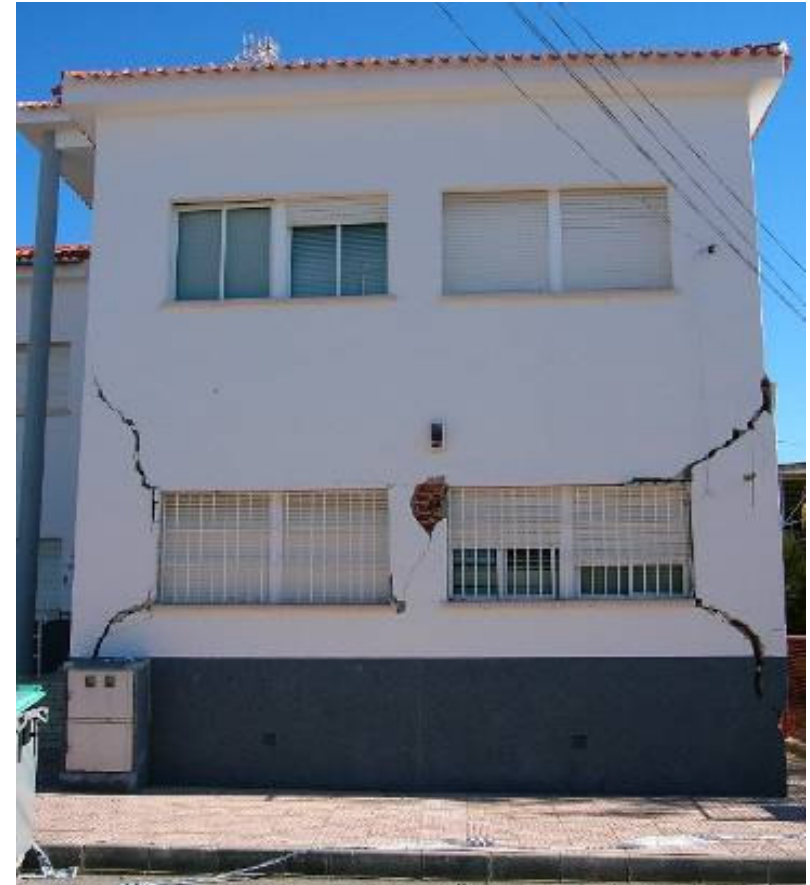
This civic centre in La Paca has suffered moderate non-structural damage to partition masonry infill panels. A general survey of the building reveals no horizontal bracing system available other than the slender column connections to the heavy floor slabs. The lack of stiffness of the structure has resulted in large displacements of the ground floor which have been transmitted to the brick infill panels and partitioning walls, shearing them to pieces. Note the soft storey effect, with damage confined to the ground floor where horizontal loads are greatest on account of the heavier mass above and denser partitioning in the upper floor. This building was desperately in need of some stiffness and a concrete lift shaft might have given the structure the necessary shear strength to avoid loading the partition walls, but it was a fragile brick shaft and even that was badly sheared. Despite heavy partition damage there is only minor structural damage with hairline cracking and spalling in column heads signalling the beginning of plastic hinge formation. Despite low structural damage, public confidence in this civic building is shattered and thus a candidate for replacement or major overhauling.

Diagnosis No primary seismic resistant strategy evidenced; lack of structural stiffness, brittle and fragile infill walls, soft storey effect.
(Damage grade 3 vulnerability C)

X cracks are unequivocal evidence that these curtain walls have been subject to shear by lack of stiffness of the mainstructure,
