FIELD REPORT FOR THE JANUARY 29TH 2005 EARTHQUAKES IN LORCA, SPAIN

1 Executive summary

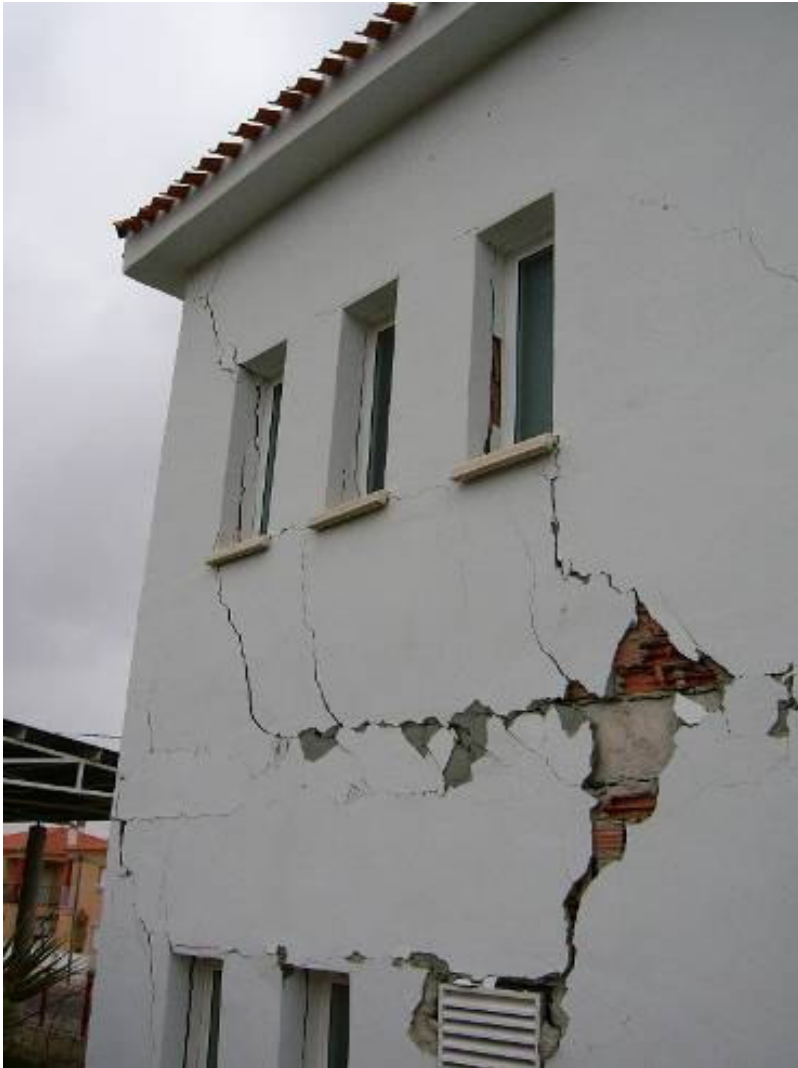
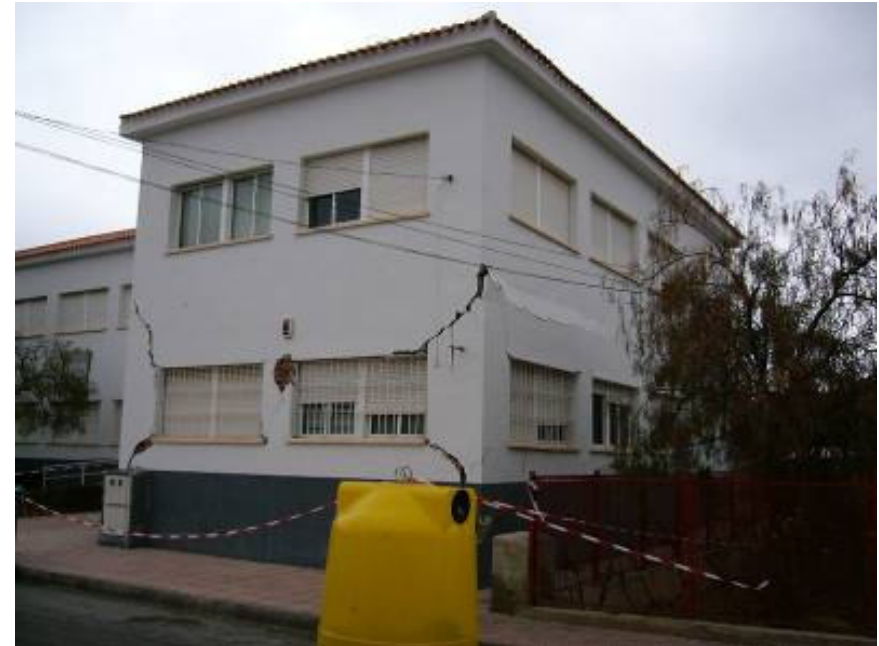
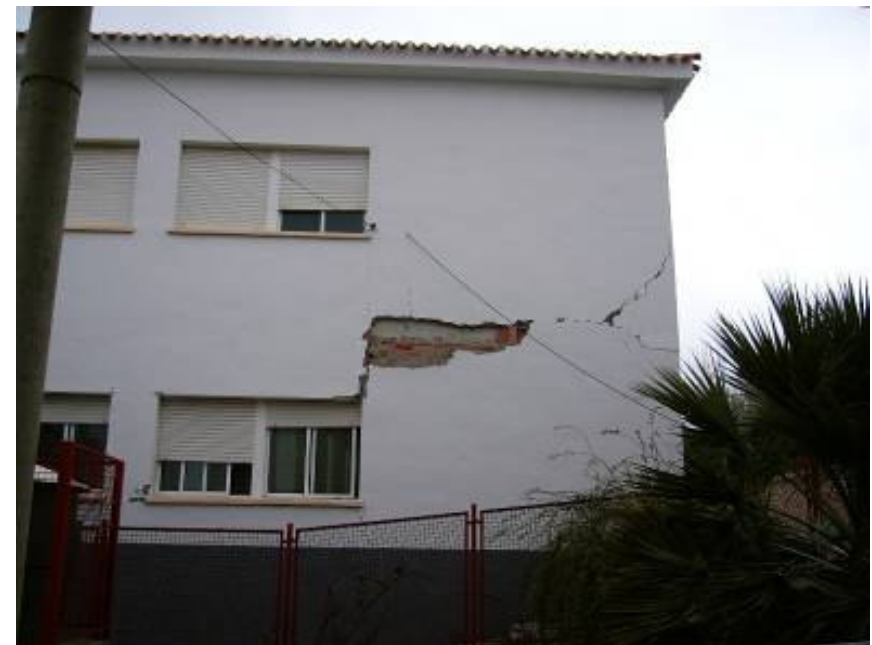
External views of the building showing moderate to heavy damage to brittle infill brick walls

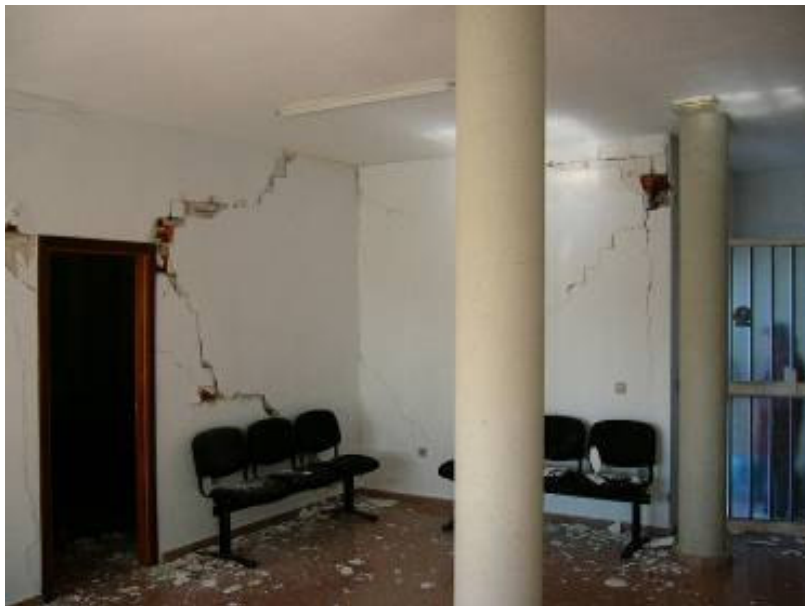
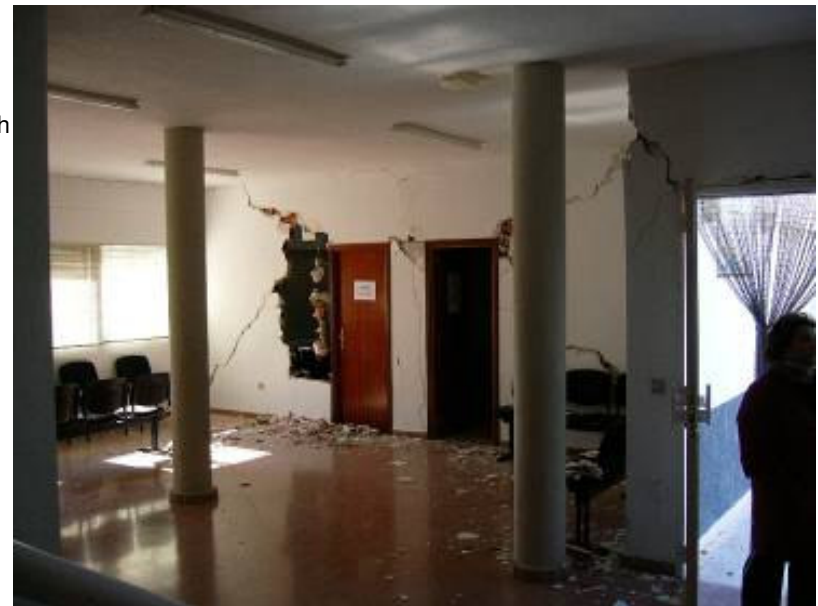
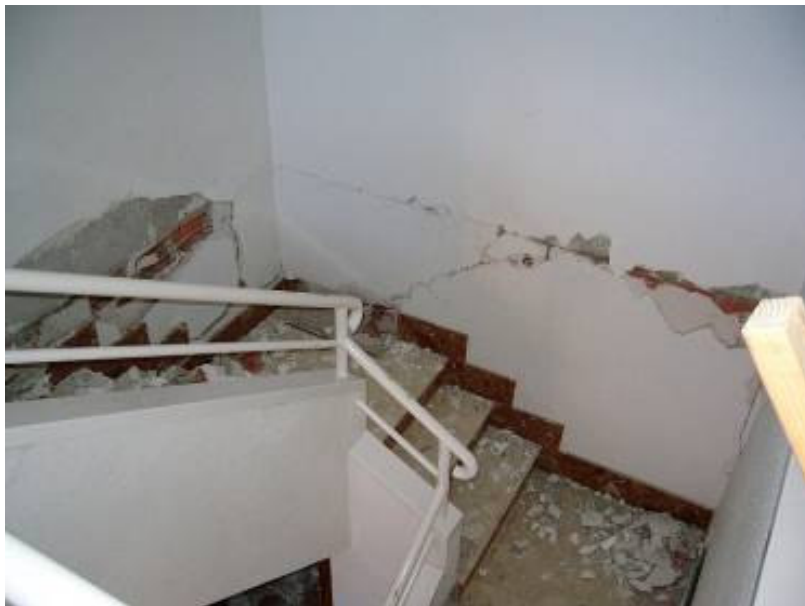
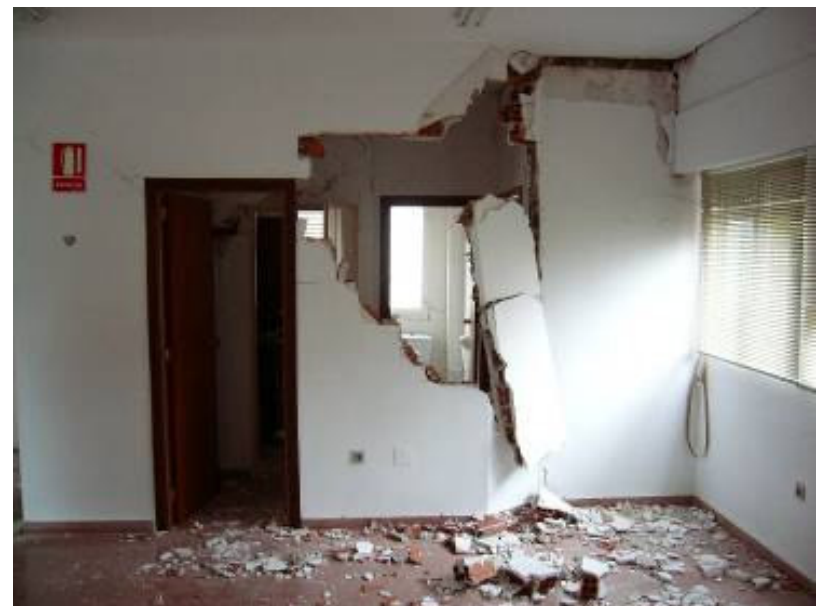
Indoor partitions have also been subject to heavy shear forces with conspicuous X cracks and partial failure of entire wall sections. Although structural damage appears to be slight, this is an unacceptable degree of damage for an institutional building.

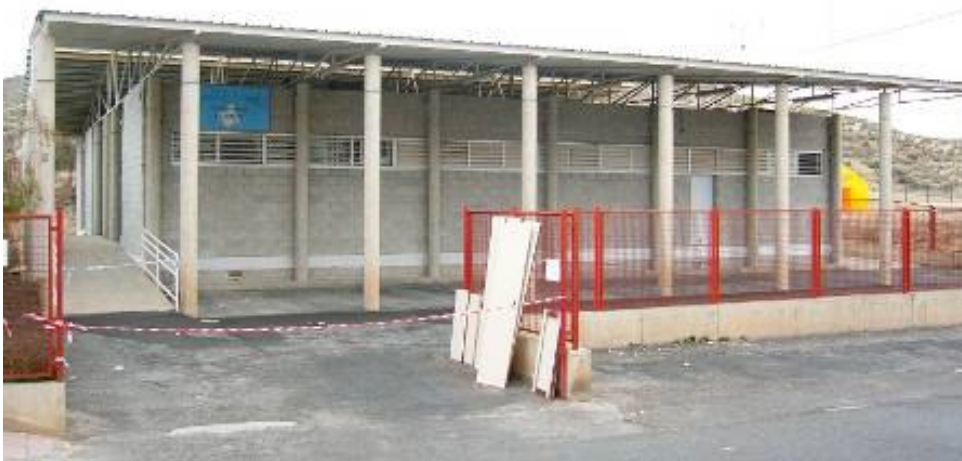
This health centre in La Paca has a very lightweight steel truss roof over a RC column grid with internal and external walls of concrete blocks. This very unrestrained and unconfined structure with many stand-alone columns shook itself free from the brittle concrete blocks built against and around its structural members. This is a poorly conceived building from the point of view of architectural detailing. All wall contacts with structural members have been damaged. Many partition walls inside show signs of shear damage. Some of the steel roof trusses appear to have shifted from their anchor plates on the column heads. There appears to be no structural damage but there is moderate non-structural damage to most walls including ceilings and indoor fittings. This is unacceptable damage for a medical centre.

Diagnosis Lack of structural stiffness, brittle and fragile infill walls, Inadequate architectural detailing. (damage grade 2 vulnerability C)

This is the wrong type of walling material for the wrong type of structure and detailed in the wrong way.

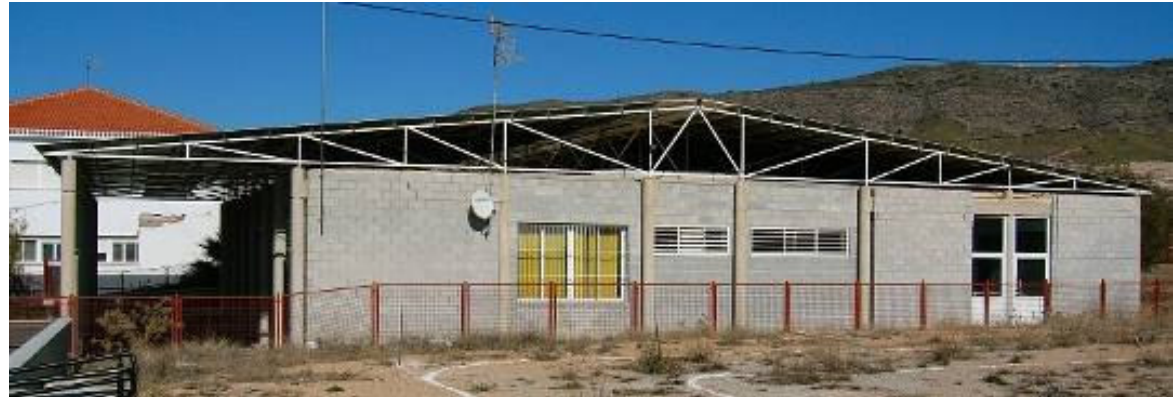
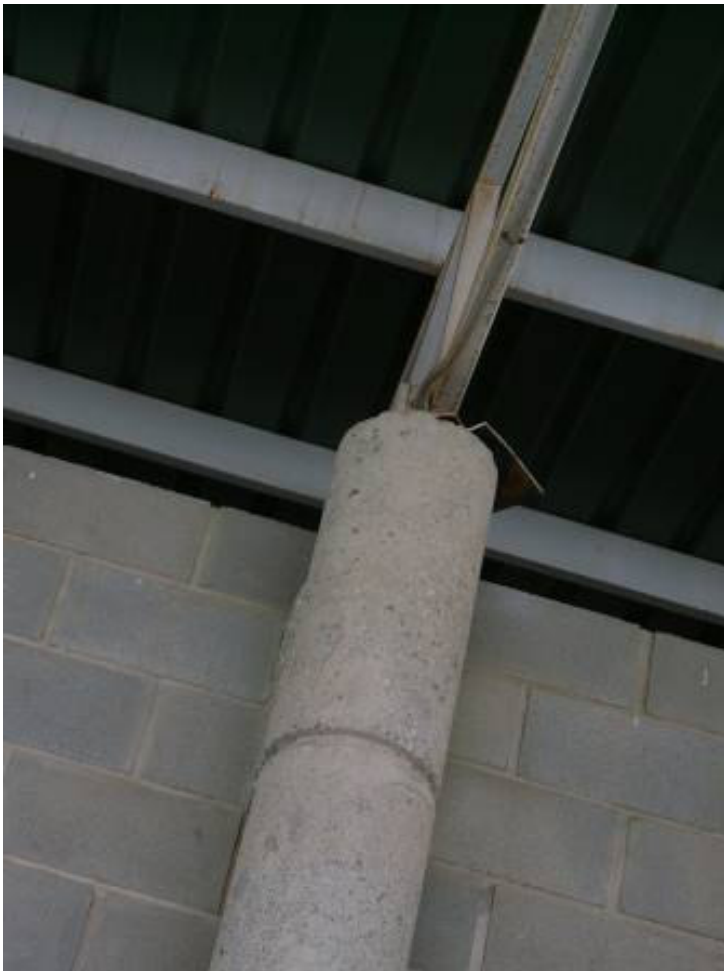
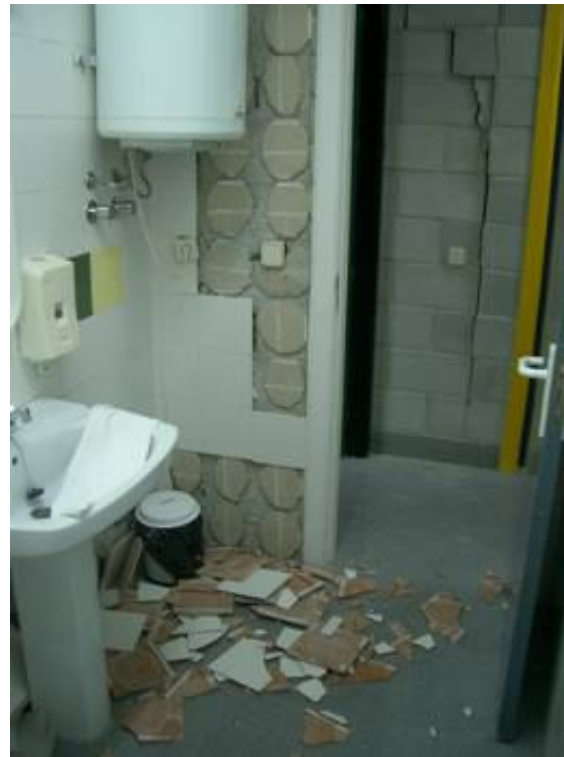
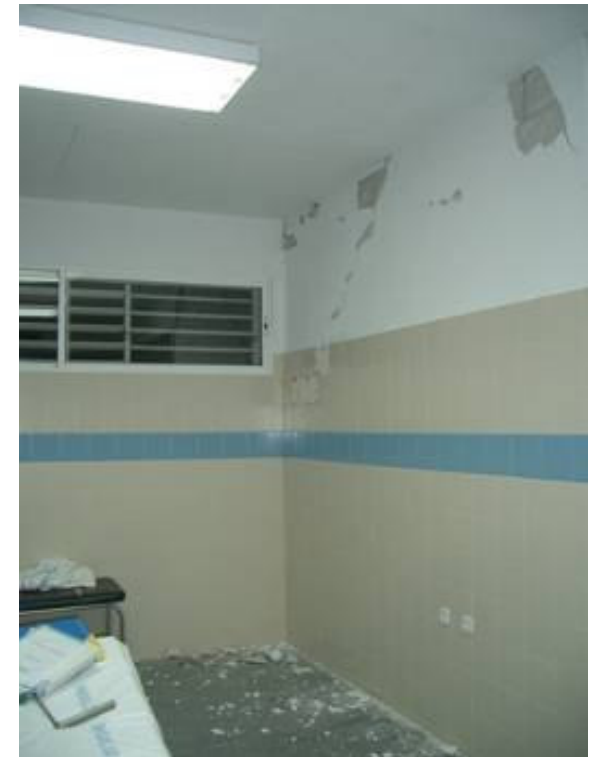
Internal walls in this health centre show signs of shear damage with diagonal cracks. Ceramic tiles have been dislodged everywhere and the roof trusses appear to have been shifted from their base plates on the column heads.

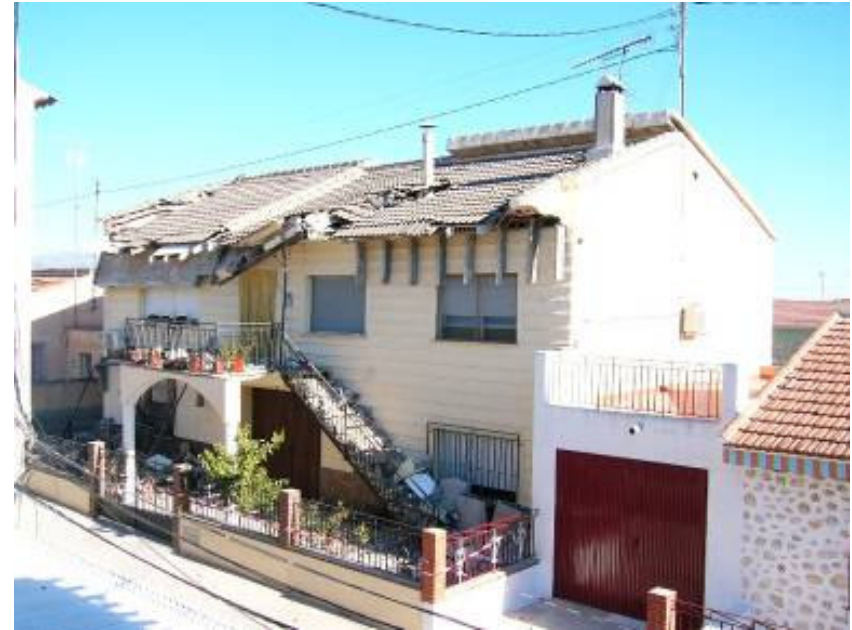
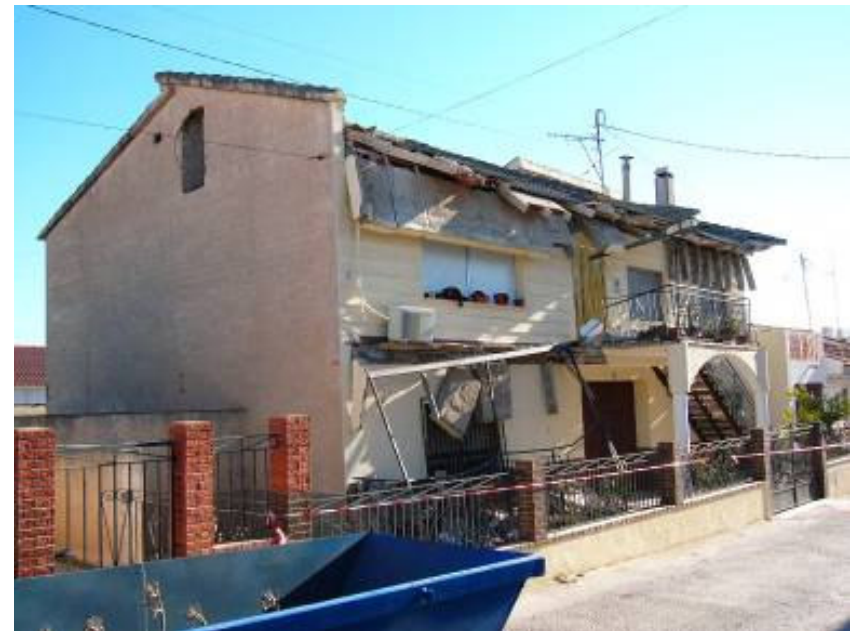
Sadly for the affected family, this appallingly conceived house is a non-engineered mish-mash of structural solutions with very poor structural and architectural detailing. Ambitiously cantilevered balconies and roof eaves were executed with no ring beams at the ends of prefabricated RC joists, allowing members to vibrate and wobble freely like individual keys of a piano. Roof joists rested as point loads on the edge of this non code-compliant cantilever which snapped off destroying the first floor cantilever in its way down. This extraordinarily hazardous building type illustrates the risk generated by unskilled construction practices in rural Spain.

Diagnosis Poor structural concept and unskilled architectural detailing. (damage of grade 4 vulnerability B)

External views of the building showing heavy damage to individual roof and balcony elements.

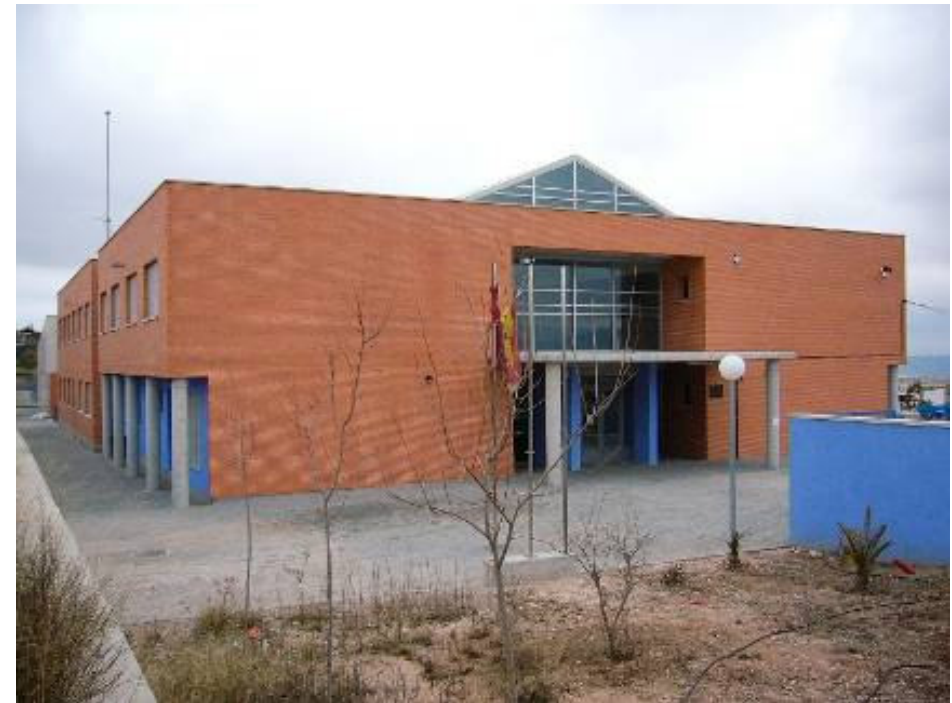
This fine building suffered only very minor damage to non-structural elements like spalling of brickwork at expansion joints and the fall of suspended ceiling panels and light fixtures.

Diagnosis Good engineered building with fine architectural detailing. Non-structural damage grade 1 vulnerability D

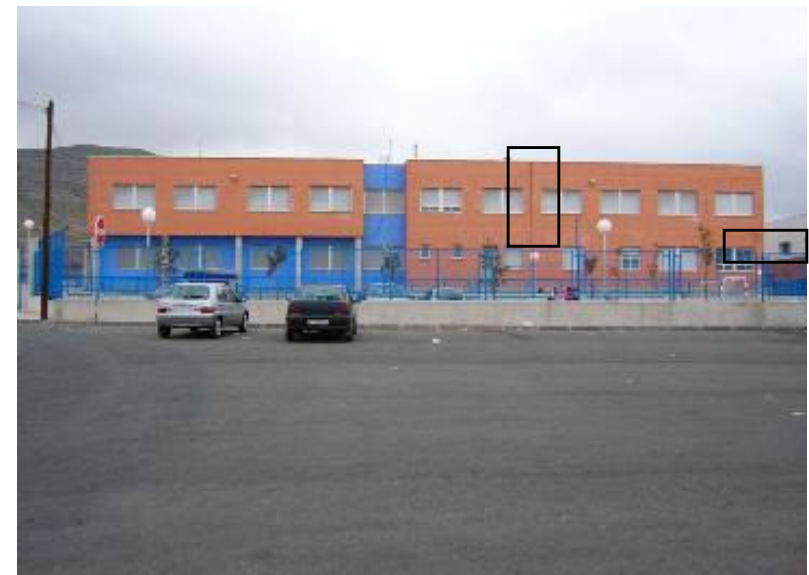
Slight pounding damage between two sides of an expansion joint and slab contact with the brick face. Cosmetic damage to a well built building.

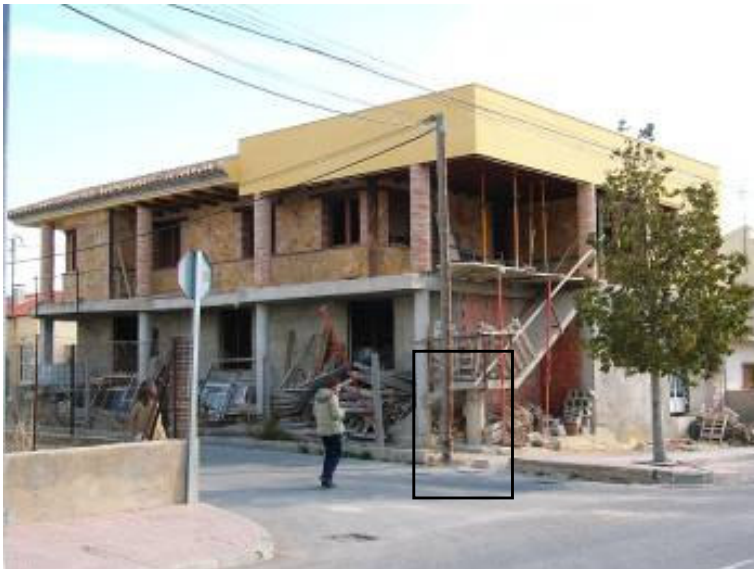
A 'short column' effect was observed in this RC frame house under construction. Structural elements become loaded for horizontal forces according to their stiffness, and this very stiff stair column (because its short) received a large horizontal force from the rest of the structure because the stair slab was connected to the main structure. An expansion joint between the slab and main building column would have avoided damage.

Diagnosis *Damage to an individual structural element because of an inadequate structural concept. Damage grade 3 vulnerability D*

Members attract horizontal loading according to their stiffness. Because the stair slab was connected to the main structure, the small stiff stair column received horizontal loading from the whole structure.

Short column location under a stair slab that is connected to the main structure; poor rebar splicing detailing is also visible, probably contributing to the column failure in this location.

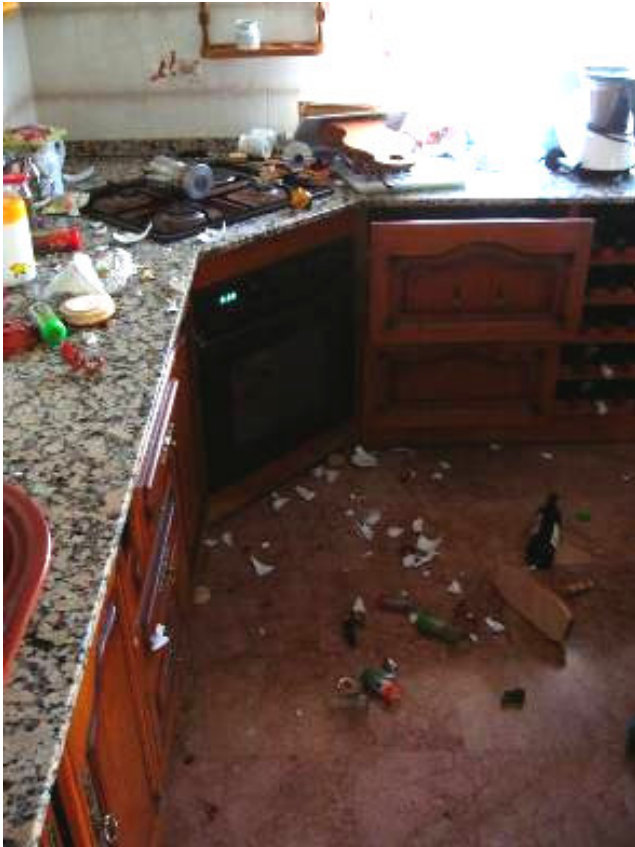
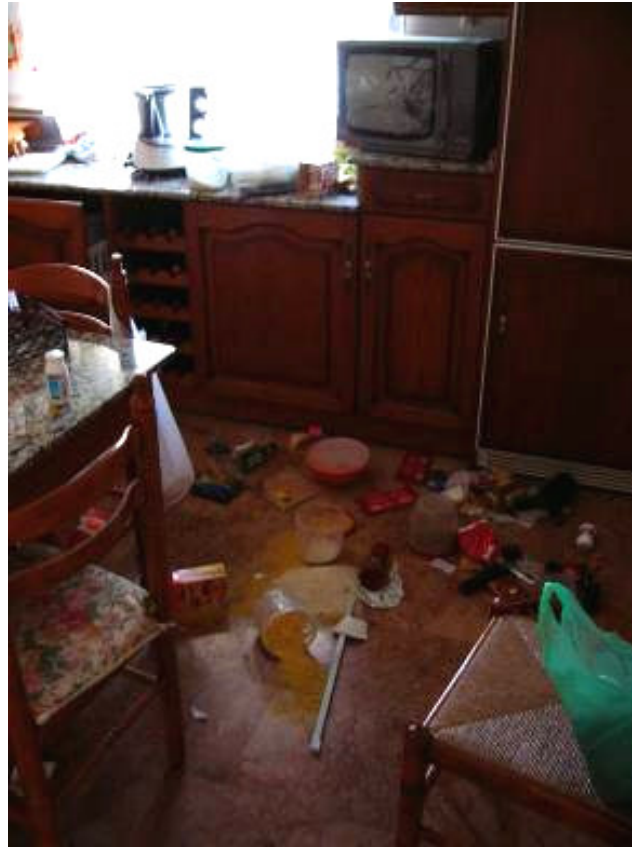
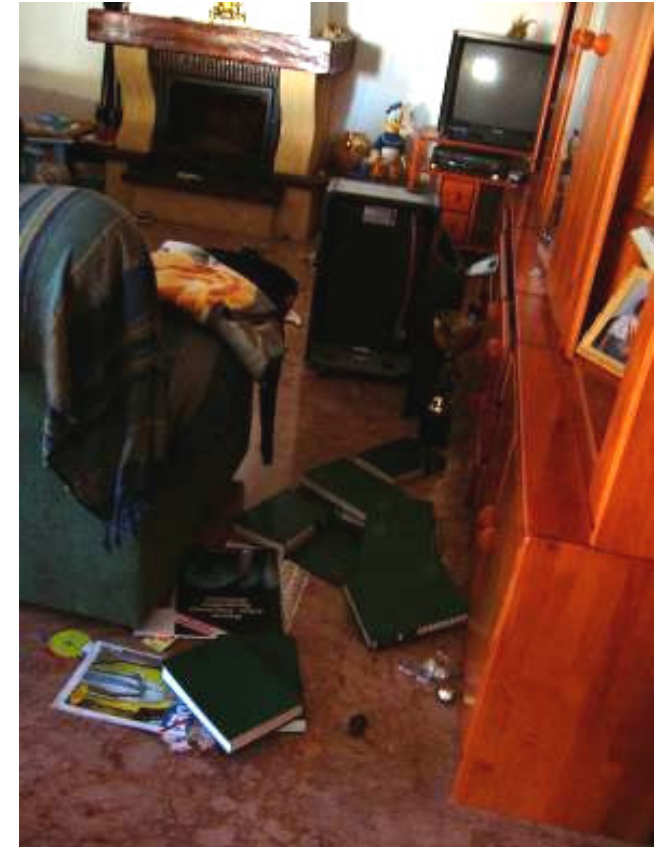
3 pictures from a second floor in a home in Zarcilla; drawers and cabinets were thrown open and contents spilled onto the floor including contents from the fridge. Note the damaged TV set in the kitchen which was also thrown down. Heavy books were knocked down from the bookcase in the living room suggesting an intensity of at least 6 or more.

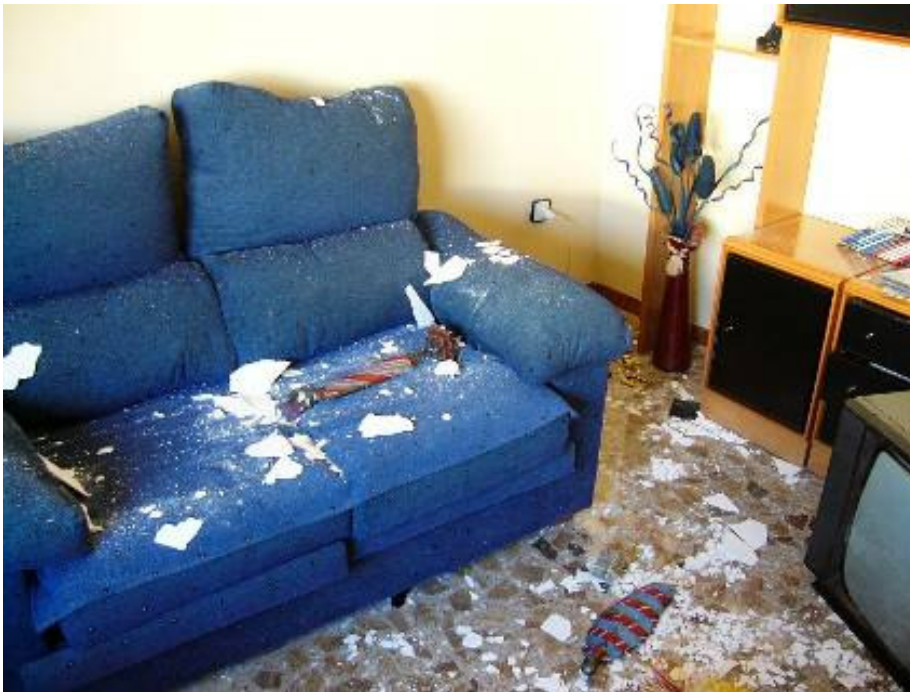
3 pictures from a second floor living room in a home in Zarçilla; Objects and glassware were thrown down and broken including the TV set. Some glassware that was not thrown down was broken by impacting each other or the cabinet formwork. Heavy fall of ceiling plaster.

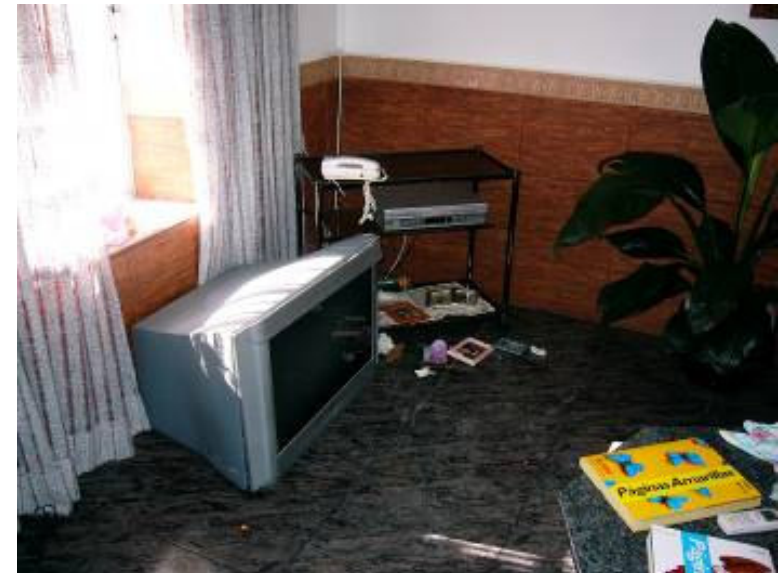
Fallen and damaged television set in a home in La Peca

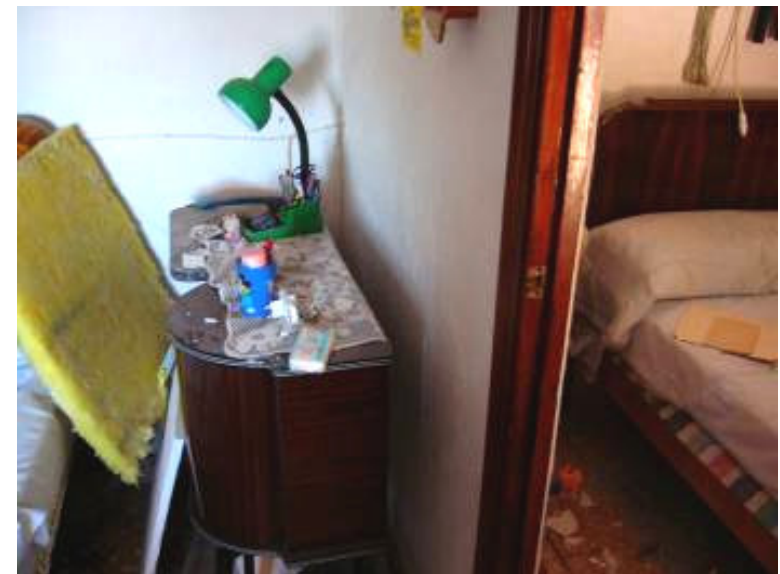
Light furniture was shifted >10cms in this home in Zarcilla

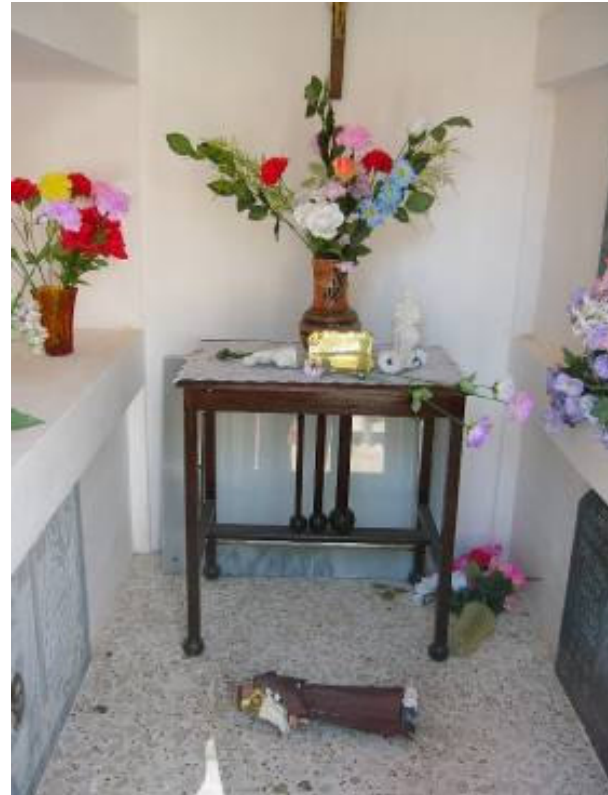
Vases and statues thrown down from an altar

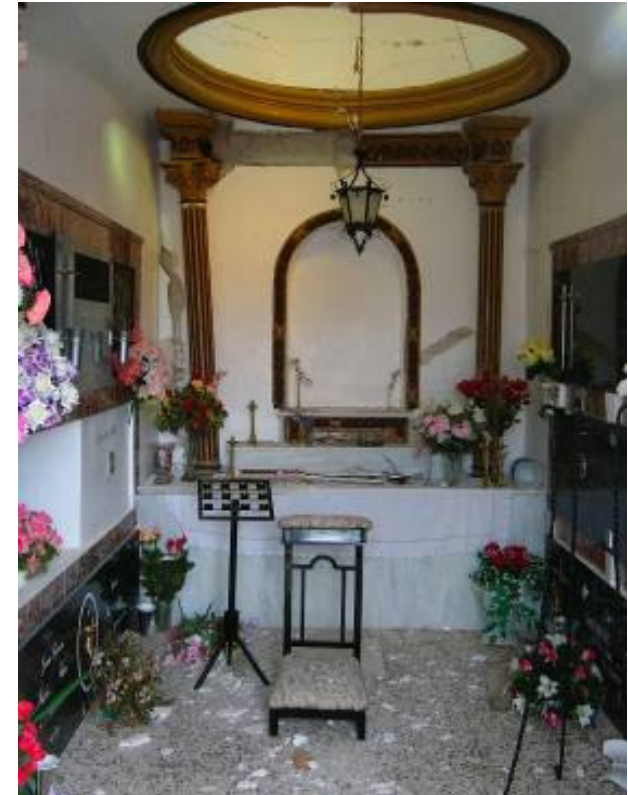
Damage to a crypt building

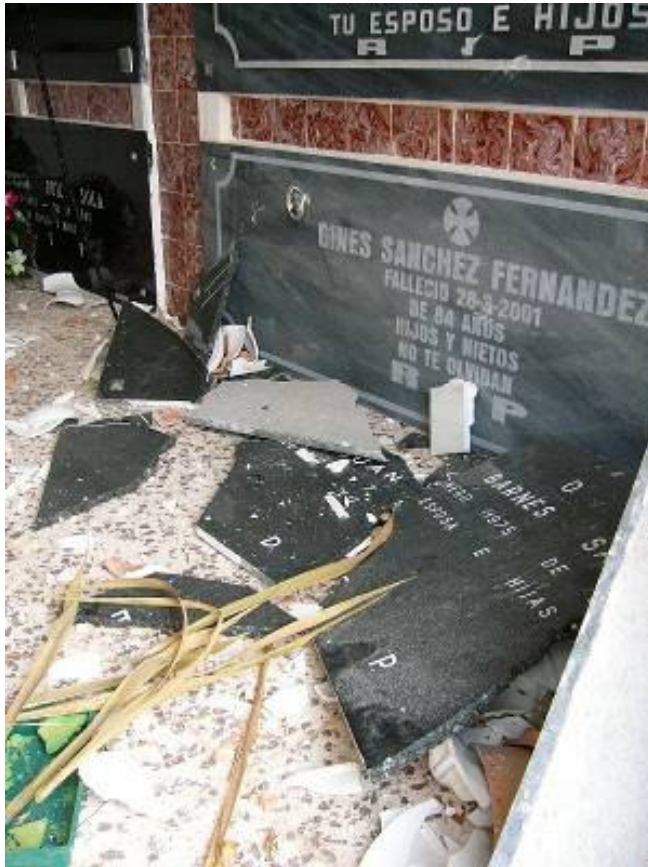
Damage to gravestones in Zarcilla

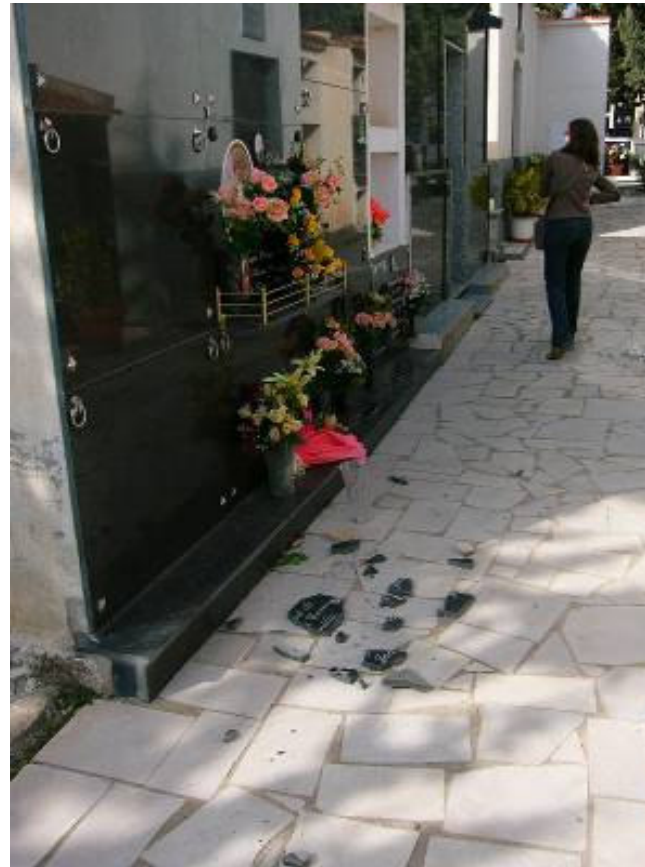
Damage to gravestones in Zarcilla

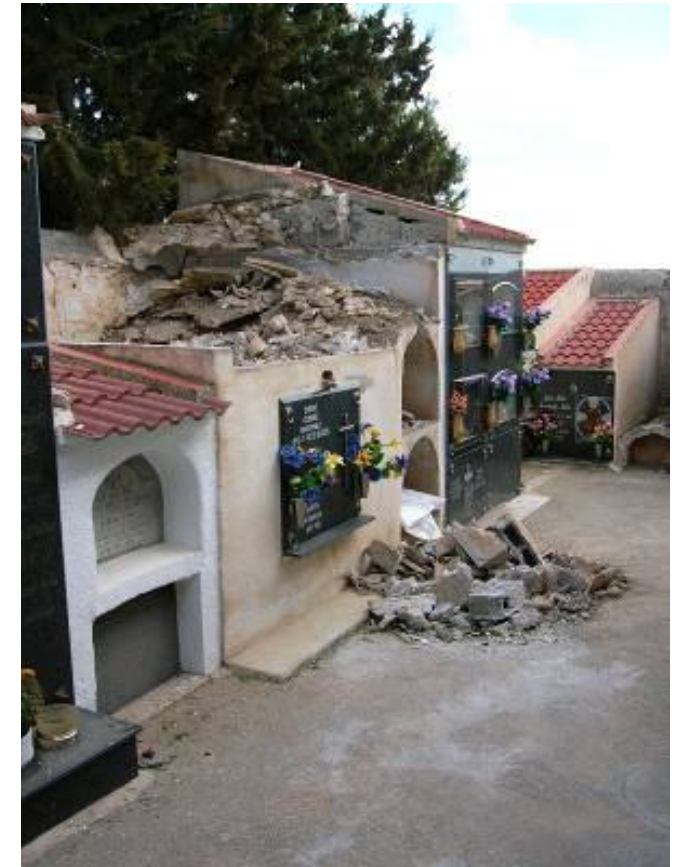
Damage to niche structures in Zarcilla

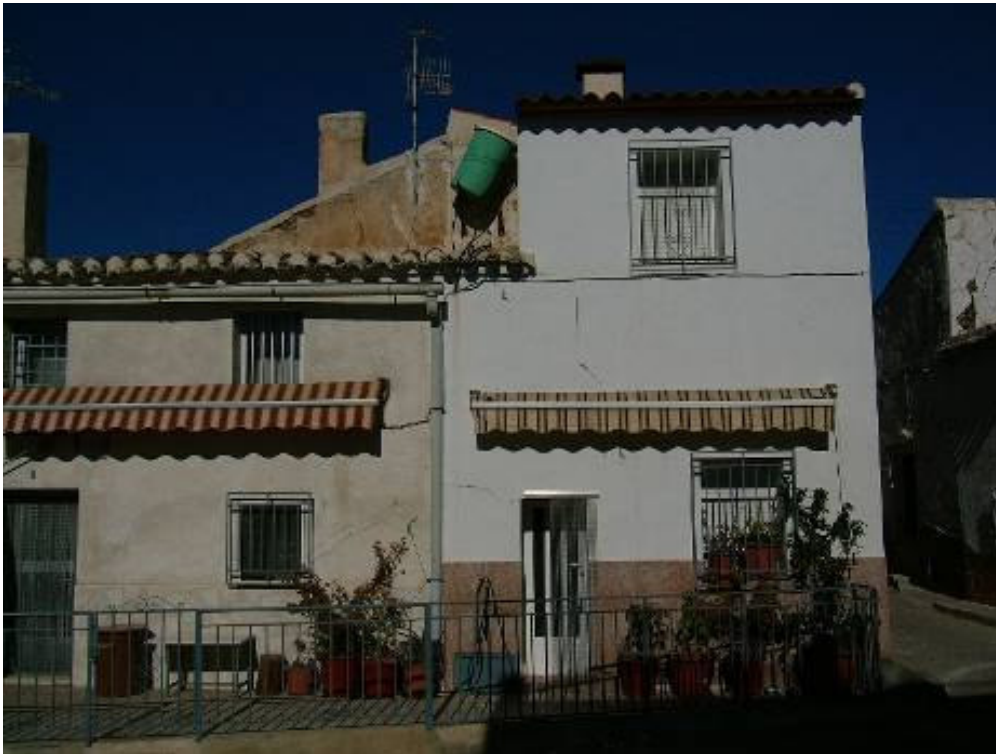
Toppling of a water tank in Zarçilla. Note shear damage to wall suggesting grade 2

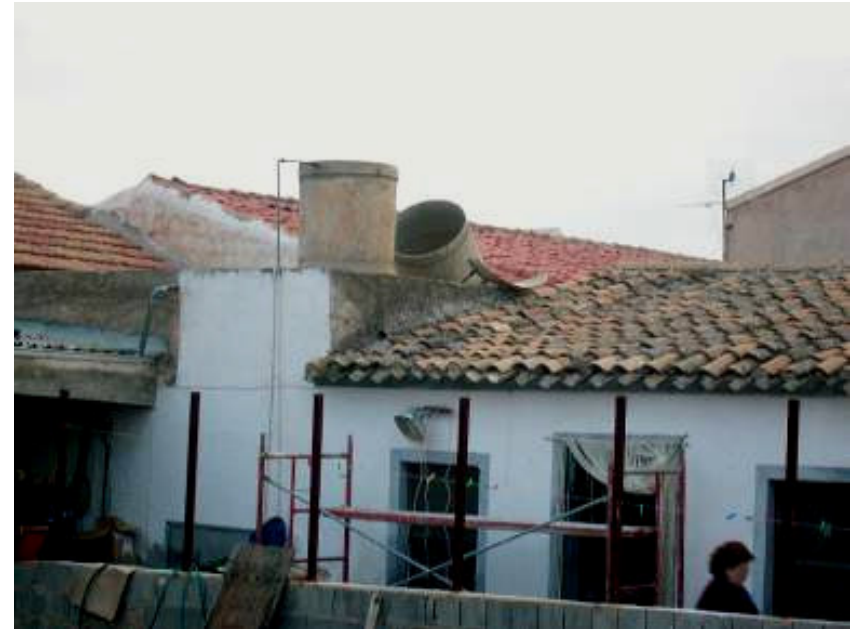
Overturning of a water tank in Zarçilla.

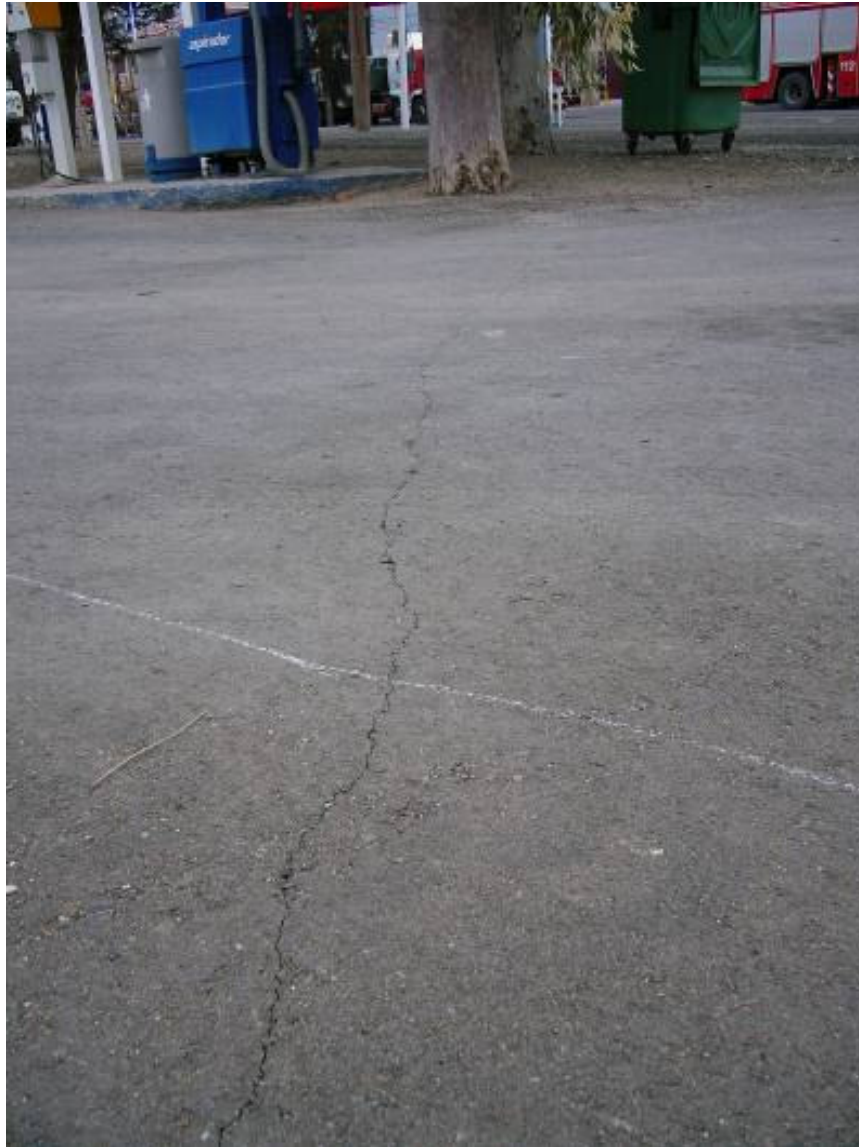
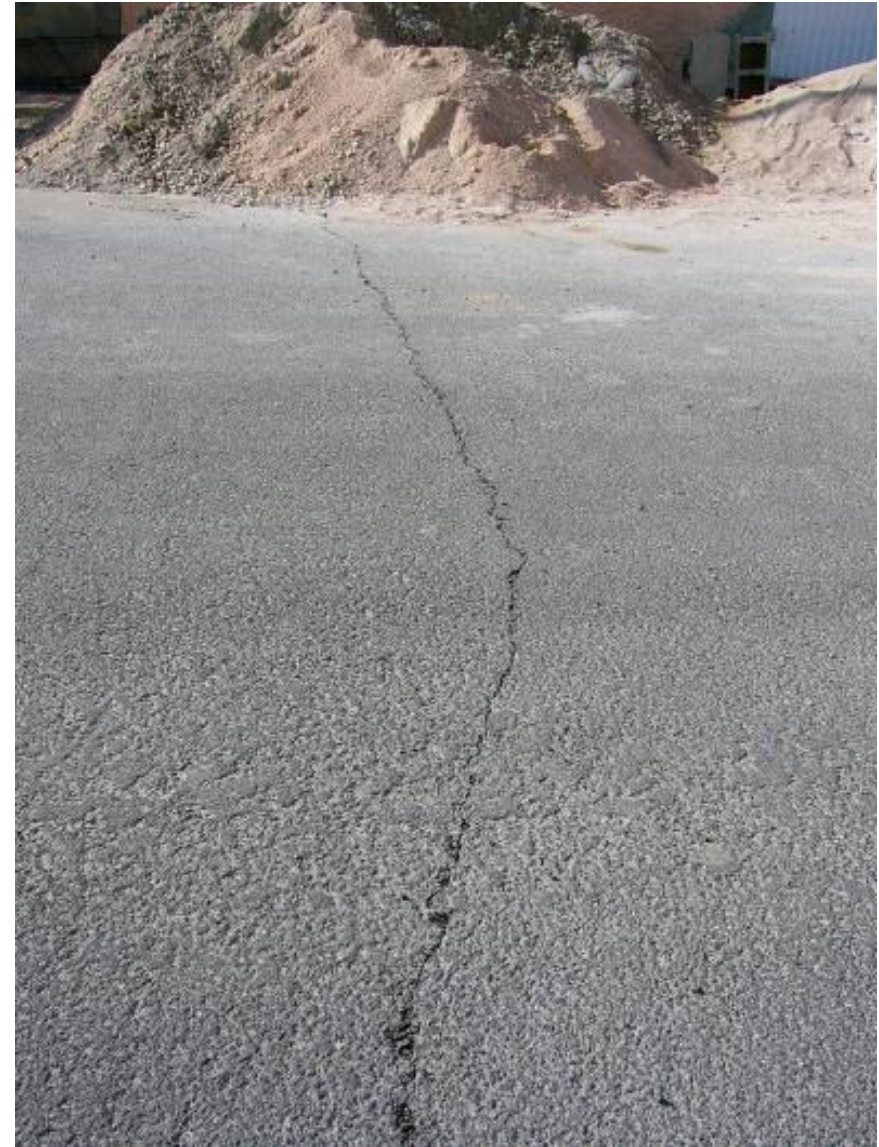
Fine cracking <5mm as observed on asphalt road surfaces at various locations

Cracking in streets of La Paca (left) and Zarcilla (right)

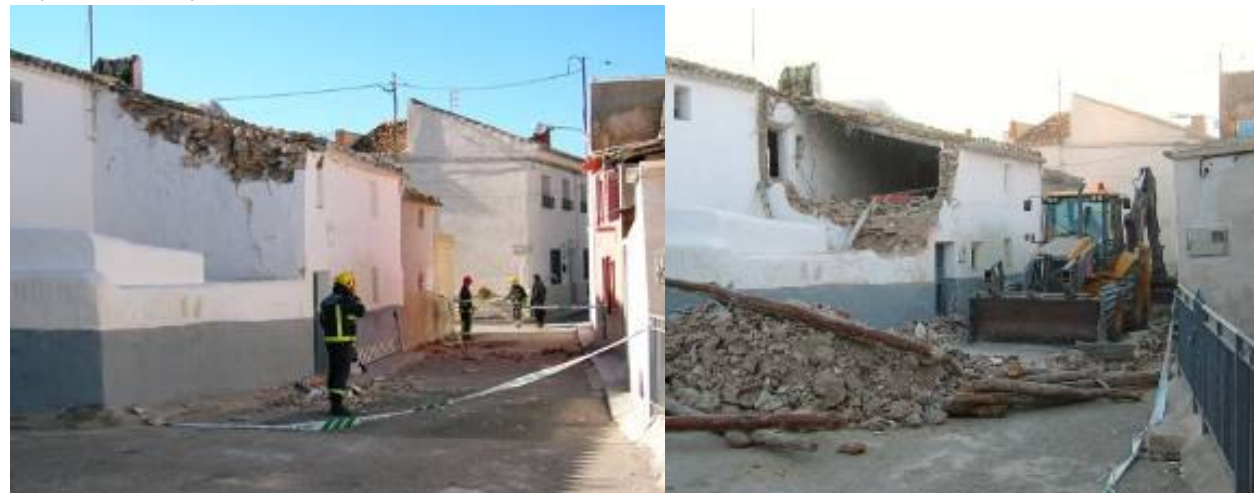
Damaged by the earthquake (left) but finished off by *Protección Civil* (right) a day after the earthquake, shows the importance of a quick site visit for accurate observations.

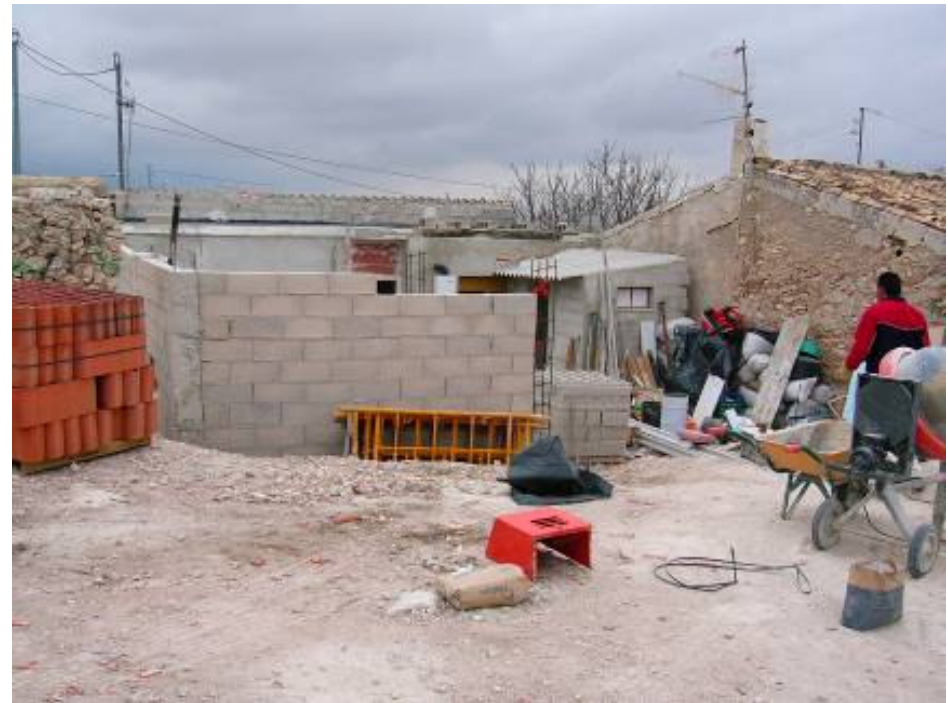
Hours after the earthquake a homeowner embarks in self-reconstruction using sub standard materials and poor technical knowledge. There is probably no planning permission for this hazardous job which will be surely damaged in the future.
