FIELD REPORT FOR THE JANUARY 29TH 2005 EARTHQUAKES IN LORCA, SPAIN

1 Executive summary

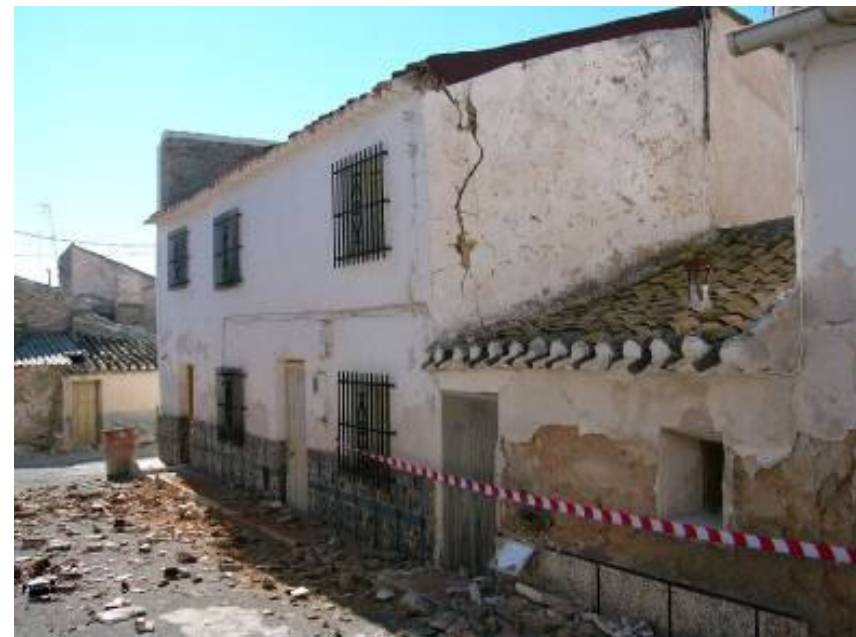
Drift of load bearing masonry façade. Zarcilla (Grade 2 vulnerability A)

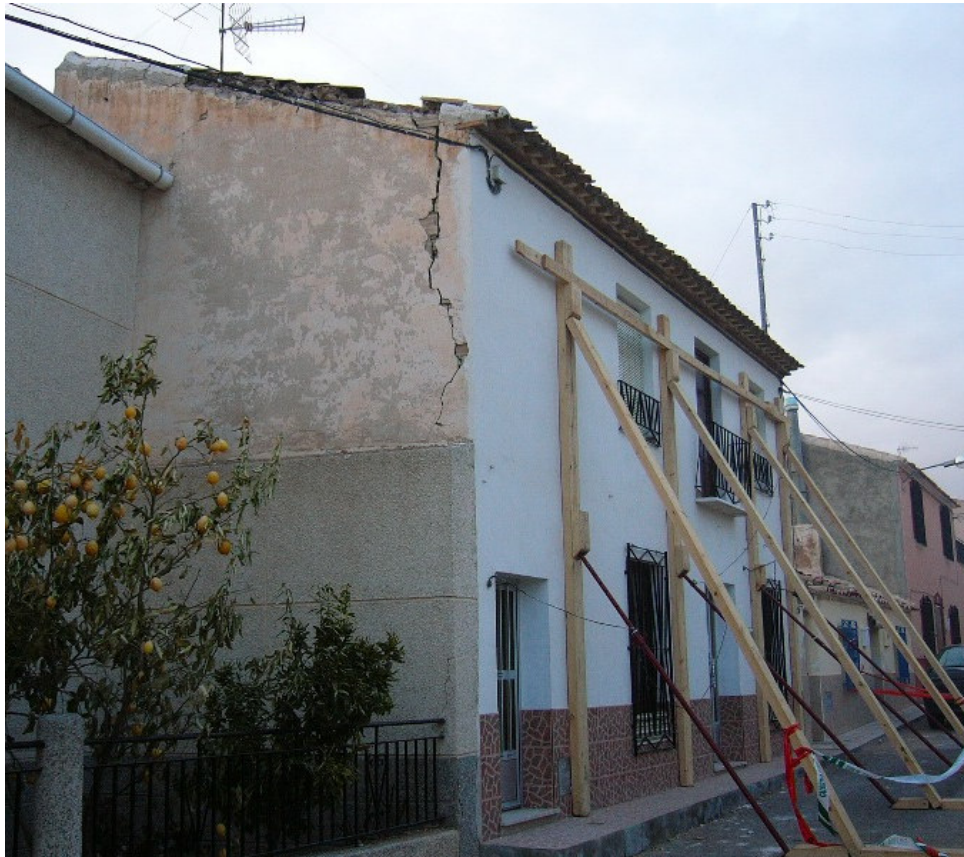
Drift of load bearing masonry in Zarcilla. (Grade 2 vulnerability B)

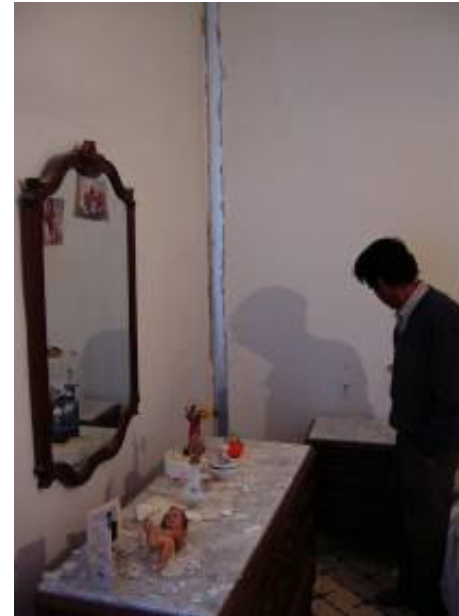
Drift of bearing walls also affects internal partitioning as in this building in Zarcilla. (Grade 2 vulnerability B)

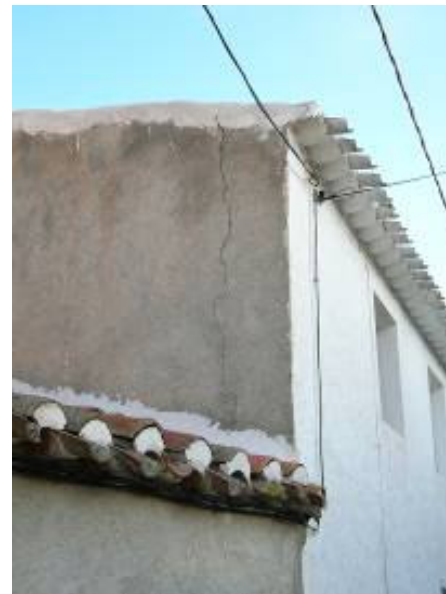
Very slight drift of load bearing masonry in masonry construction. Doña Inés (Grade 1 vulnerability A)

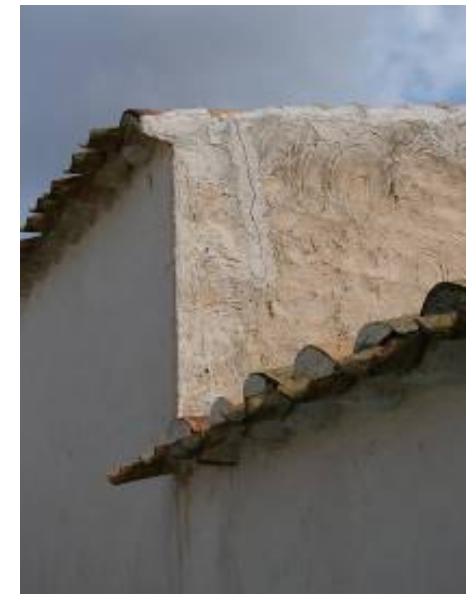
Slight drift of load bearing masonry in fieldstone construction. El Rincón. Note patched damage of the 2002 earthquake (Grade 1 vulnerability A)

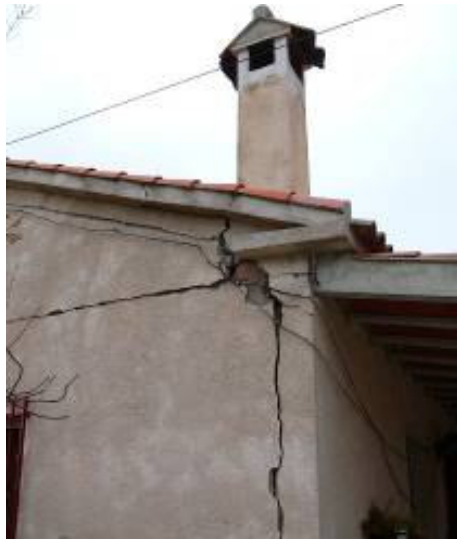
Heavy Drift of many elements in blockwork construction. La Paca (Grade 3 vulnerability B)

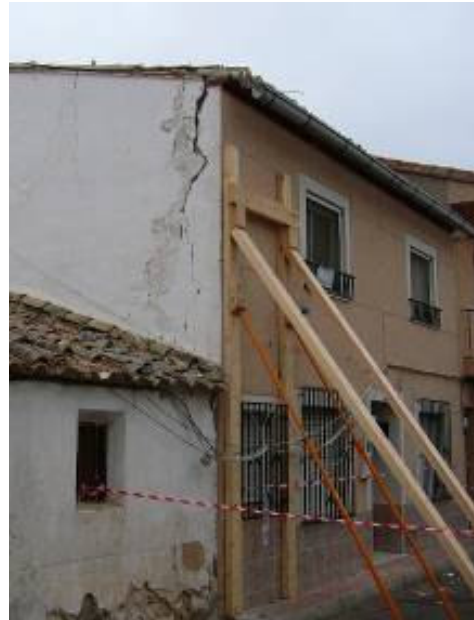
Drift of load bearing masonry in composite construction. La Paca. Note repairs from the 2002 earthquake (Grade 2vulnerability B)

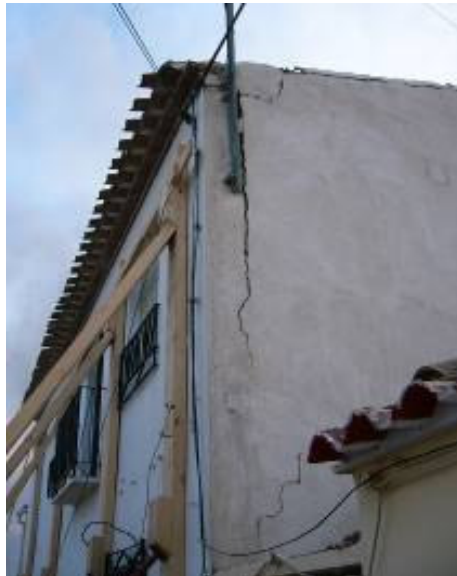
Drift of walls in blockwork construction. Zarcilla (Grade 2 vulnerability B)

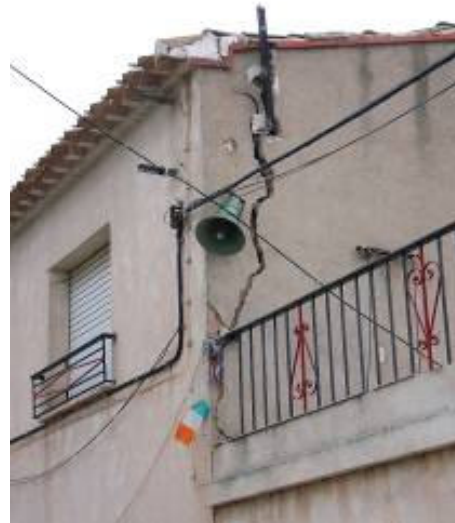
Heavy Drift of walls in blockwork construction. La paca (Grade 3vulnerability B)

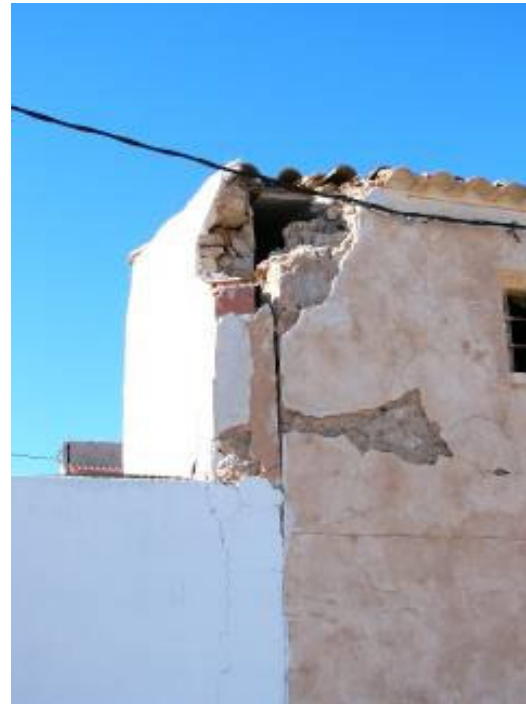
Corner failure in masonry construction in Zarçilla. (Grade 3 vulnerability B)

Detail of building at left

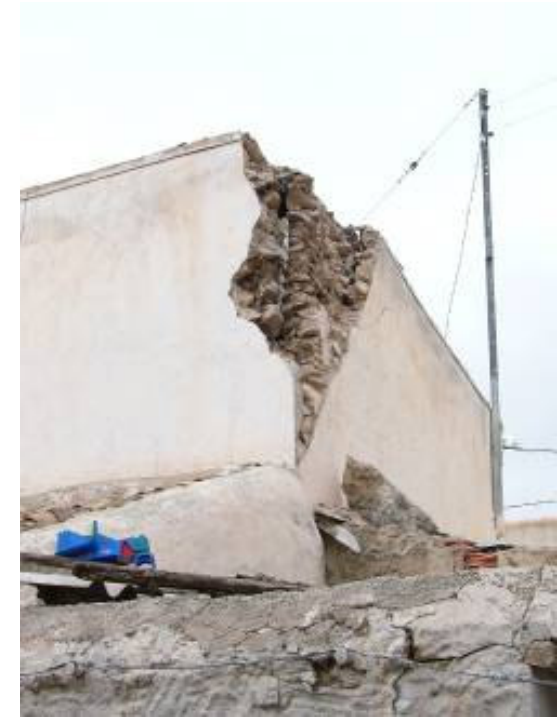
Corner failure. La Paca. (Grade 3 vulnerability A)

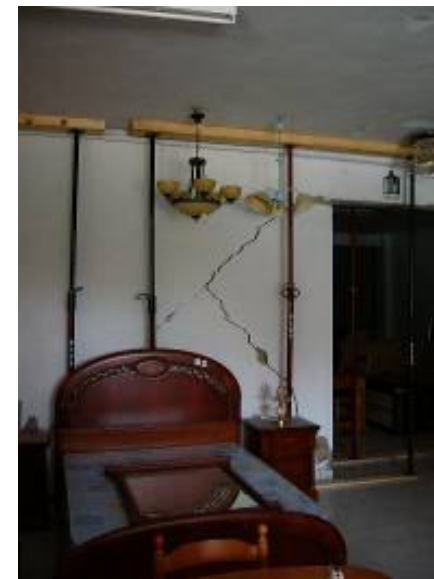
(left) shear damage in a building in Zarilla (Grade 2 vulnerability B)

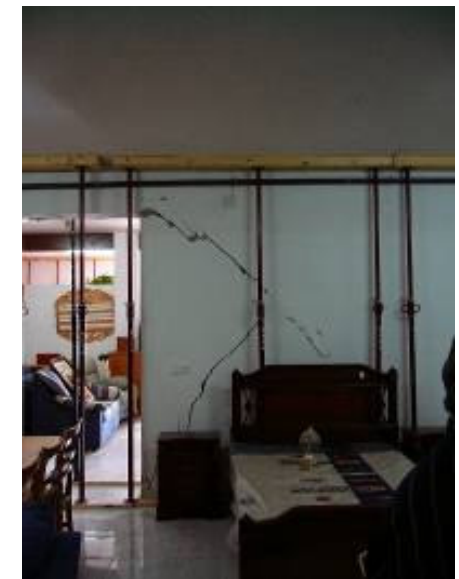
(right) The larger the window openings, the smaller the piers for shear resistance in unreinforced masonry construction, as in this furniture shop in Zarilla. Inside shear walls are also similarly damaged. (Grade 3 vulnerability B)

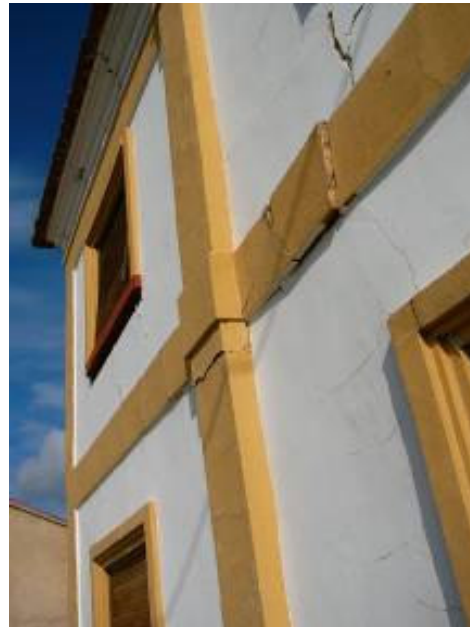
This house in Zarcilla suffered extensive shear damage in all walls and especially in vulnerable places like window lintels and corners. There is pounding damage to the column connection at the first floor level and heavy damage to internal partitions. (Grade 3 vulnerability B)

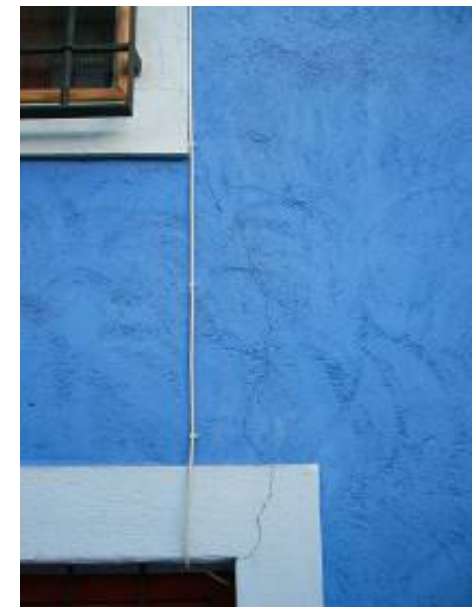
The town of Doña Inés, located over a limestone outcrop was only slightly damaged as compared with Zarcilla and La Paca located over quaternary fill, despite a smaller epicentral distance. This type of slight shear damage to walls was typical of damage in this location and assigned an intensity of 5 (Grade 1 vulnerability A)

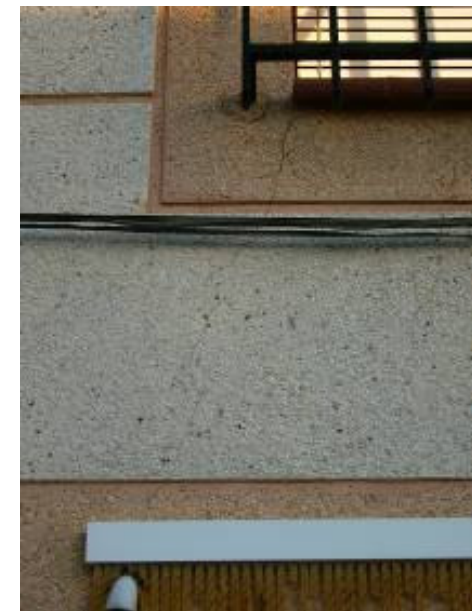
Another slightly damaged home in Doña Inés (Grade 1 vulnerability B)

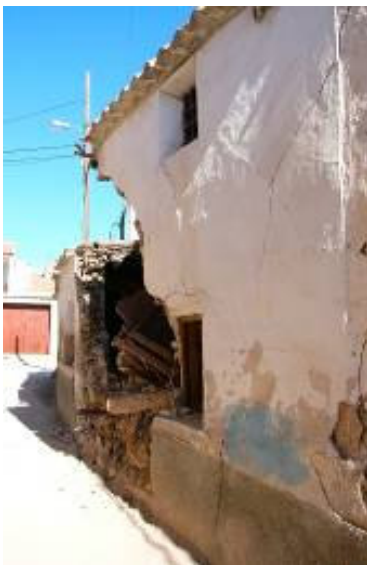
The direction of the roof joists in this house in Zarcilla to the right indicate the failed wall was an unsupported gable wall. Heavy damage has resulted to the roof and other walls from this failure. (Grade 4 vulnerability A)

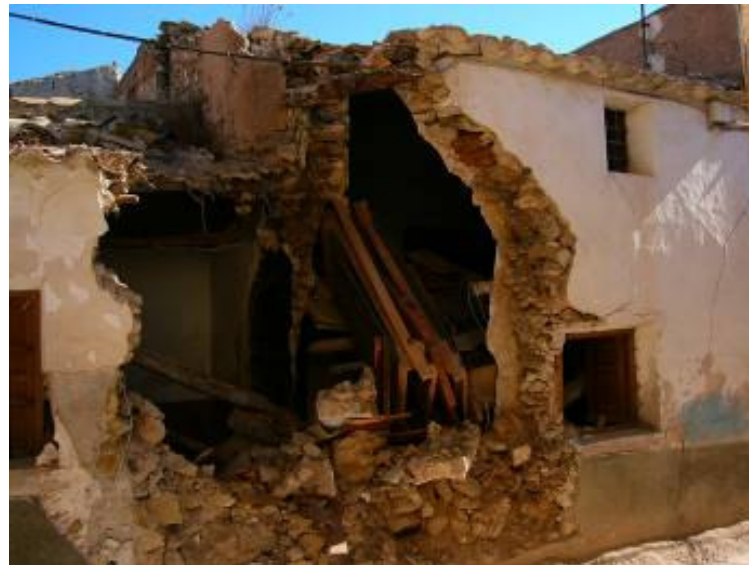
This heavily damaged wall in a vulnerable home in La Paca fell out after losing connection with an internal perpendicular wall that has also been damaged. (Grade 4 vulnerability A)

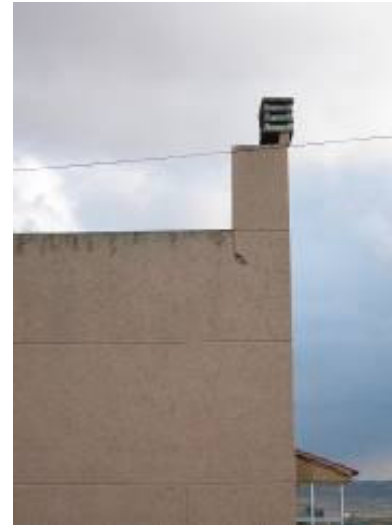
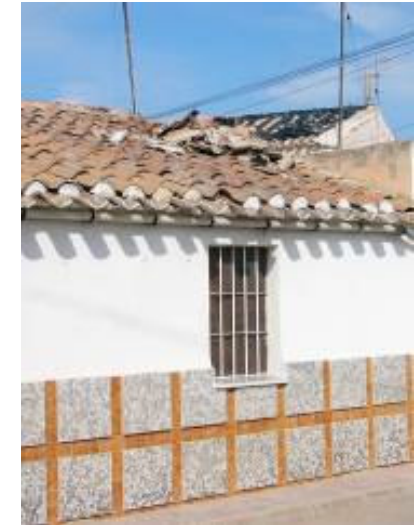
Unreinforced chimneys are fragile elements easily damaged by mild shaking.

A missed opportunity. Hours after the earthquake a new unreinforced chimney is built while the remains of the former one litter the road, assuring a similar outcome during the next earthquake.

Damaged chimneys; old and new

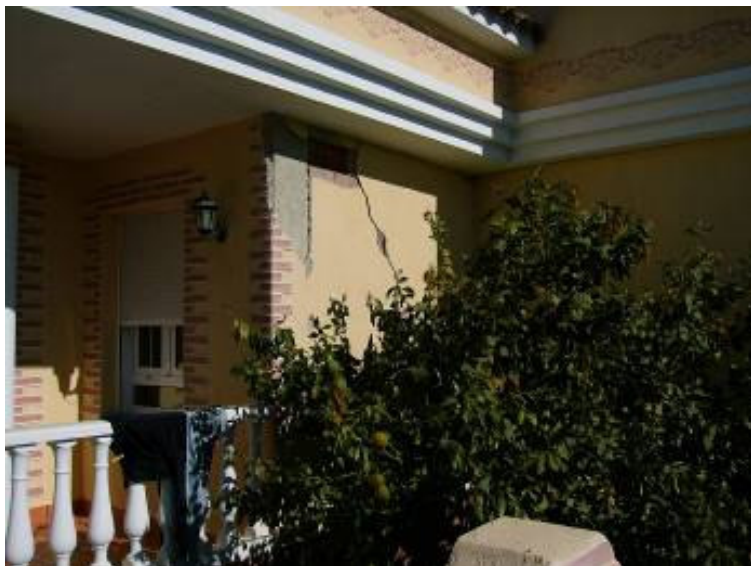
Moderate damage to infill walls in this recently completed home in La Paca (grade 2 vulnerability C)

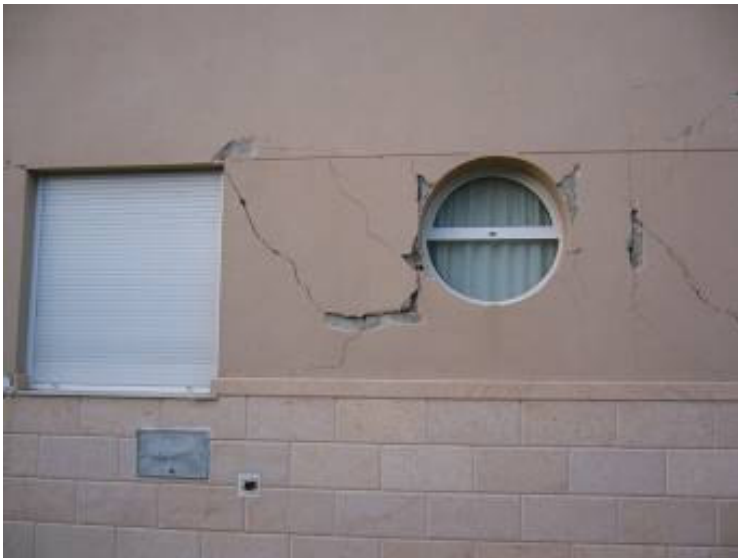
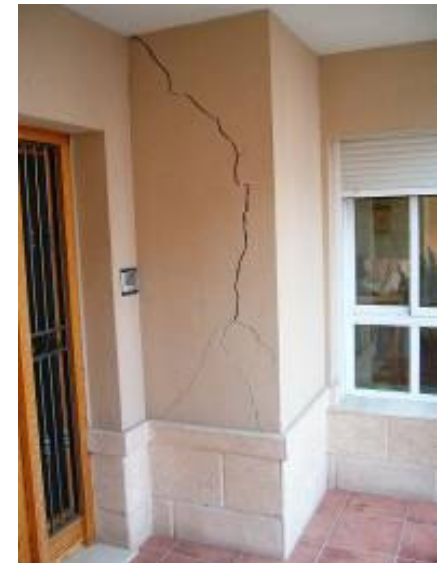
Moderate damage to infill walls in this recently completed home in Zarcilla. Note the continued damage done by aftershocks and inspection in the photograph on the right taken a few days later. (grade 3 vulnerability C)

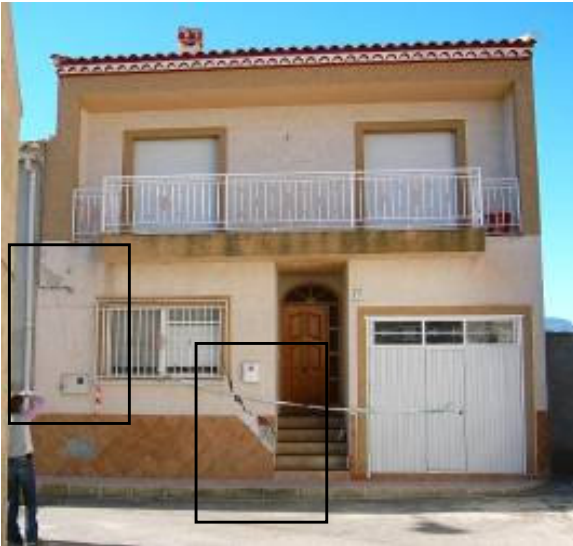
Moderate damage to infill walls in this home in Zarçilla. There appears to be slight damage to the column slab connection in the left hand photograph. (grade 3 vulnerability C)

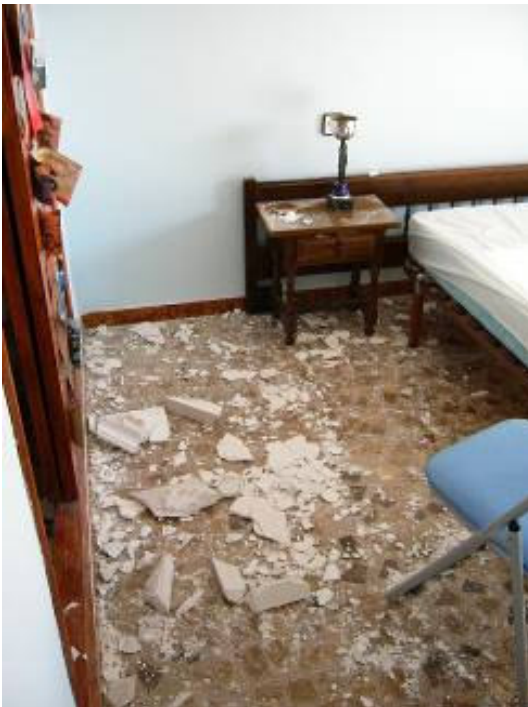
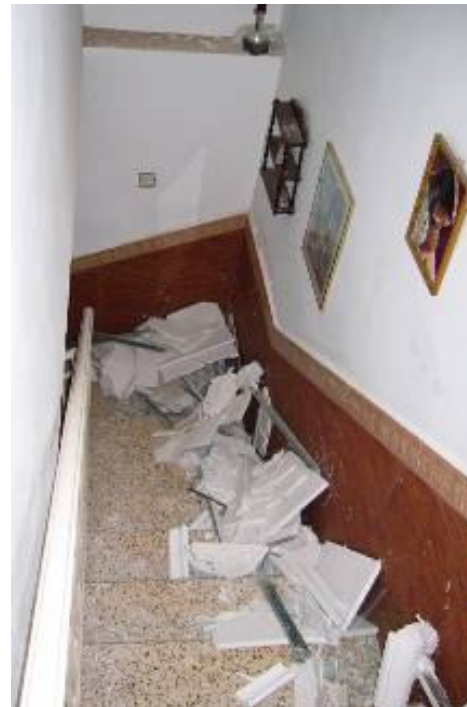
Two main ceiling types in the area; suspended plaster or fibre ceilings and plastered surfaces laid directly onto ceiling slabs. With the exception of mechanised suspended systems in engineered buildings like the school at La Paca, brittle plaster ceilings were extensively damaged during the earthquake often falling over corridors, stairs and other vital escape routes. In mechanised systems damage was limited to fall of lighting baffles or lighting units, still posing a hazard.

Damaged ceilings of different types in various buildings in La Paca and Zarcilla

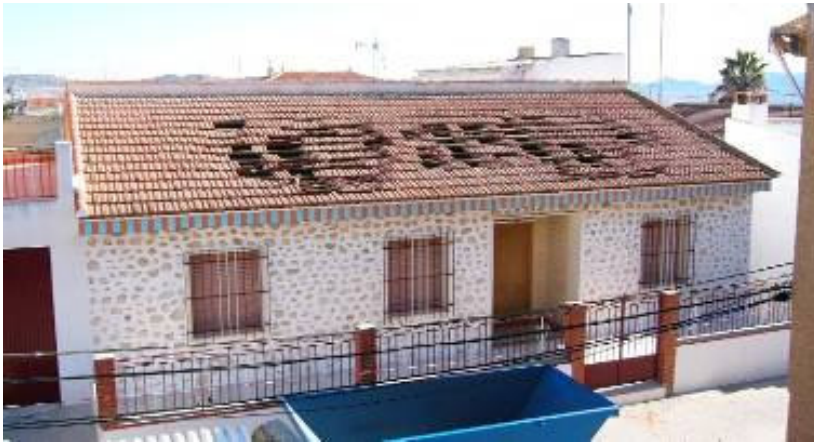
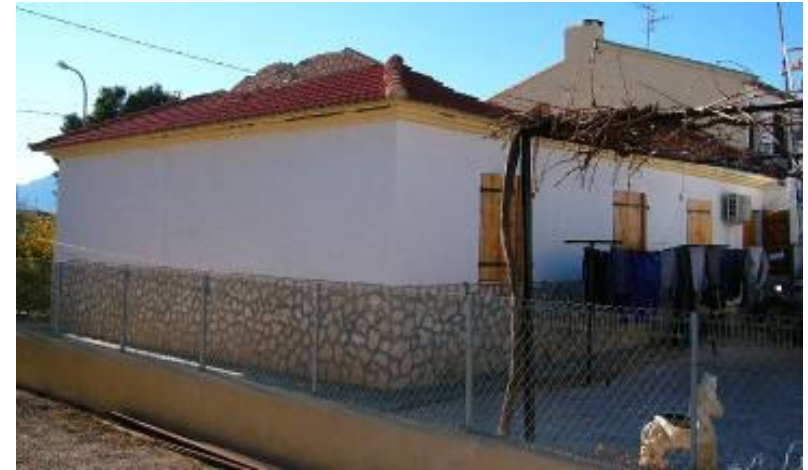
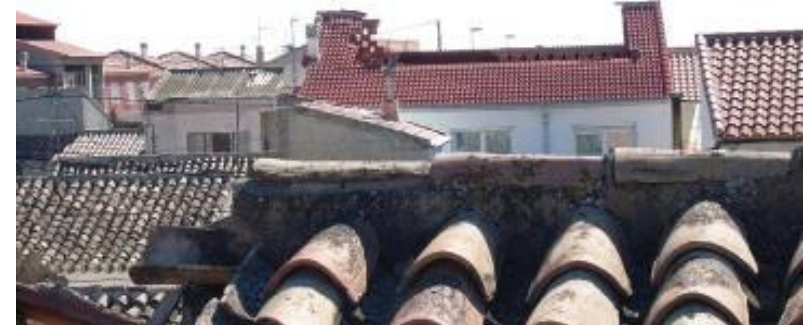
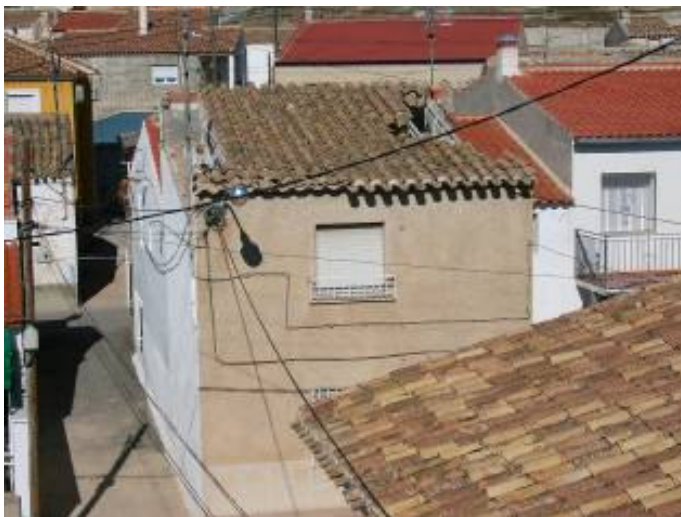
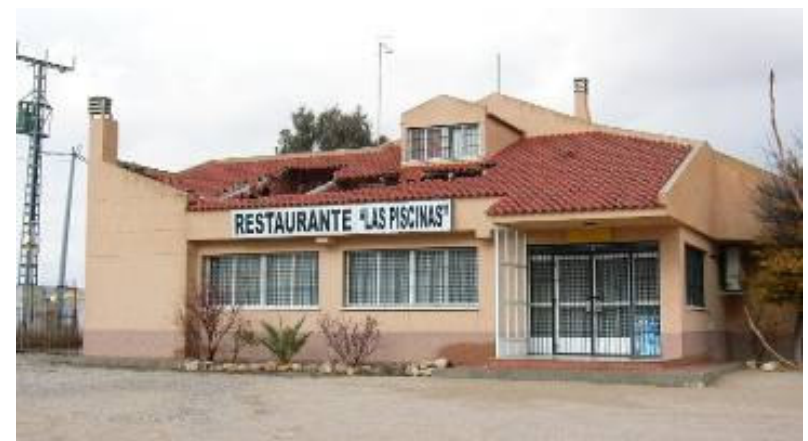
Loose tiles that are not fixed down are easily dislodged at intensities above >6 EMS. A commonly observed damage was that caused by roofs laid over brick spacer walls as in the two lower right photographs; an established practice for roof formation in Spain.

Damaged Roofs in various buildings in La Paca and Zarcilla

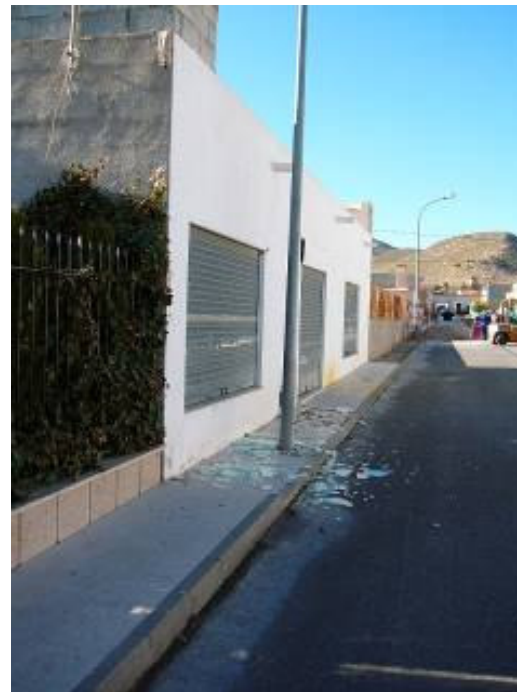
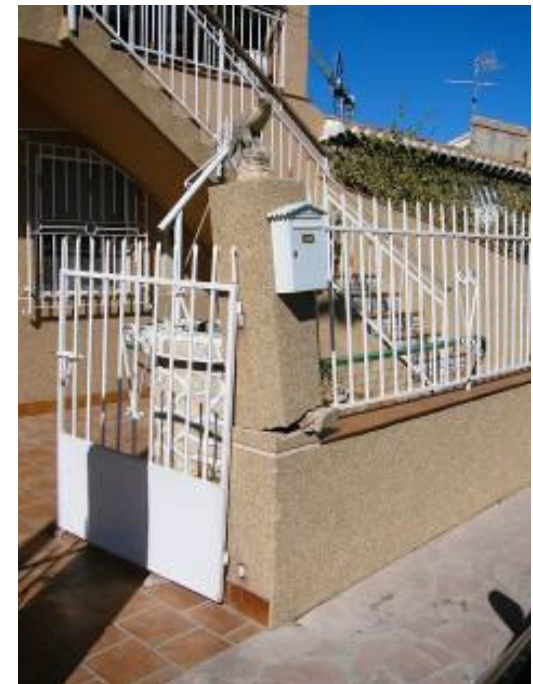
Different types of damage to decorative elements, balustrades and facing material in Zarcilla corresponding to damage of grade 2 across different vulnerability types.

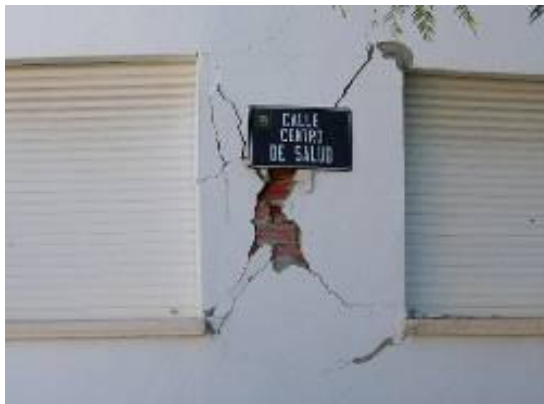
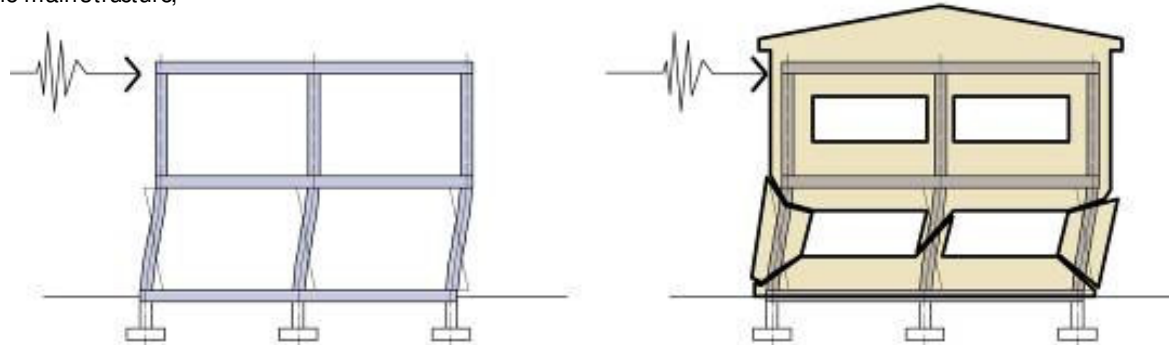
This civic centre in La Paca has suffered moderate non-structural damage to partition masonry infill panels. A general survey of the building reveals no horizontal bracing system available other than the slender column connections to the heavy floor slabs. The lack of stiffness of the structure has resulted in large displacements of the ground floor which have been transmitted to the brick infill panels and partitioning walls, shearing them to pieces. Note the soft storey effect, with damage confined to the ground floor where horizontal loads are greatest on account of the heavier mass above and denser partitioning in the upper floor. This building was desperately in need of some stiffness and a concrete lift shaft might have given the structure the necessary shear strength to avoid loading the partition walls, but it was a fragile brick shaft and even that was badly sheared. Despite heavy partition damage there is only minor structural damage with hairline cracking and spalling in column heads signalling the beginning of plastic hinge formation. Despite low structural damage, public confidence in this civic building is shattered and thus a candidate for replacement or major overhauling.

Diagnosis No primary seismic resistant strategy evidenced; lack of structural stiffness, brittle and fragile infill walls, soft storey effect.
(Damage grade 3 vulnerability C)

X cracks are unequivocal evidence that these curtain walls have been subject to shear by lack of stiffness of the mainstructure,

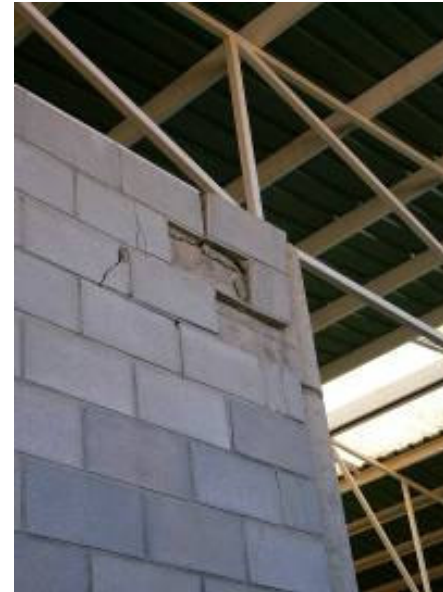
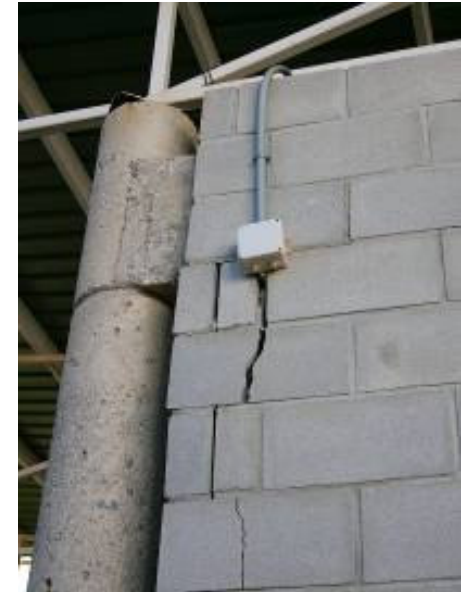
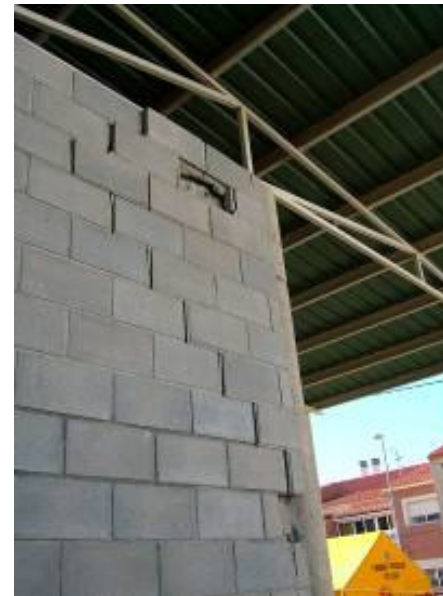
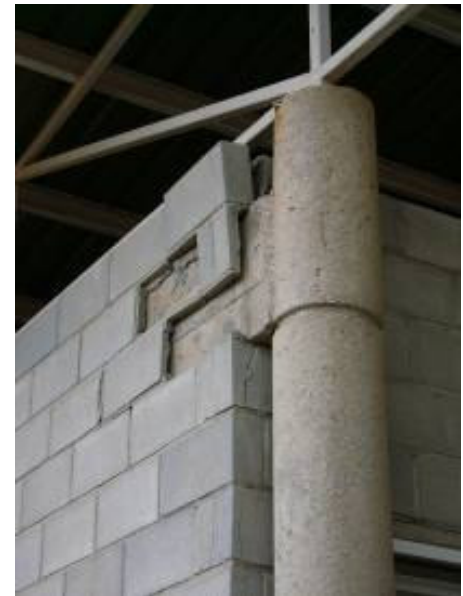
This health centre in La Paca has a very lightweight steel truss roof over a RC column grid with internal and external walls of concrete blocks. This very unrestrained and unconfined structure with many stand-alone columns shook itself free from the brittle concrete blocks built against and around its structural members. This is a poorly conceived building from the point of view of architectural detailing. All wall contacts with structural members have been damaged. Many partition walls inside show signs of shear damage. Some of the steel roof trusses appear to have shifted from their anchor plates on the column heads. There appears to be no structural damage but there is moderate non-structural damage to most walls including ceilings and indoor fittings. This is unacceptable damage for a medical centre.

Diagnosis Lack of structural stiffness, brittle and fragile infill walls, Inadequate architectural detailing. (damage grade 2 vulnerability C)

This is the wrong type of walling material for the wrong type of structure and detailed in the wrong way.

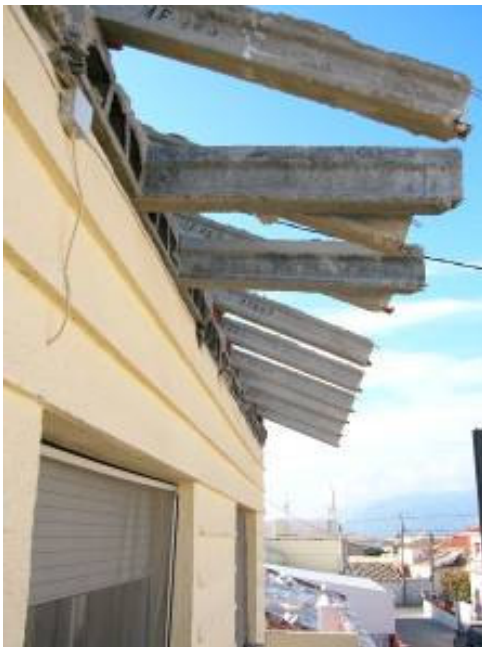
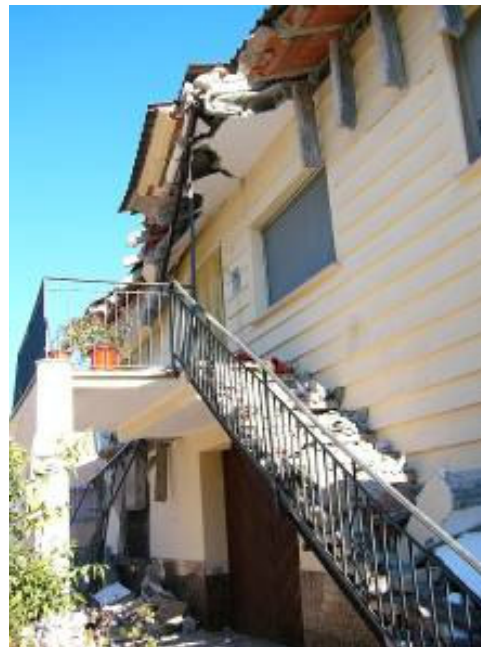
Sadly for the affected family, this appallingly conceived house is a non-engineered mish-mash of structural solutions with very poor structural and architectural detailing. Ambitiously cantilevered balconies and roof eaves were executed with no ring beams at the ends of prefabricated RC joists, allowing members to vibrate and wobble freely like individual keys of a piano. Roof joists rested as point loads on the edge of this non code-compliant cantilever which snapped off destroying the first floor cantilever in its way down. This extraordinarily hazardous building type illustrates the risk generated by unskilled construction practices in rural Spain.

Diagnosis Poor structural concept and unskilled architectural detailing. (damage of grade 4 vulnerability B)

External views of the building showing heavy damage to individual roof and balcony elements.

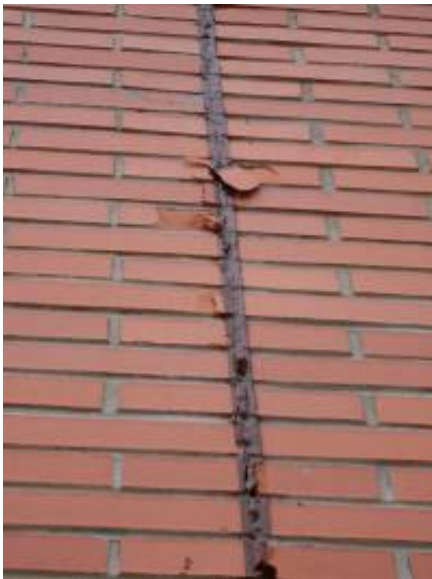
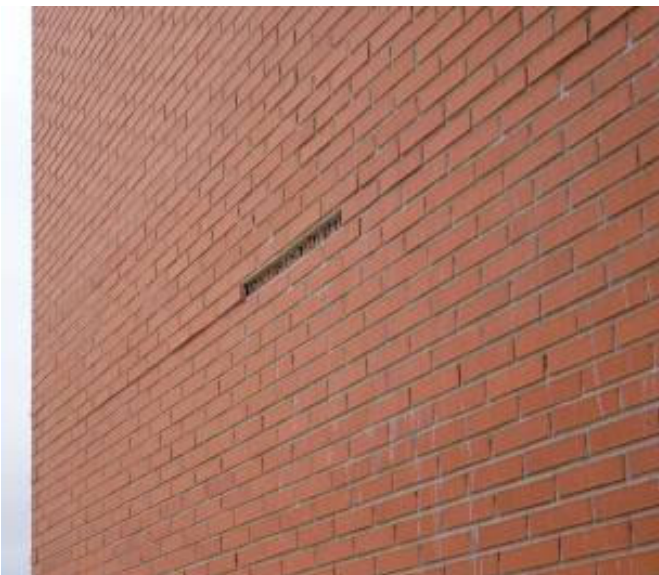
This fine building suffered only very minor damage to non-structural elements like spalling of brickwork at expansion joints and the fall of suspended ceiling panels and light fixtures.

Diagnosis Good engineered building with fine architectural detailing. Non-structural damage grade 1 vulnerability D

Slight pounding damage between two sides of an expansion joint and slab contact with the brick face. Cosmetic damage to a well built building.

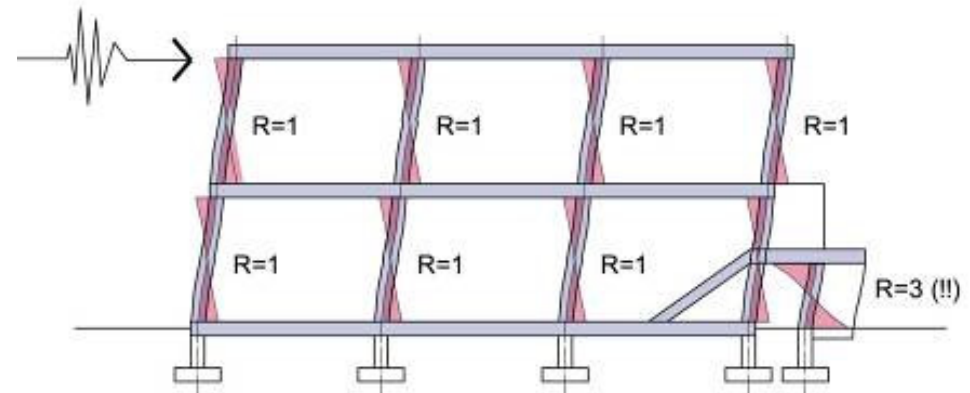
A 'short column' effect was observed in this RC frame house under construction. Structural elements become loaded for horizontal forces according to their stiffness, and this very stiff stair column (because its short) received a large horizontal force from the rest of the structure because the stair slab was connected to the main structure. An expansion joint between the slab and main building column would have avoided damage.

Diagnosis *Damage to an individual structural element because of an inadequate structural concept. Damage grade 3 vulnerability D*

Members attract horizontal loading according to their stiffness. Because the stair slab was connected to the main structure, the small stiff stair column received horizontal loading from the whole structure.

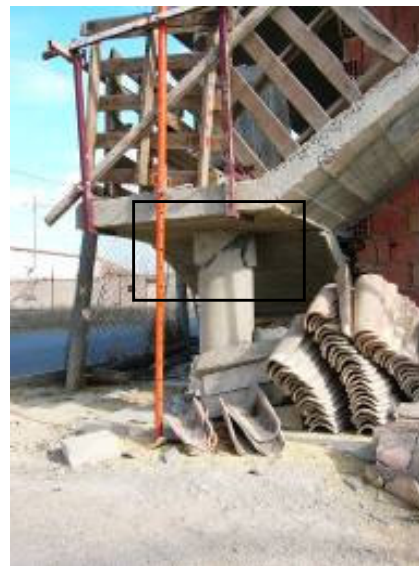
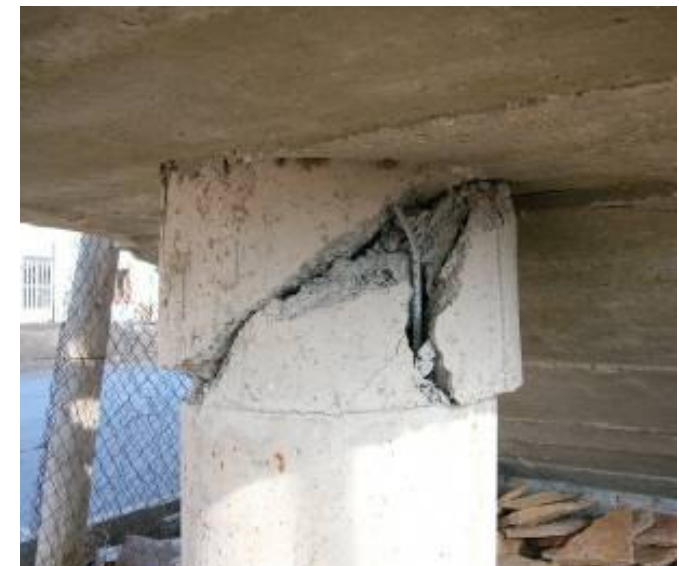
Short column location under a stair slab that is connected to the main structure; poor rebar splicing detailing is also visible, probably contributing to the column failure in this location.

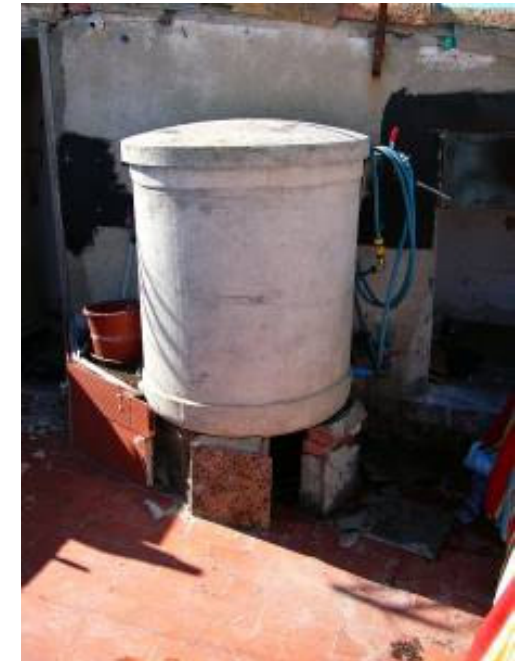
This water tank in La Peca was shifted, bending the plumbing connection and damaging the pedestal

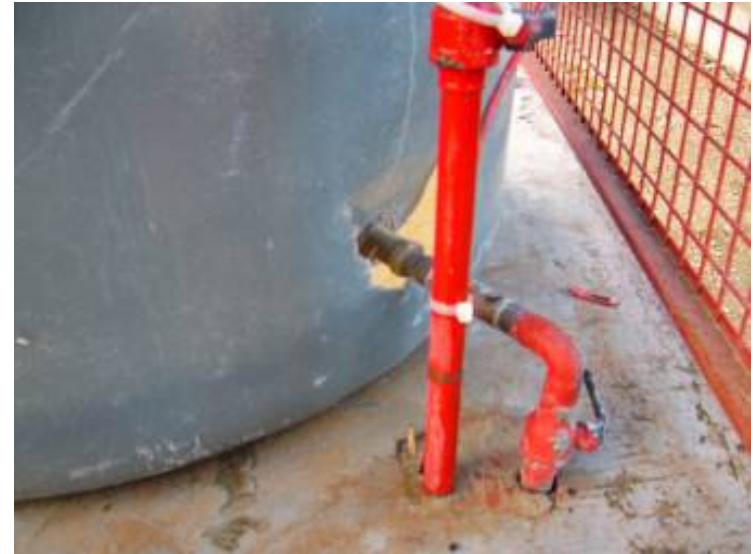
In this building a 1.2m diameter X 1.6m high fibre-glass water tank (about 1500L) set upon a 1m high RC pedestal on ground was shifted >10cms and punctured by the plumbing connection which was bent backwards. The tank was also ripped open by what appears to be stress caused by sloshing water.

The side was burst open, resembling the 'elephant foot' damage observed in larger steel silos by sloshing water in major earthquakes

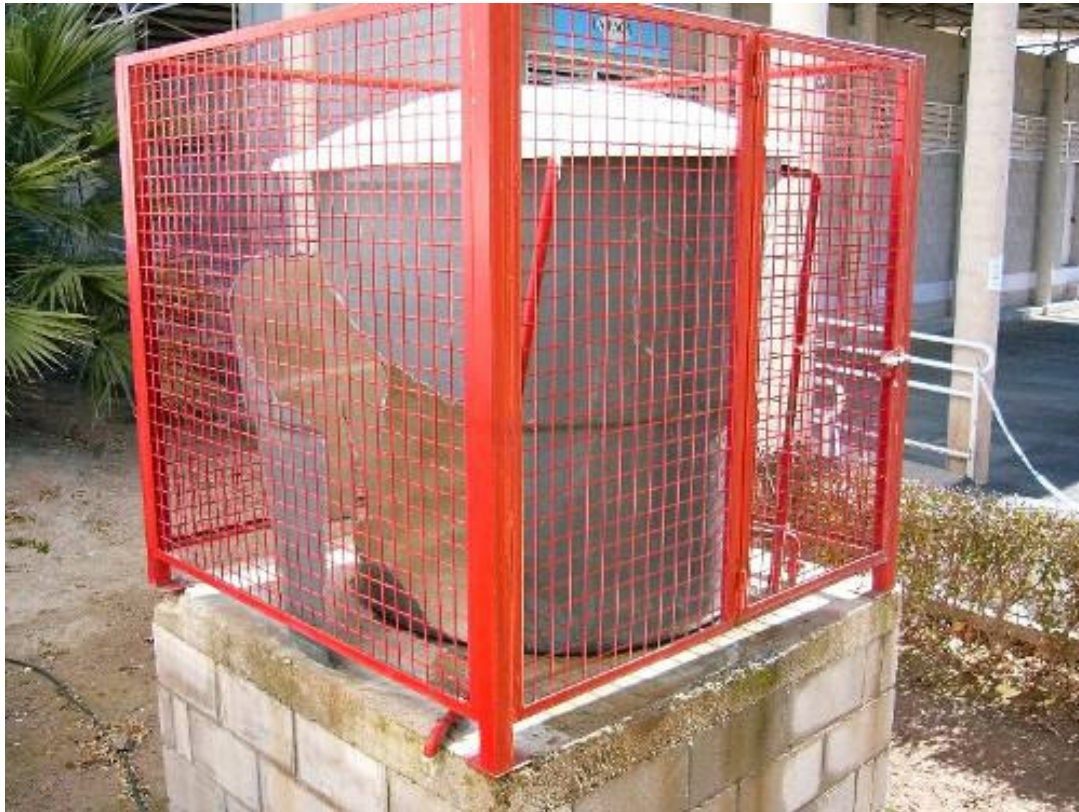
Bent and punctured connection, suggesting the tank was violently displaced in this direction.

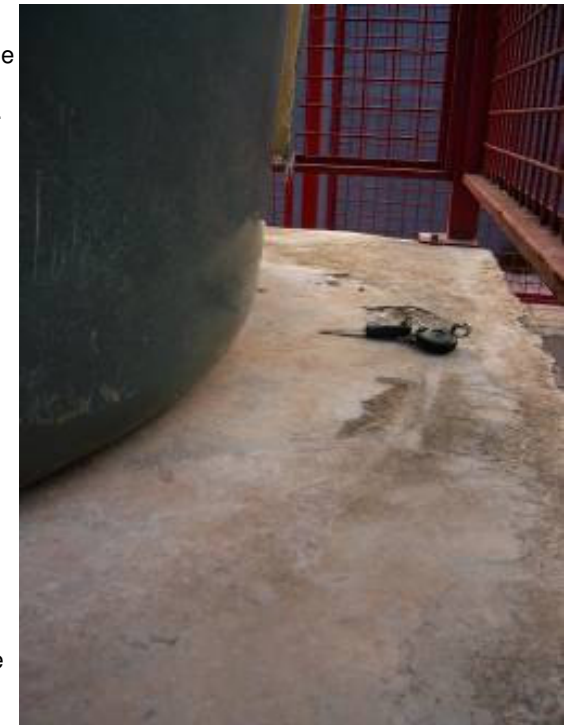
Marks on the concrete pedestal leave a tell-tale story of the tank's displacement

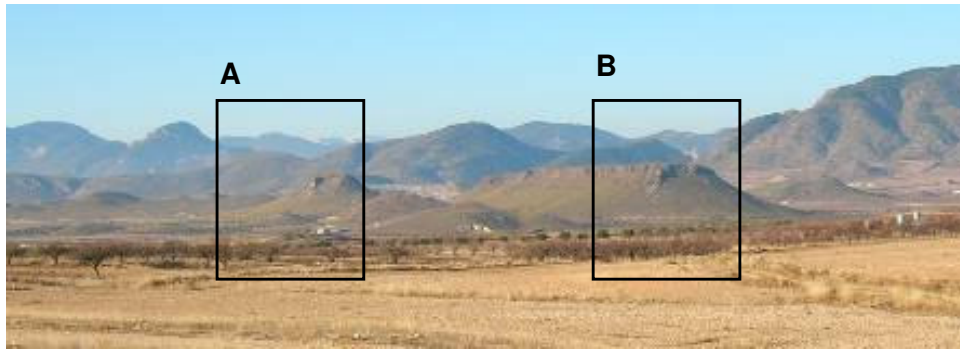
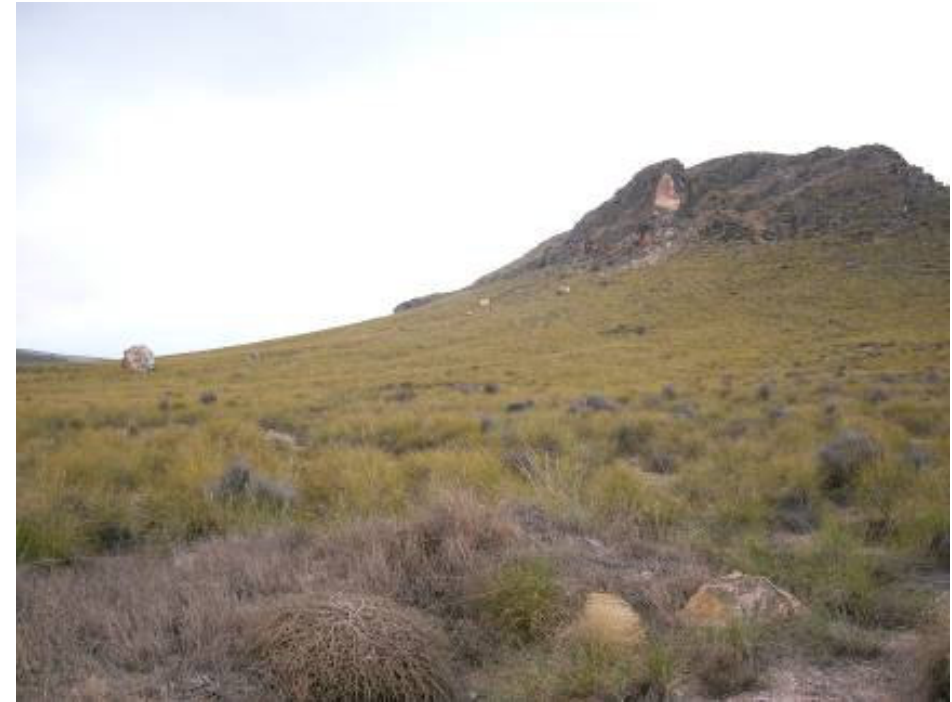
Two rock fall sites were initiated by the August 2002 earthquake. Fresh rock falls from the current shocks are hard to distinguish from the earlier event but appear to be less voluminous as unstable faces were already shaken off in 2002. The well weathered limestone rock faces appear to have been in a state of precarious balance before the 2002 event suggesting high intensities >6 had not been recorded locally for some time.

2 Rock fall sites in the hills between La Paca and Zarcilla.

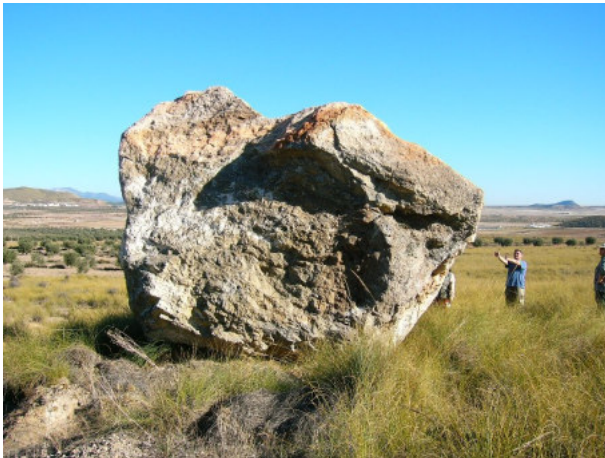
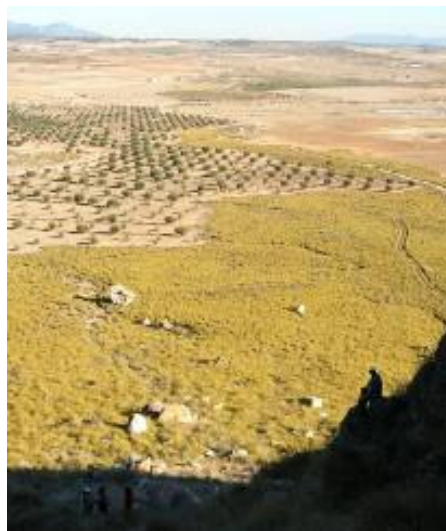
Rock fall site A from the 2002 earthquake. Main boulder is circa 25m³

25m³ boulder from rock fall site A

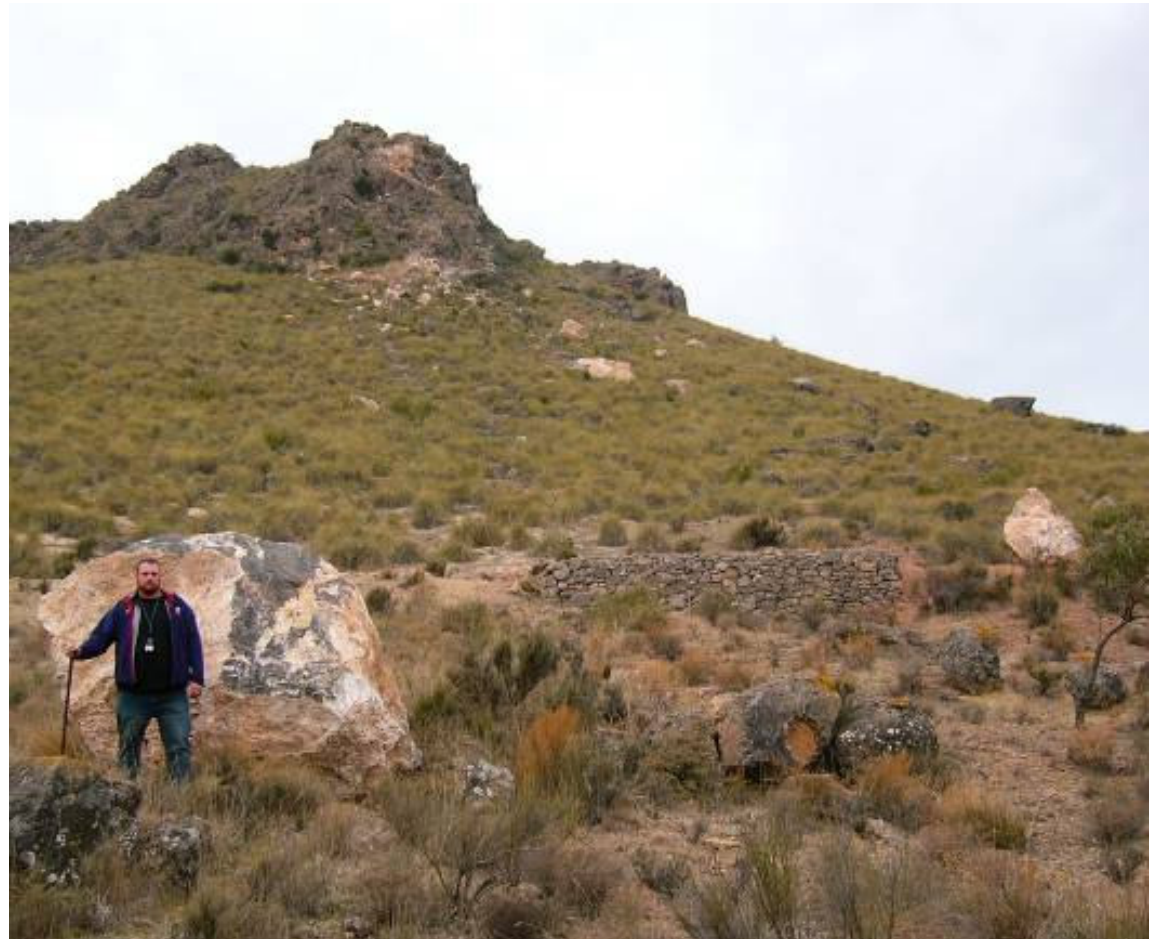
Rock fall on an old quarry face, Zarcilla
