**KANDİLLİ OBSERVATORY AND EARTHQUAKE  
RESEARCH INSTITUTE**

***May 19, 2011 KUTAHYA-SIMAV  
EARTHQUAKE***

**Prepared by; Dr. Can Zülfikar  
Res. Assist. Yaver Kamer  
Res. Assist. Eren Vuran**

**June, 2011  
ISTANBUL**

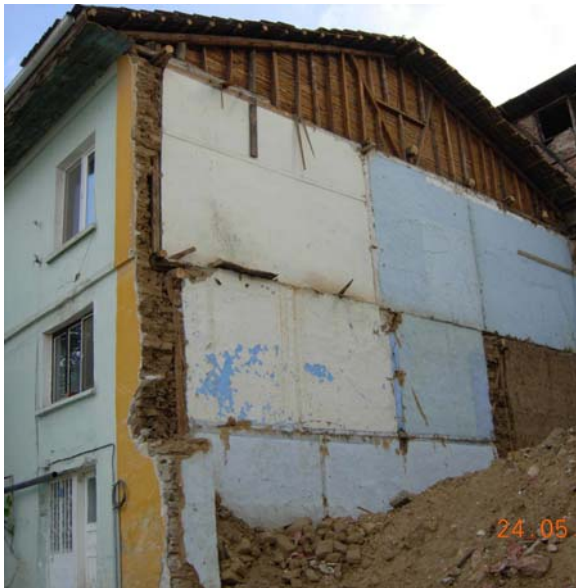
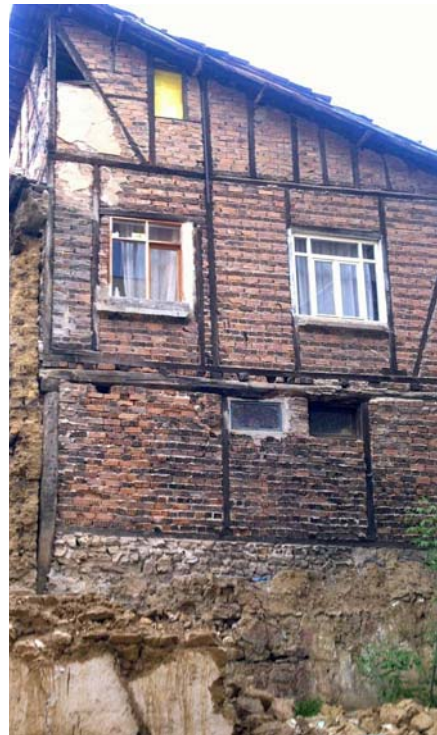
**Figure 38:** *2-3 storey brick masonry buildings, adjacent to collapsed adobe masonry building*

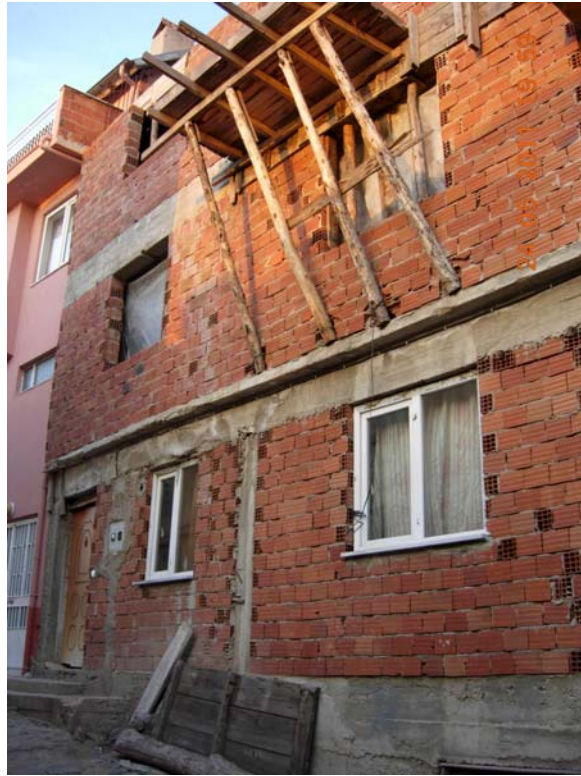
**Figure 45:** 3 storey building of which infill bricks are being used as a structural load bearing elements, combined with RC beams!!!

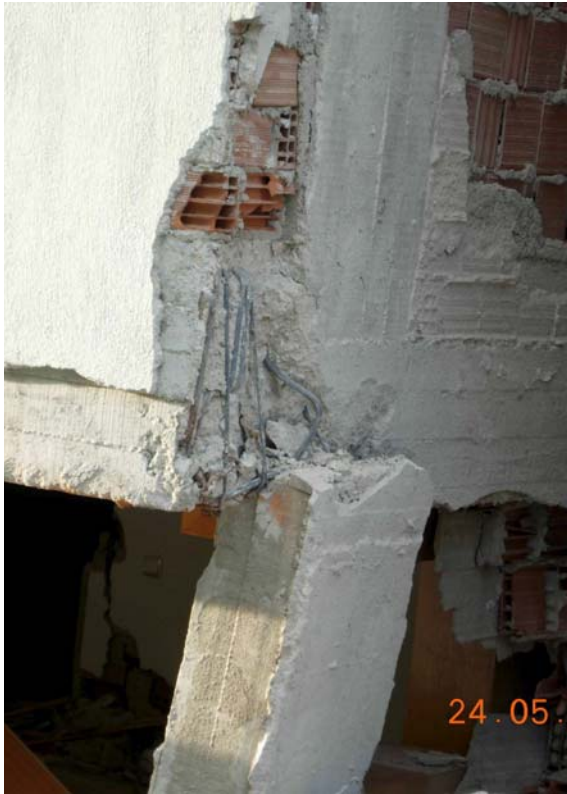
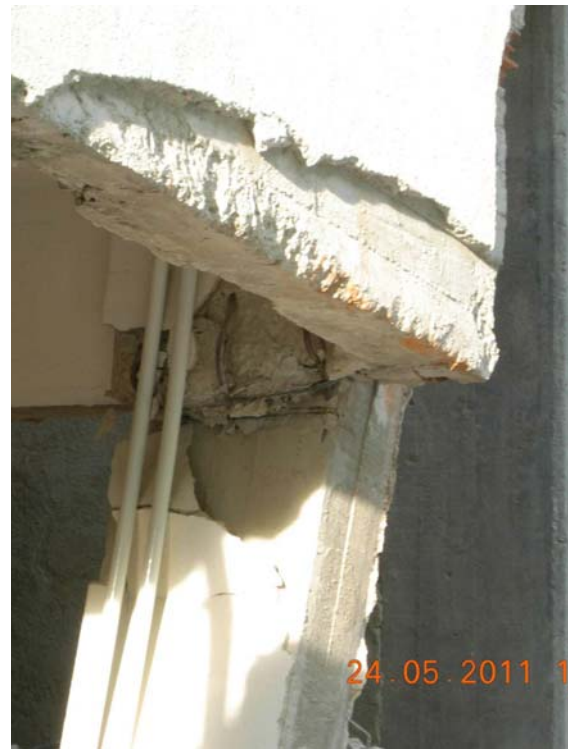
**Figure 48:** *South-east corner column of the collapsed building*

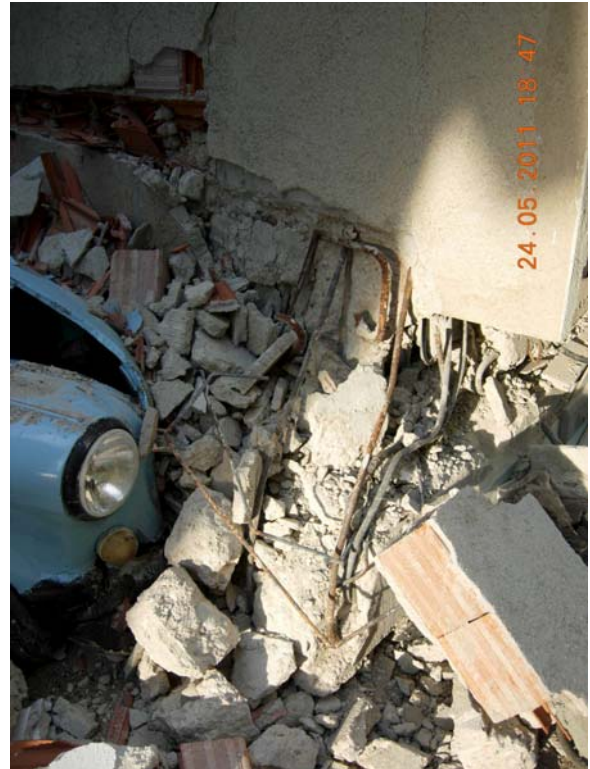
- In the collapsed building, there were beam-column joint failures of which the column was totally splitted up from the joint.
  - Transverse reinforcements in columns and beams, which are supposed to provide confinement effect on the section, were not designed with proper intervals, bar size and 135 degrees hooks.

**Figure 49:** *South-west corner column of the collapsed building*

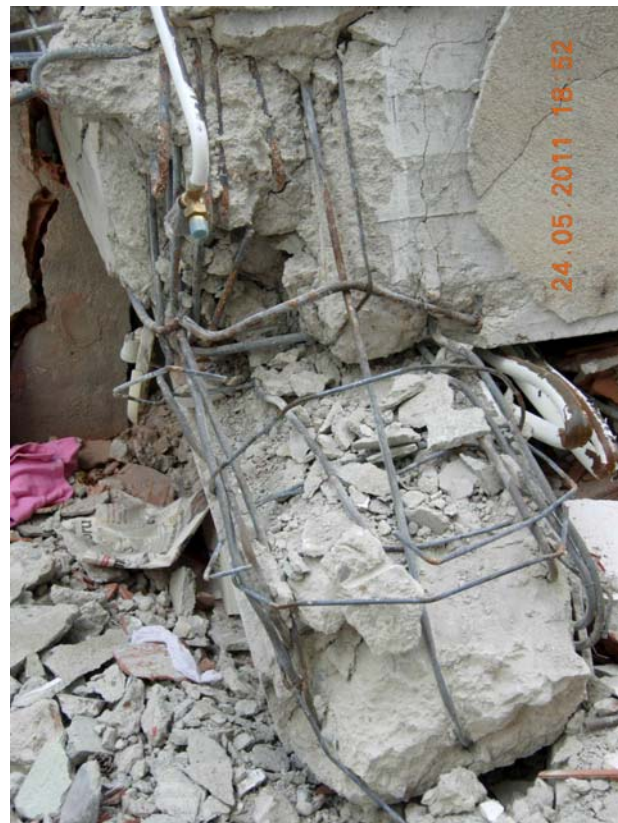
**Figure 51:** Beam-column joint detail of the north-west corner
